Lack of A/C Performance at Idle in High Ambient Temperature

YEAR(S)	MODEL(S)	ADDITIONAL INFORMATION
2016 - 2020	Tacoma

Introduction

Some 2016 – 2020 model year Tacoma vehicles may exhibit a condition where the air conditioning system shuts down and stops blowing cool air during periods of extended engine idle with ambient temperatures greater than 100°F. Follow the Repair Procedure in the bulletin to address this condition.

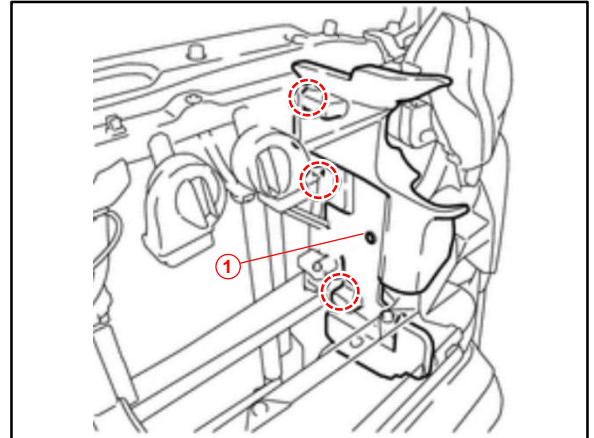
Figure 2.

4. Remove the left-hand radiator side deflector by removing the clip and disengaging the three claws.

1	Clip
⊙	Claw

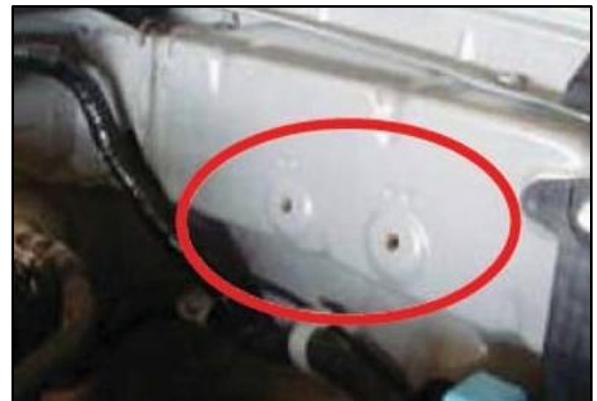
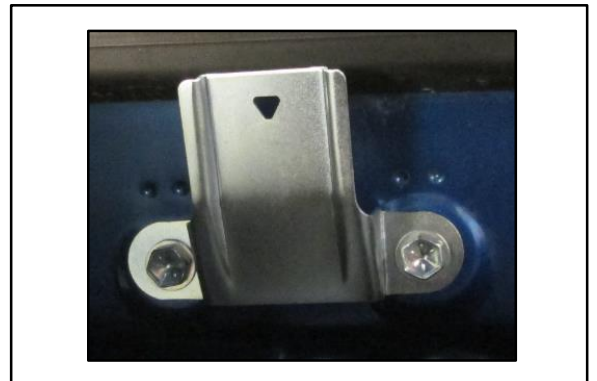
Figure 5.

7. Locate the bolt holes on the driver side inner fender. Attach the NEW bracket to the inner fender with the bolts provided in the kit.

Torque: 9.8 – 18.1 N*m
(100 – 185 kgf*cm, 7.5 – 13ft*lbf)

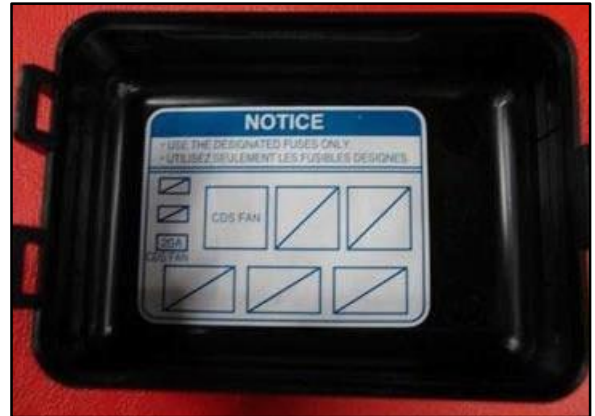
Figure 7.

8. Install the NEW notice label on the inside of the NEW relay block relay cover.

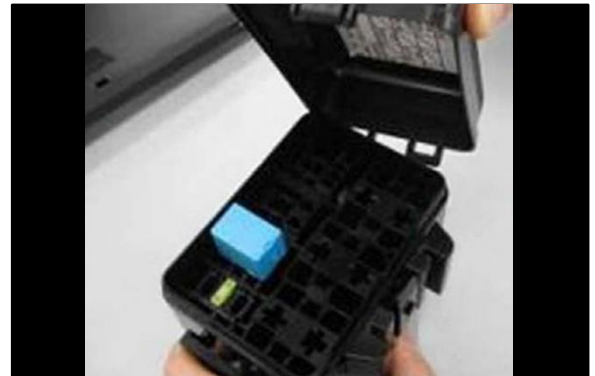
Figure 8.

9. Install the NEW relay into the “CDS FAN” location as indicated on the notice label.

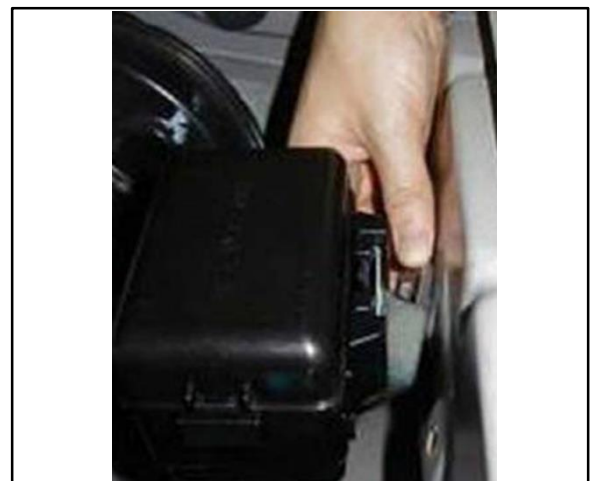
Figure 9.

10. Attach the relay block to the bracket installed in step 7.

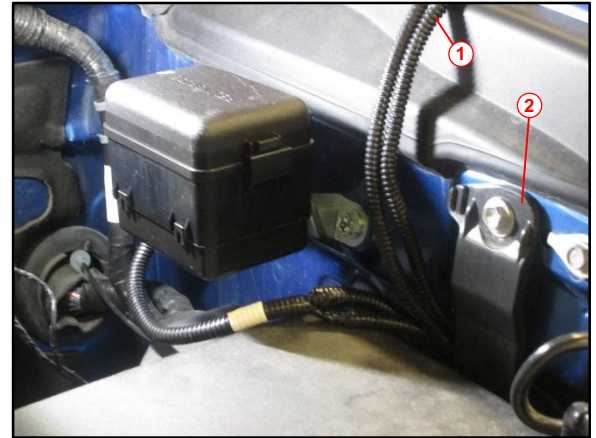
Figure 22.

- A. Remove the bolt from the engine room relay block bracket and route the NEW sub-wire harness behind the bracket.
- B. Loop and bring the NEW A/C ECU pigtail and driver J/B sub-wire harnesses back behind the bracket, which will later be routed into the passenger compartment.
- C. Apply a tie band at the marked location on the sub-wire harness, attach it to the engine room relay block bracket, and cut off the excess.

1	A/C ECU Pigtail & Driver J/B Sub-wire Harnesses
2	Engine Room Relay Block Bracket Bolt

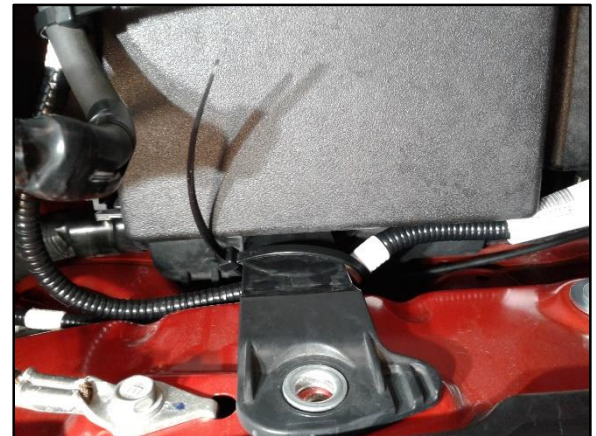
Figure 23.

- D. Reinstall the engine room relay block bracket bolt.

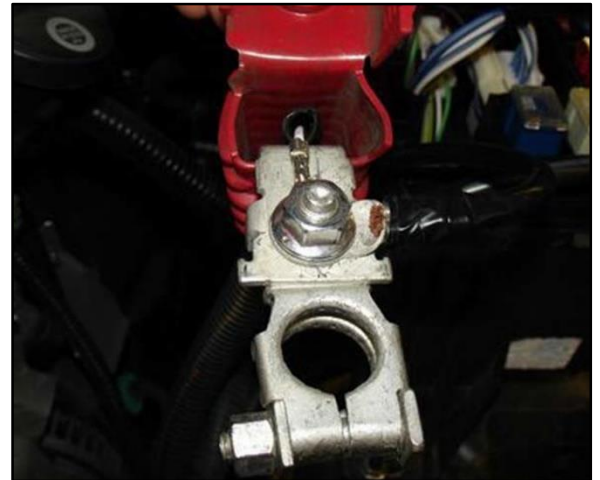
Figure 25.

- F. Unscrew the nut from the stud bolt on the positive battery cable.
- G. Put the ring terminal from the NEW sub-wire harness (white) onto the stud bolt flange side up.
- H. Tighten the nut.
Torque: 9.8 – 15.7 N*m
(103 – 159 kgf*cm, 7.5 – 11.5 ft*lbf)

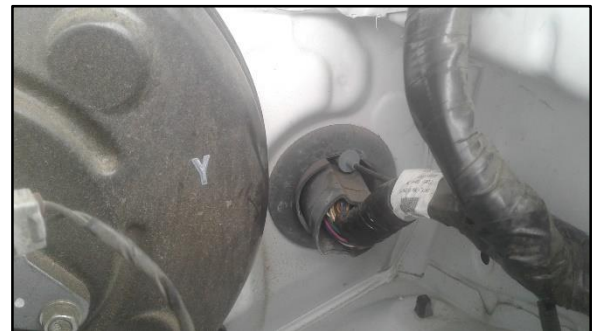
Figure 33.

- 21. The A/C ECU pigtail and driver J/B sub-wire harnesses from the engine compartment will be routed into the passenger compartment through the engine compartment bulk head grommet located next to the power brake booster.

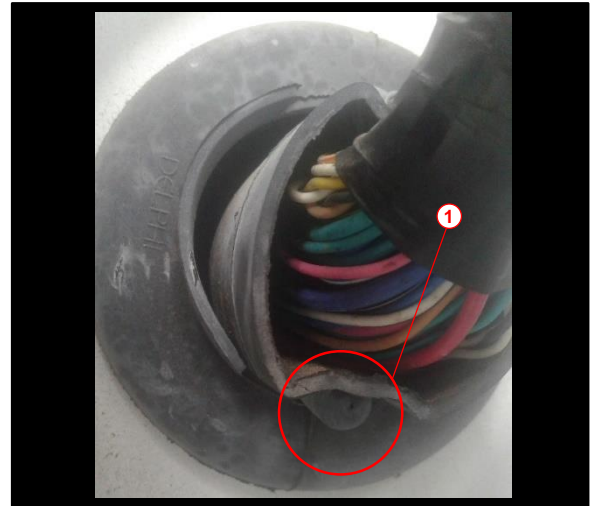
Figure 34.

22. The A/C ECU pigtail and driver J/B sub-wire harnesses will be routed into the passenger compartment through the bottom of the grommet that will require modification.

1	Sub-wire Harness Grommet Passage
----------	---

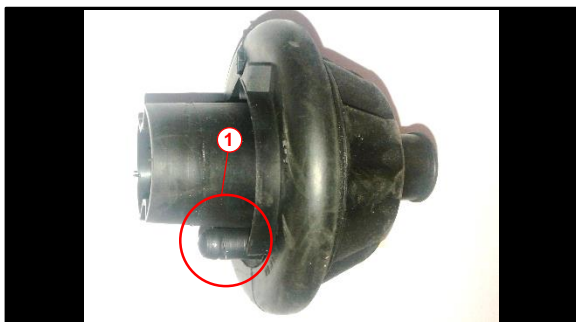
Figure 35.

23. Modify the bulk head grommet by using scissors or equivalent and cut off the rubber end of the passage at the indent mark to expose the passage through to the passenger compartment.

1	Grommet Indent Mark
----------	----------------------------

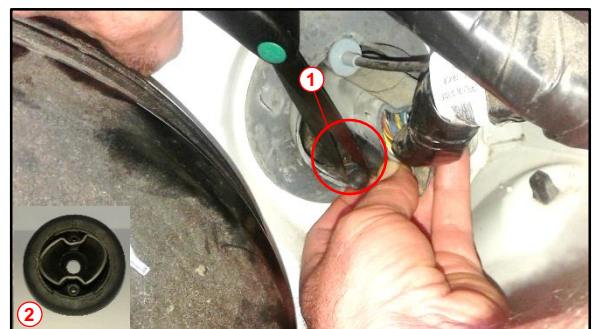
Figure 36.

1	Cut at Grommet Indent Mark
2	Modified Grommet

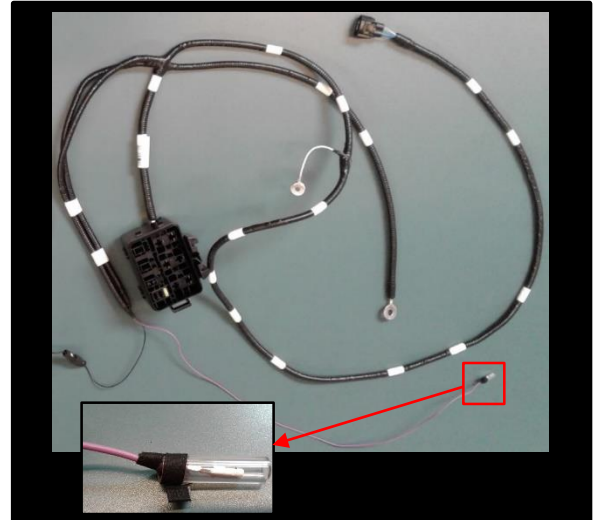
Figure 39.

26. Remove the vinyl tube protecting the pin on the end of the driver J/B sub-wire harness by removing the black tape and vinyl tube exposing the pin.

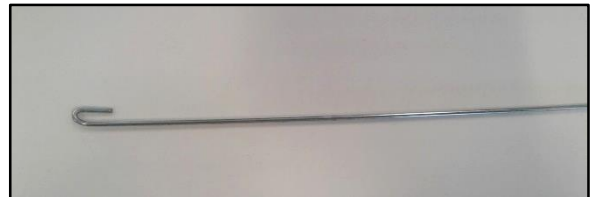
Figure 40.

27. Cut the bottom straight portion of a wire coat hanger approximately 30 cm in length and bend one end of it backward onto itself.

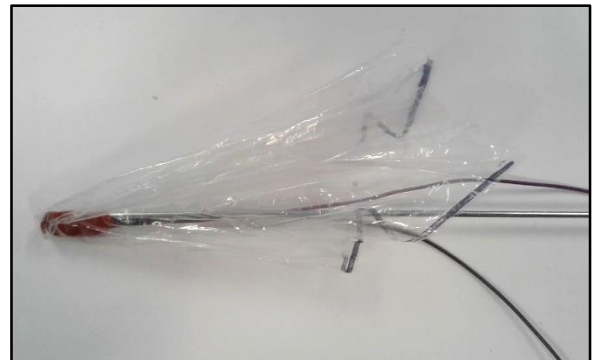
Figure 44.

31. Wrap the bent end of the wire coat hanger with the cut corner of the plastic parts bag and dip the end in isopropyl rubbing alcohol.

This step aides in passing the wire coat hanger and the attached wires through the rubber grommet passage.

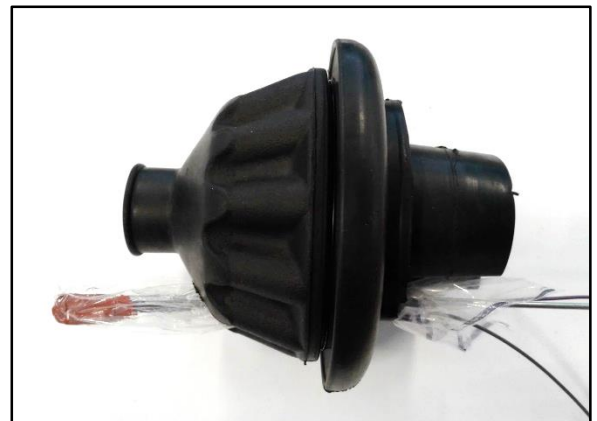
Figure 45.

32. From the engine compartment side, gently insert the bent end of the wire coat hanger through the bulk head grommet passage previously made in step 23.

The wire coat hanger assists sending the wires through the passage to the passenger compartment side of the grommet.

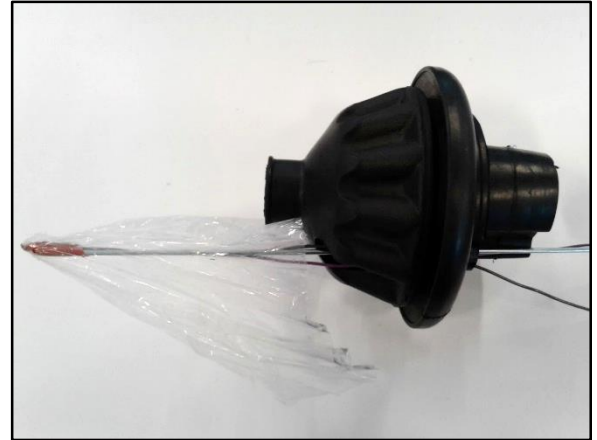
Figure 46.

33. Insert the bent wire coat hanger all the way through into the passenger side so the plastic is free of the grommet.

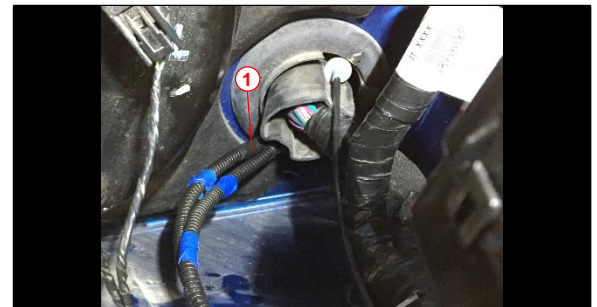
Figure 48.

1	Engine Compartment – Corrugated Sub-wire Harness Covers
----------	--

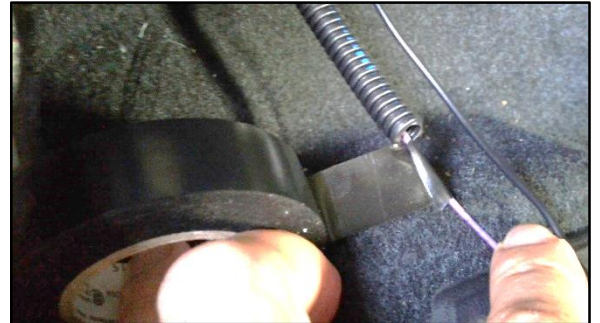
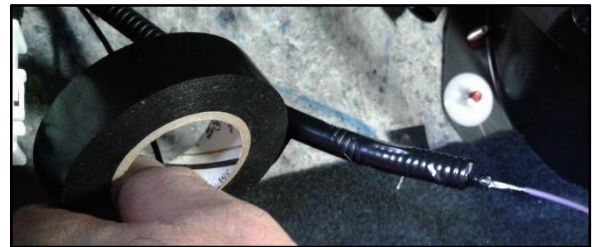
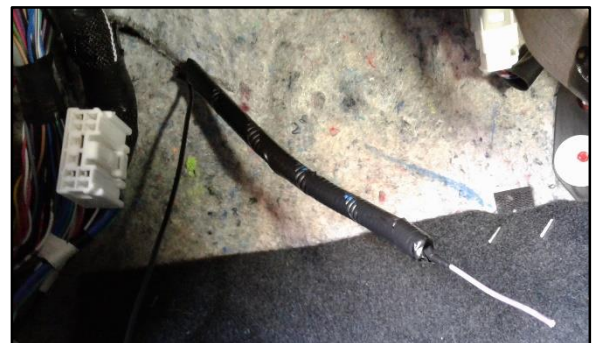
- B. Wrap the entire length of the corrugated tube with electrical tape.
Begin at the section of wire protruding closest to the end of the corrugated tube as shown.

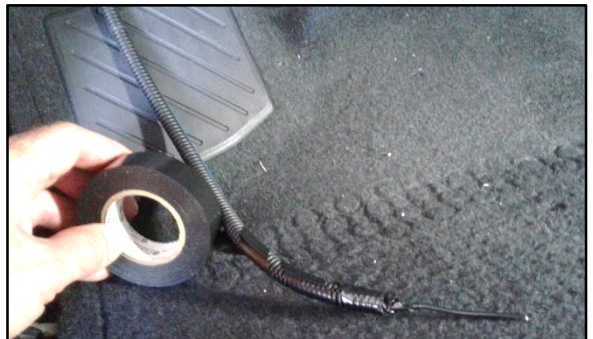
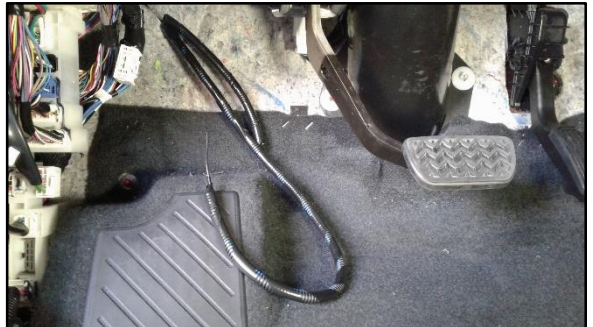
- D. Wrap the entire length of the corrugated tube with electrical tape as shown.

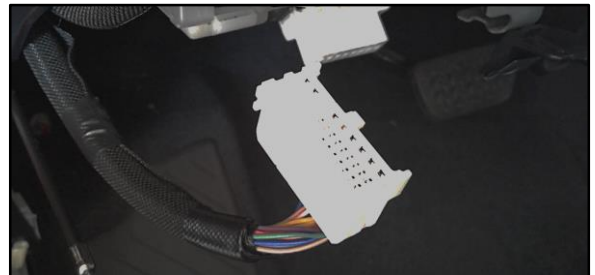
39. Remove the black, plastic lock lever from the connector.

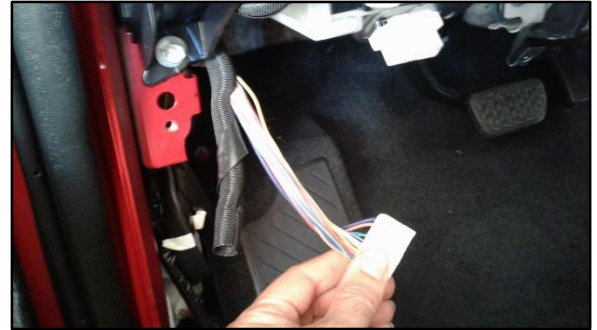
Figure 62.

40. Remove the electrical tape from the connector harness and pull back the wire harness cover to expose the wires.

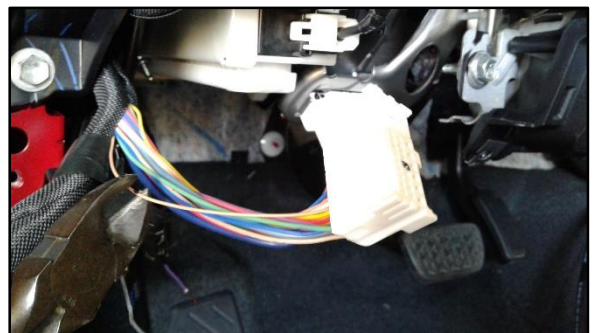
Figure 65.

41. Confirm there is a pin and wire in pin location 16 in connector 1F. The connection will be made with a wire splice procedure.
 - A. From the back side of connector 1F, locate and isolate the pin 16 wire.
 - B. Measure 60 mm along the pin 16 wire from the base of connector 1F and mark the wire.
 - C. Using the diagonal cutters, cut the pin 16 wire at the 60 mm mark.

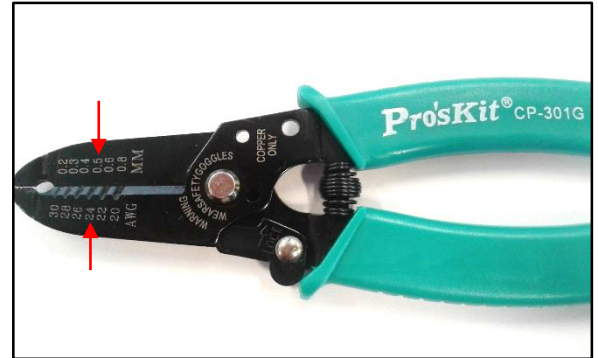
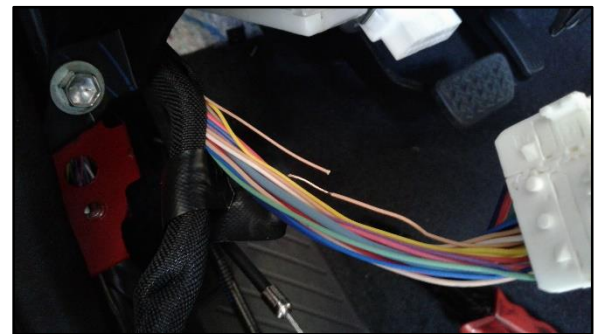
- D. Using the wire stripper (P/N CP-301G; use 24 AWG/0.5 mm to strip insulation from wire), strip 11 mm of the wire insulation from the end of pin16 wire.

- Due to the small gauge of the pin 16 wire, be very careful NOT to cut off ANY strands of the wire while stripping the wire insulation, or the integrity of the wire will be compromised.
- If strands of wire are cut off during the wire stripping process, cut off the stripped wire and repeat the process. Be careful not to cut the wire too short, or the splice process will be difficult.

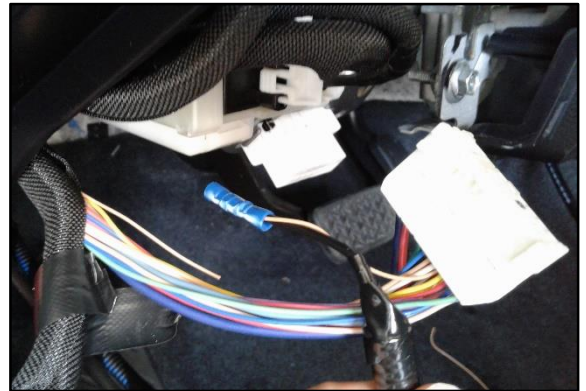
Figure 76.

- L. While holding the joint terminal, gently tug on the wires to ensure the crimp is good.

If the wires pull out of the joint terminal or the crimp fails, replace the joint terminal with a **NEW** one and then crimp again.

- M. Crimp both ends of the joint terminal with the crimp tool at the INS position.

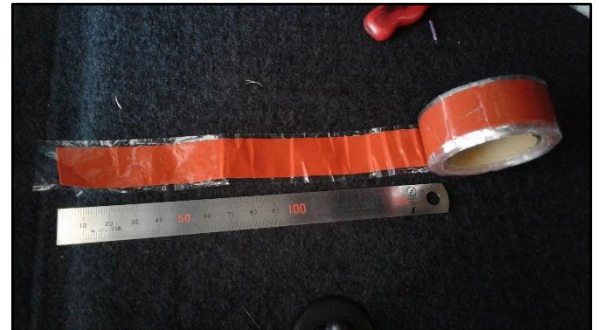
Figure 77.

- N. Using silicone tape, measure a 150-mm length piece of tape and cut it with scissors.

Do **NOT** let the silicone tape fold or touch itself as it is very difficult to unstick once this has occurred.

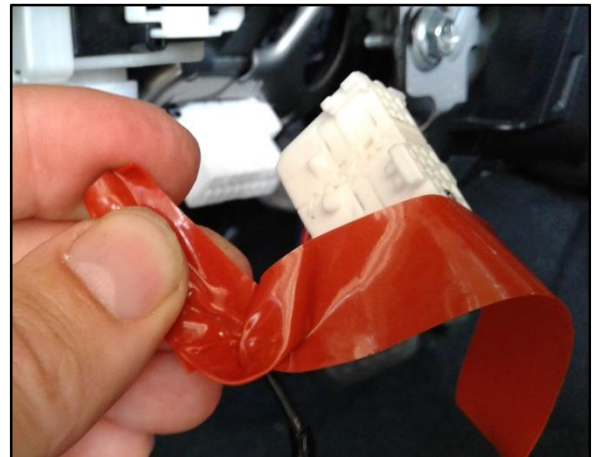
Figure 79.

- P. Fold the silicone tape over the top of the joint terminal and down the opposite side of the terminal, adhering the tape to itself over the terminal area.

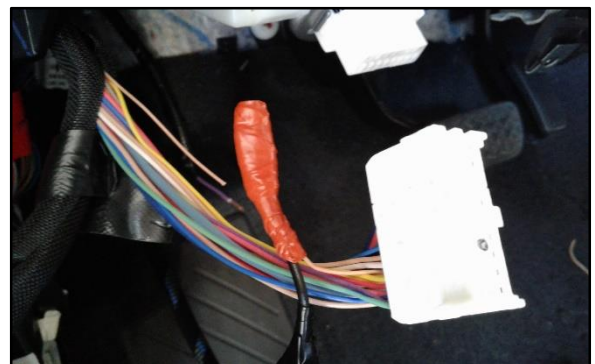
Figure 80.

- Q. Continue to wrap the terminal from the bottom up to the top of the terminal, and ensure the tape is adhered to itself.

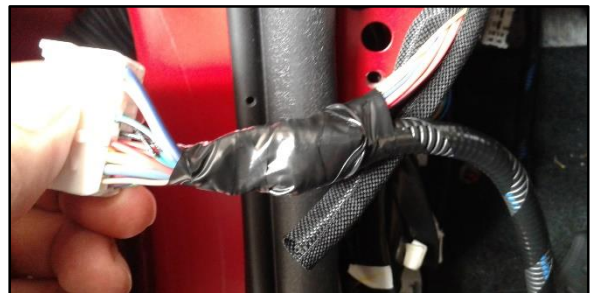
- S. Place the splice connection along the wire harness, fold back the driver J/B sub-wire harness along the connector harness, and completely wrap with electrical tape.

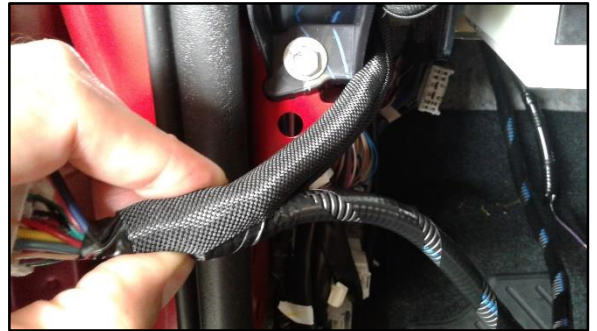
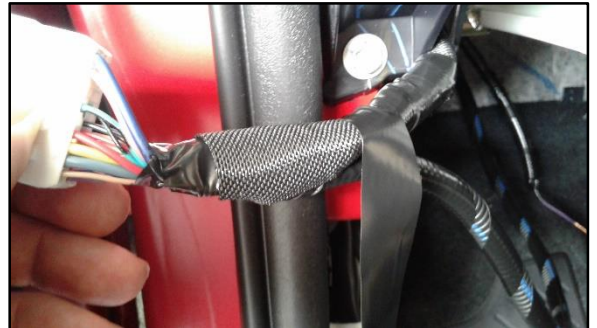
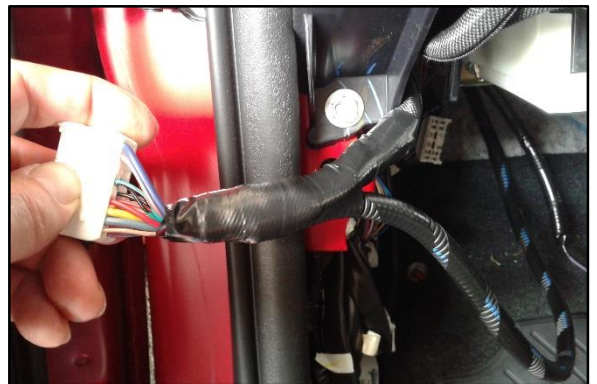
- C. Close the pin lock retainer at the top of connector 1F.
 - D. Hold the driver J/B sub-wire harness along the driver side J/B harness and completely wrap the wire harnesses together with electrical tape (similar to the procedure in step 41, substep S).
43. Reapply the driver side J/B wire harness cover previously pulled back in step 40 and completely wrap with electrical tape.

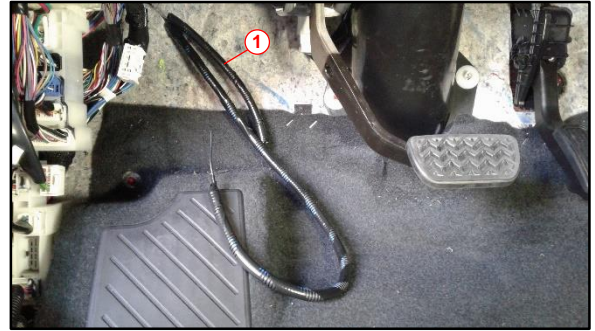
Figure 92.

46. Locate the NEW A/C ECU pigtail and slide the NEW joint terminal over the end of the wire.

1	A/C ECU Pigtail
----------	------------------------

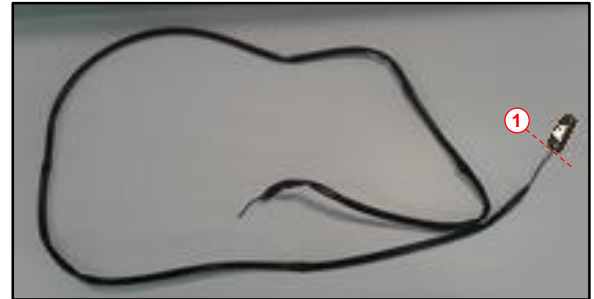
Figure 95.

48. Locate the NEW A/C ECU sub-wire harness, and using the diagonal cutters, cut the plastic connector off and discard the connector.

1	Cut Connector End Off From the A/C ECU Sub-harness
----------	---

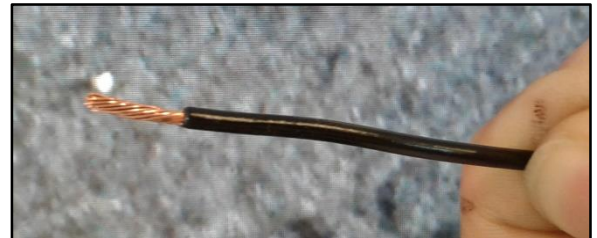
Figure 96.

49. Using the wire stripper, strip 11 mm of wire insulation from the end of the A/C ECU sub-wire harness where the plastic connector was previously cut off in step 48.

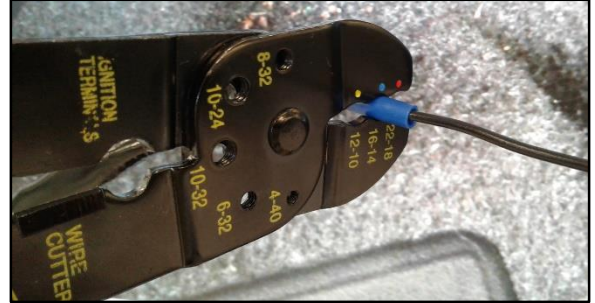
Figure 101.

52. Using a crimp tool, place the joint terminal into the blue dot position of the crimp jaws and center the terminal.

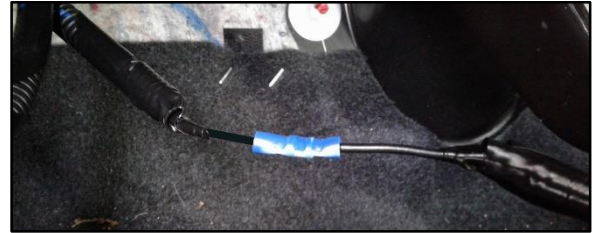
Figure 104.

55. Crimp both ends of the joint terminal with the crimp tool at the INS position.

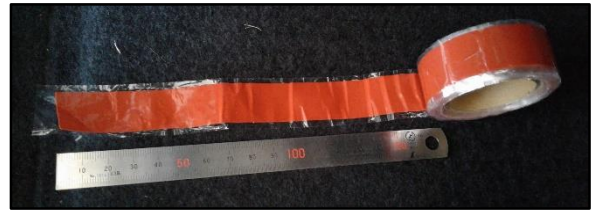
Figure 105.

56. Using silicone tape, measure a 150-mm length piece of tape and cut it with scissors.

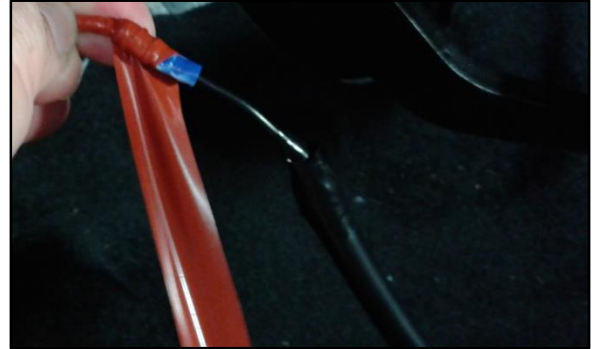
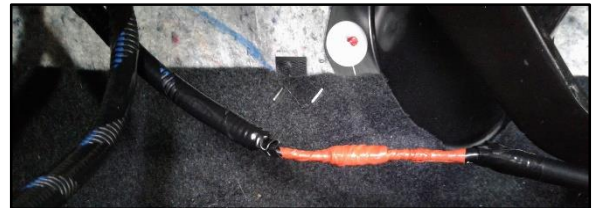
58. Continue to wrap the tape around the joint terminal, ensuring good adhesion until the terminal is completely wrapped.

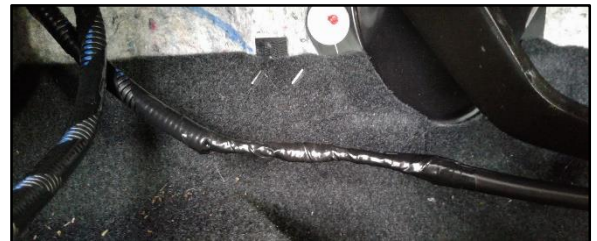
Figure 109.

59. Repeat the same joint terminal wrapping process as used in steps 56 – 58, using electrical tape.

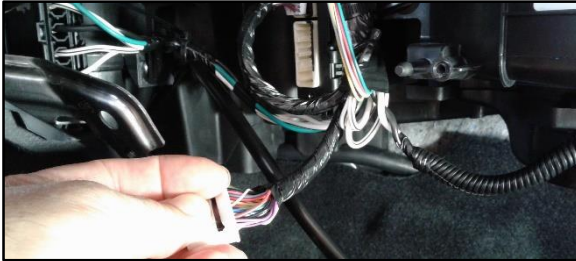
69. Remove the electrical tape from the connector harness to expose the wires.

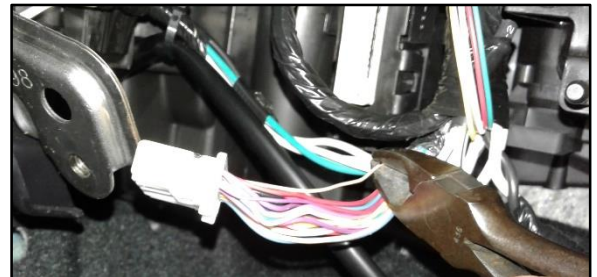
Figure 121.

- A. From the back side of connector A35, locate and isolate pin 8 wire (pin 16 in connector A14 for manual A/C).
- B. Measure 60 mm along the pin 8 wire from the base of connector A35 and mark the wire.

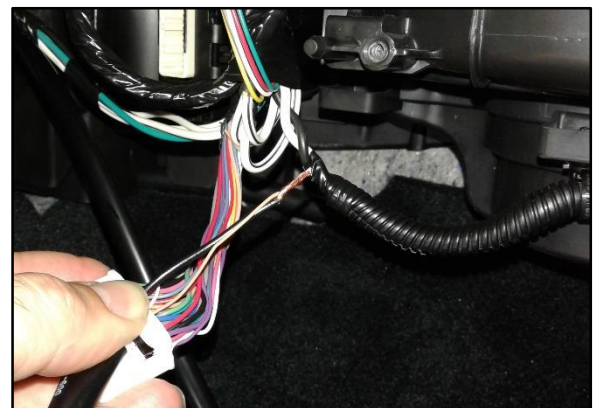
Figure 124.

- G. Join the stripped end of the NEW A/C ECU sub-wire to the stripped end of the pin 8 wire in connector in A35 (pin 16 wire in connector A14 for manual A/C).

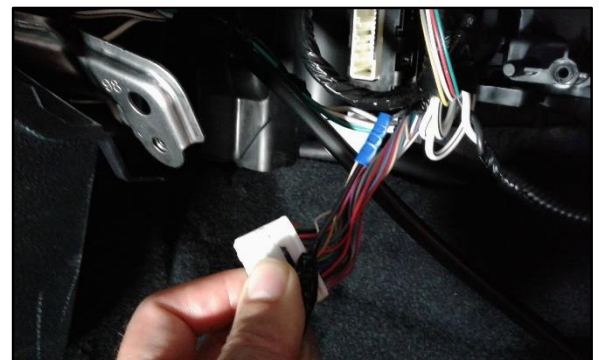
Figure 130.

- K. Crimp both ends of the joint terminal with the crimp tool at the INS position.

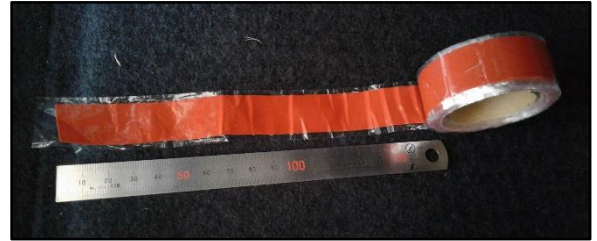
Figure 131.

- L. Using silicone tape, measure a 150 mm length piece of tape and cut it with scissors.

Do NOT let the silicone tape fold or touch itself as it is very difficult to unstick once this has occurred.

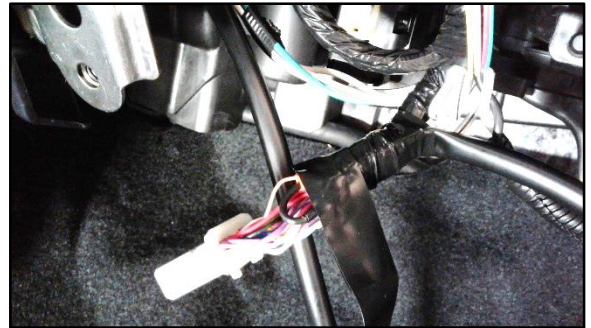
- Q. Place the splice connection along the wire harness and fold back the A/C ECU sub-wire harness along the connector harness and begin wrapping with electrical tape until it is completely wrapped.

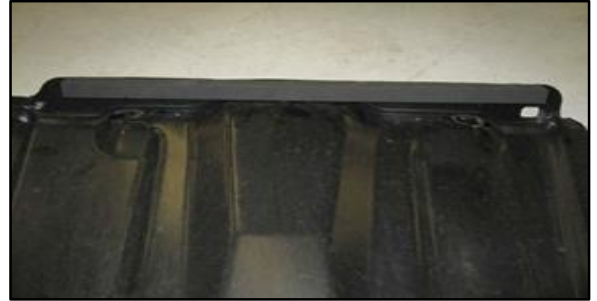
Figure 151.

- D. Install the NEW skid plate seal in the position as shown.

- E. Reinstall the No. 1 engine under cover sub-assembly with the four bolts.

Torque: 30 N*m (306 kgf*cm, 22 ft*lbf)
