GROUP Product Improvement	MODEL 2011-2014MY Optima (QF/TF) 2012-2014MY Sorento (XMa) 2011-2013MY Sportage (SL)
	NUMBER 1803 (Rev 3, 10/10/2019)	DATE November 2018
PRODUCT IMPROVEMENT CAMPAIGN		
SUBJECT: KNOCK SENSOR DETECTION SYSTEM - ECU LOGIC IMPROVEMENT (PI1803)

This bulletin provides information related to a software update to the Engine Control Unit (ECU) to install the Knock Sensor Detection System (KSDS) in order to protect the engine from excessive connecting rod bearing damage. This update is for:

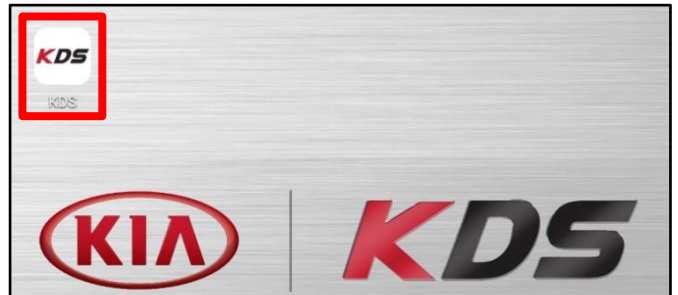
2. With the ignition ON, turn ON the KDS tablet. Select **KDS** from the home screen.
