HYUNDAI
Technical Service Bulletin

SUBJECT: THETA GDI ENGINE DTC P1326 - WIRING INSPECTION /
 INSTALLATION AND ENGINE INSPECTION / REPLACEMENT
 (SERVICE CAMPAIGN T3G)

Description: Applicable vehicles with 2.0L Turbo and 2.4L GDI engines may experience the Check Engine warning lamp illuminated with DTC P1326. Follow the procedure to inspect the vehicle and install a wire harness extension and/or replacement engine based on the inspection results.

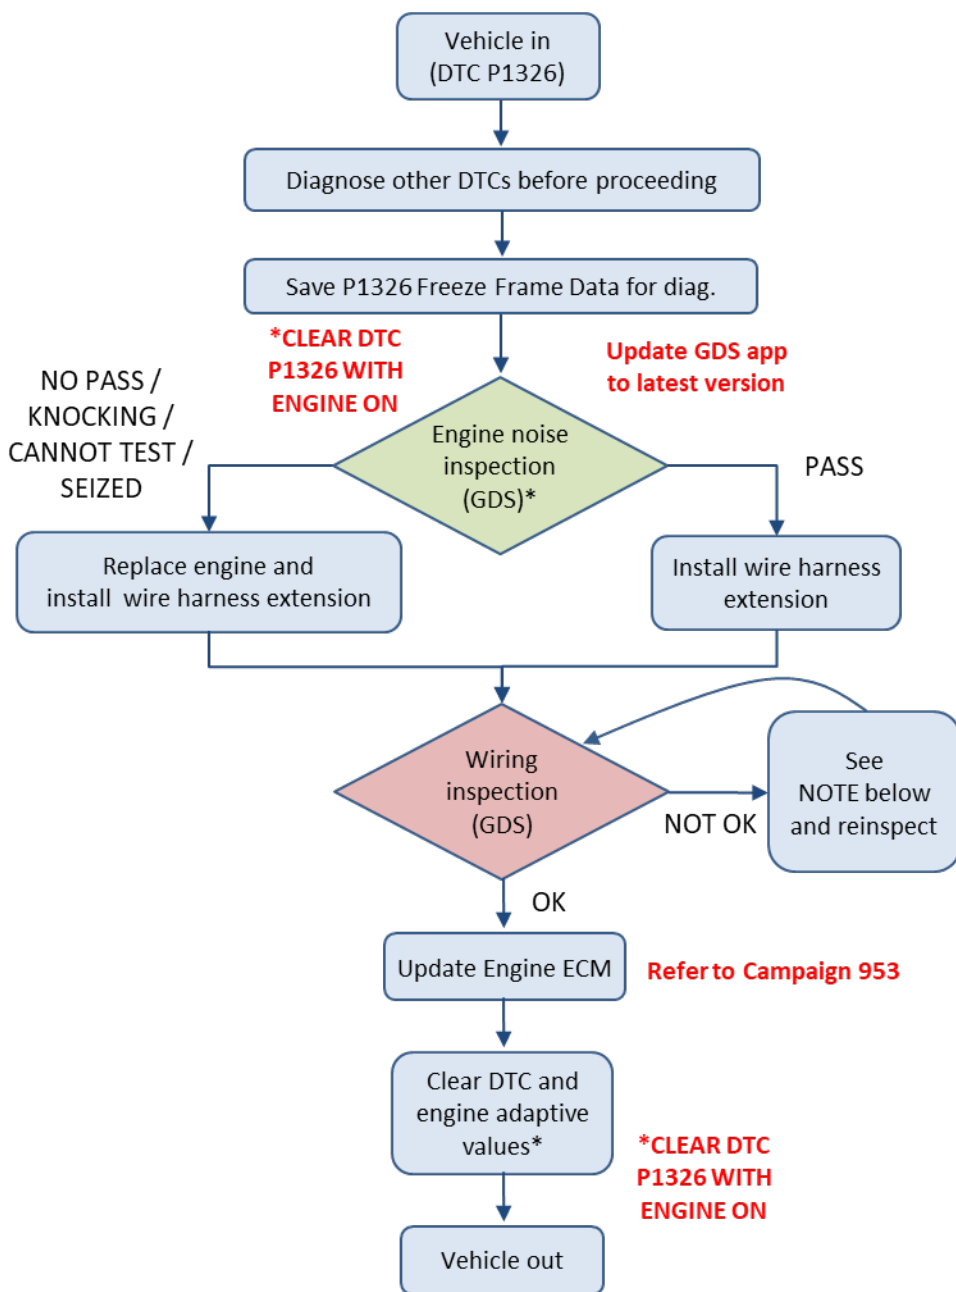
Service Procedure Flowchart:

NOTE:

If the wiring inspection is still NOT OK after installing the harness extension, proceed with the following steps until an OK test result is achieved.

- 1) Confirm pins are properly installed and secured in engine ECM connector and **reinspect**
- 2) Remove knock sensor and reinstall **with torque wrench to 15 lb-ft** and **reinspect**
- 3) Install new knock sensor **with torque wrench to 15 lb-ft** and **reinspect**

- Install the new wire harness extension kit and perform the Wiring Signal Interference Inspection.
- If the Wiring Signal Interference Inspection test result is still NOT OK after installing the extension harness, follow the Service Procedure flowchart on Page 9 until the Wiring Signal Interference Inspection test result is OK.
- Refer to Campaign 953 to update the Engine ECM if new software is available.

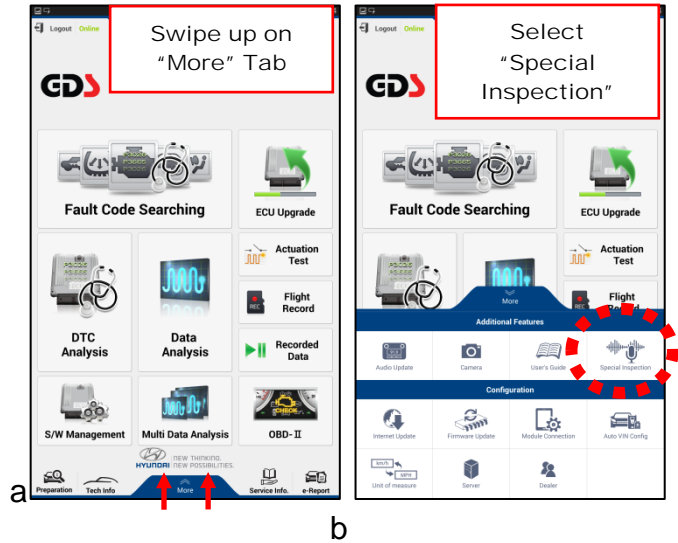
Select the “Special Inspection” function.

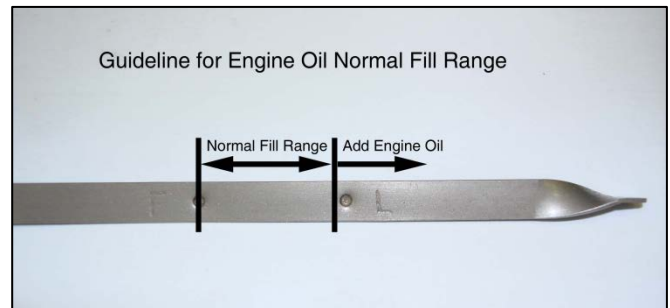
2. Prior to inspection, the engine should be in a satisfactory running condition. Engine should idle normally.
 - Engine oil level should be in the normal range (shown at right).
 - Use Quaker State 5W-30 viscosity engine oil or other brand if not available (conventional type with API SM / ILSAC GF-4 or higher service grade) to adjust the oil level if necessary.
 - Save P1326 Freeze frame data for future diagnostics
 - Clear all DTCs
 - If P1326 sets while performing the noise inspection, unplug the knock sensor and perform the test again.

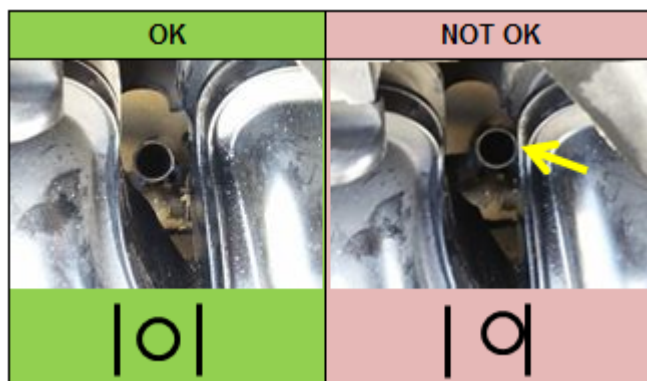
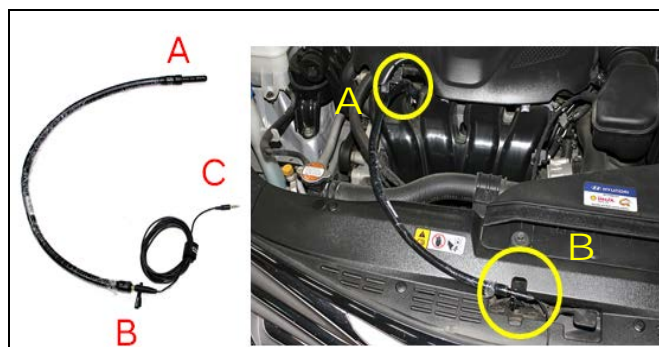
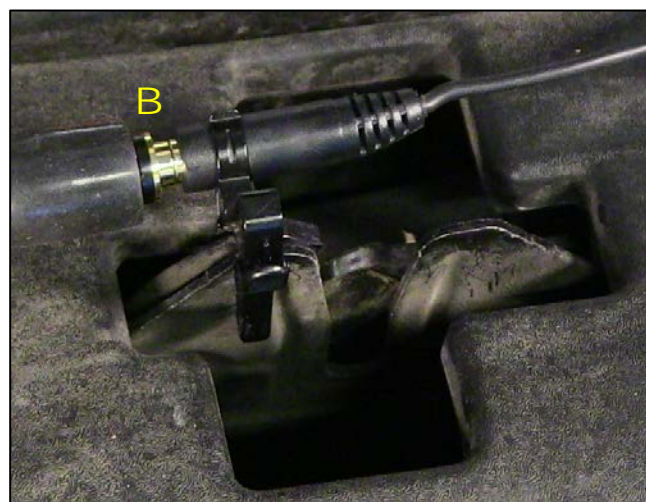
- Remove the oil level rod assy (engine oil dipstick).
- Insert the adapter (A) into the oil level gauge tube (dipstick tube).
- Check for interference between the dipstick tube and the intake manifold.

Adjust the dipstick tube to create clearance between the tube and manifold if necessary.

- Attach the clip (B) to the hood latch.
- Connect the stereo jack (C) to the GDS Mobile headphone jack.
- Feed the inspection tool through the open driver’s front window.

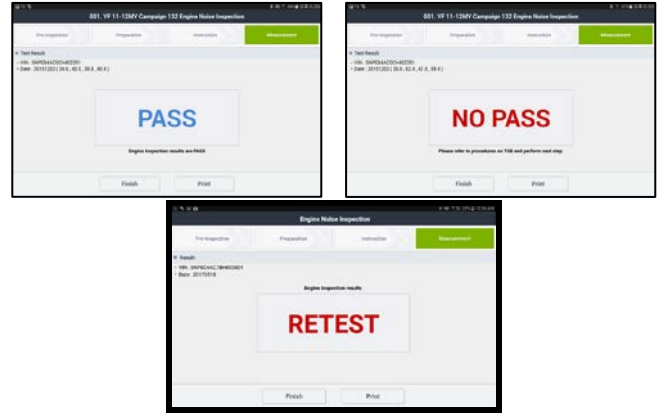
6. After the Engine Noise Inspection is complete, the application will display **PASS**, **NO PASS**, or **RETEST**.
- This information will be sent to HMA when the GDS is connected to Wi-Fi.

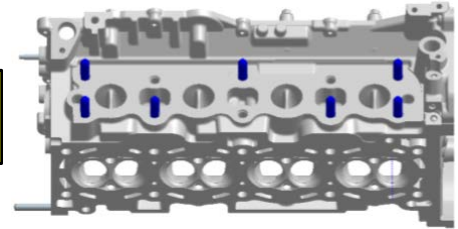
SULEV / CAL Spec

4. **For 2.4L with ULEV / FED emissions only**
 2.4L replacement engines are produced with the exhaust manifold studs configured for SULEV / CAL emissions package.

Two exhaust studs must be relocated on the new engine and 1 exhaust stud must be transferred from the old engine.

Exhaust Stud Position Relocation Information

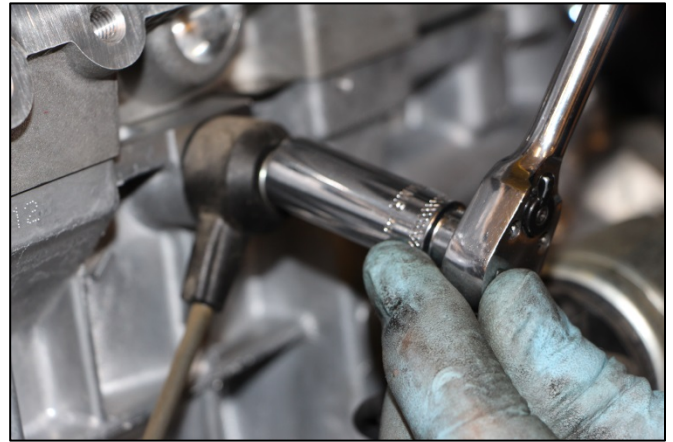
5. Remove and reinstall the engine knock sensor from the old engine to the new engine.

Knock Sensor Fastener
Tightening torque: 21Nm (15.5lb-ft)

Ensure the knock sensor is torqued to specification using a torque wrench. Improper installation can result in DTC codes.

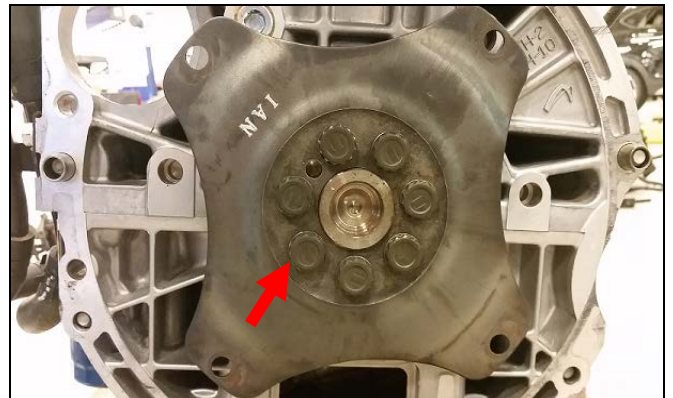
- Install the oil filler cap from the old engine to the new one.
- Install the drive plate/flywheel on the new engine using new bolts (QTY 7).

Drive Plate Tightening torque :
 111.7 ~ 127.5 Nm (86.8 ~ 94.1 lb-ft)

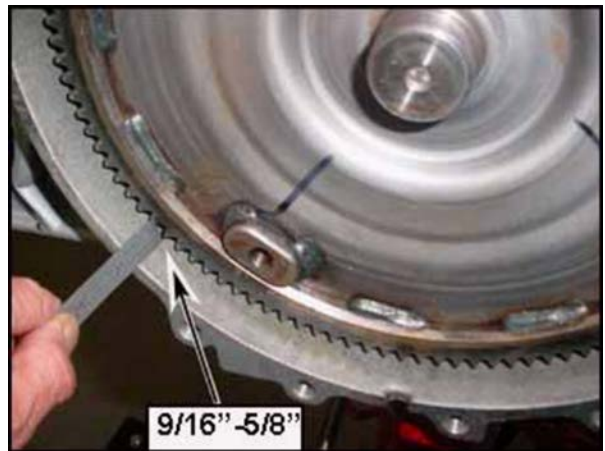
If the torque converter has moved from the fully inserted position, carefully push inward and rotate the torque converter until the converter is recessed approximately $9/16 - 5/8$ " (14 -16 mm) into the transaxle case when reinstalling the automatic transaxle.

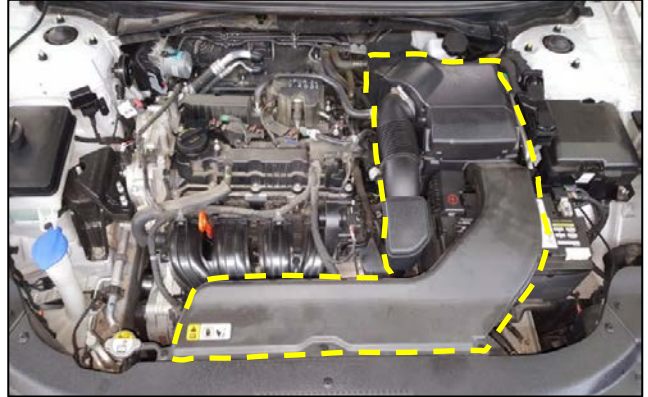
1. Remove the engine cover, air cleaner assembly, and negative battery terminal. Record vehicle's audio presets.

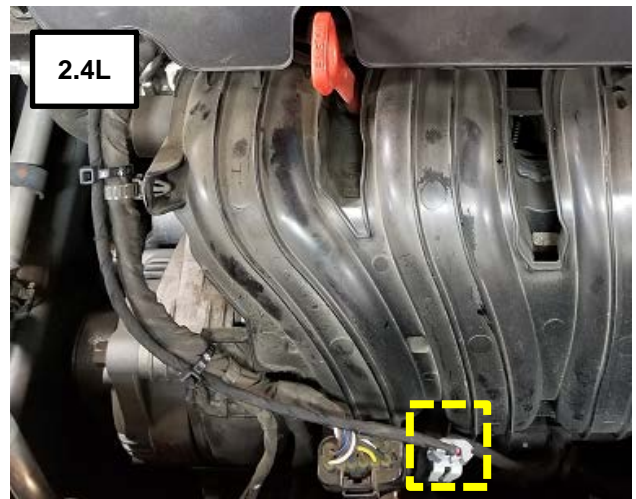
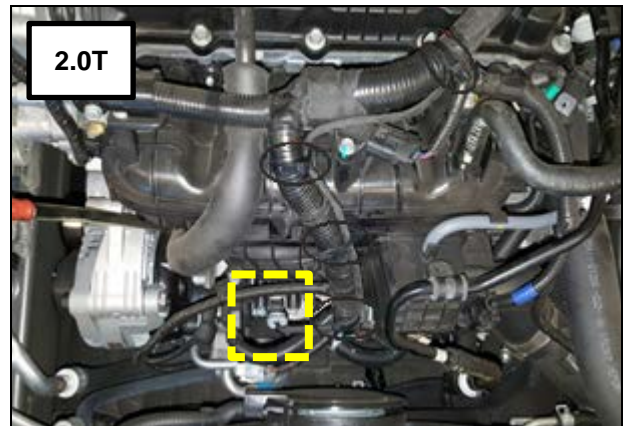
2. Disconnect the knock sensor connector and connect the connector from the new wire harness extension.

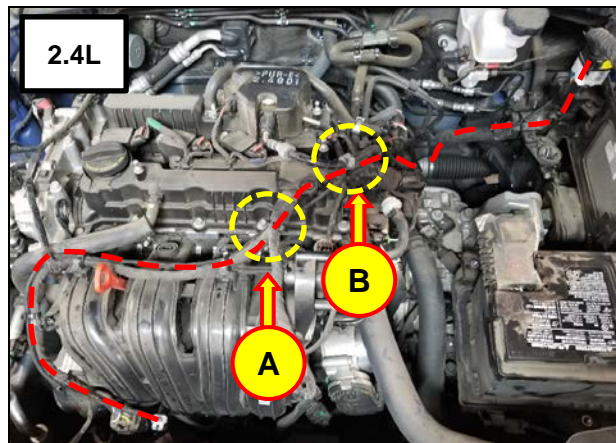
3. Route the new wire harness extension from the knock sensor connector to the engine ECM along the existing path of the engine control wire harness.

- Underneath the original engine control wire harness at (A).
- On top the original engine control wire harness plastic protector at (B).

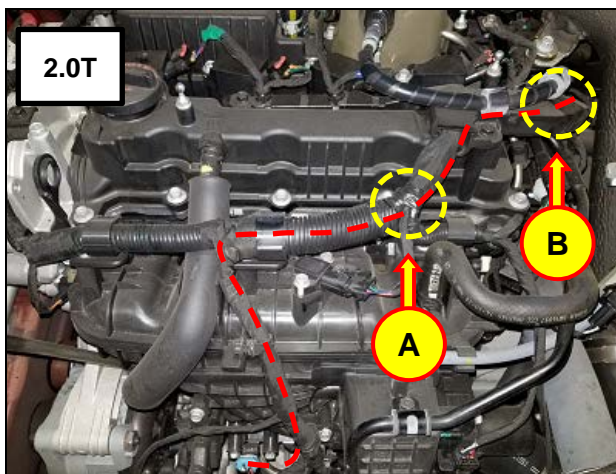
15MY Sonata (LF) vehicle is pictured for reference. Routing of the harness on other models is similar.

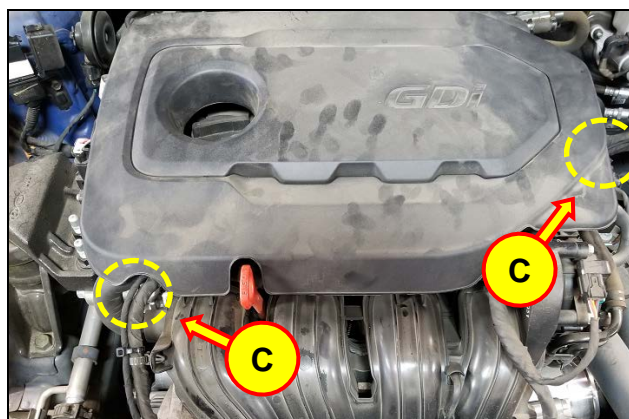
5. Reinstall the engine cover and ensure the new wire harness extension does not contact the engine cover at (C) and any other areas.

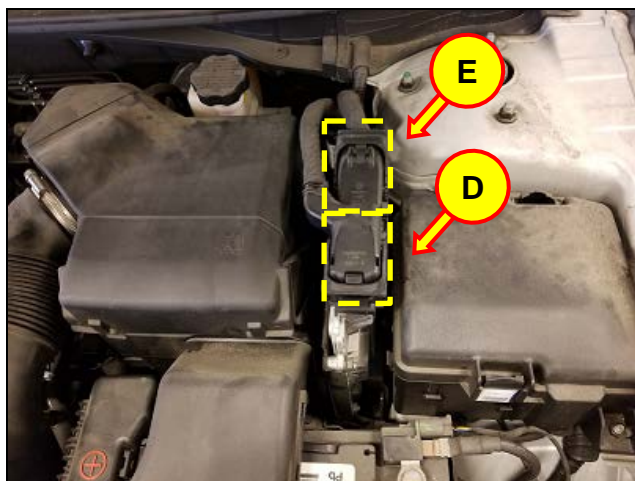
6. Identify the Engine ECM connector to modify based on model & MY. Check the connector's manufacturer as shown (BOSCH or KET).

Model / MY	Connector
11-14MY Sonata (YF) 13-16MY Santa Fe Sport (AN) 14-15MY Tucson (LM)	D
15-19MY Sonata (LF) 17-18MY Santa Fe Sport (AN) 19MY Santa Fe (TM) 18-19MY Tucson (TL)	E
19MY Veloster N (JSN)	C100-A

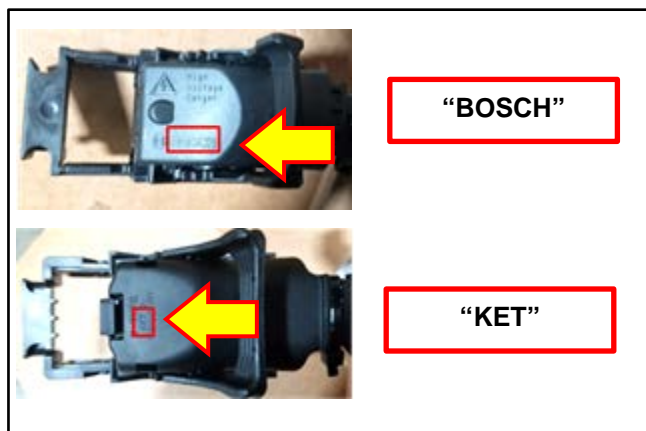
First remove ECM connector (D) to release ECM connector (E). Then remove ECM connector (E) and top cover by gently prying at (F1) or pressing on (F2) based on connector type using a flat head screwdriver.

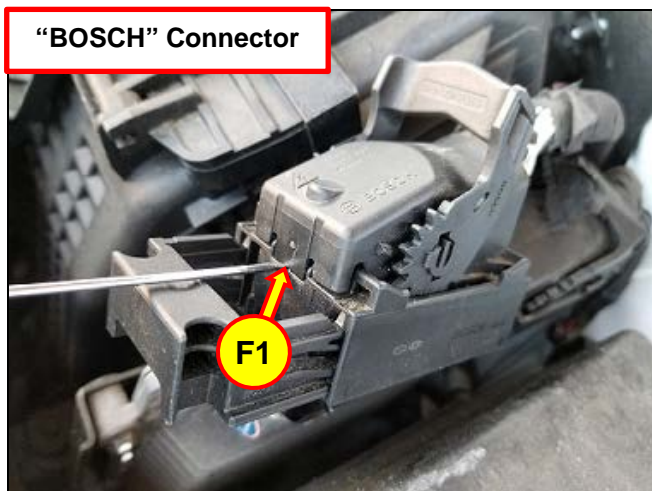
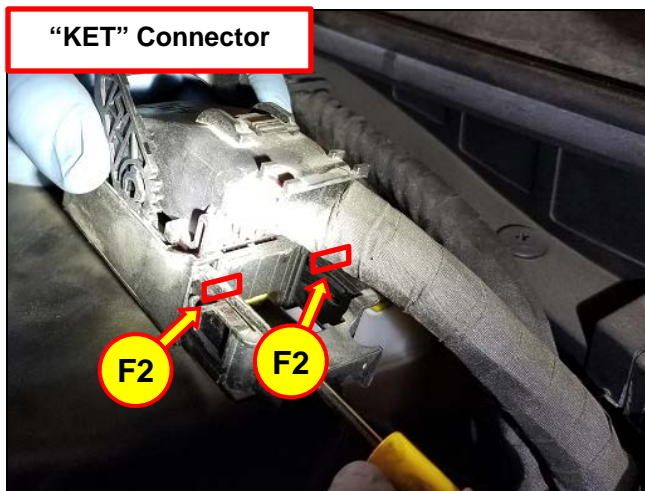
DO NOT use excessive force when removing the ECM connector cover. The cover comes off with minimal effort when using the release tab(s) F1 or F2.

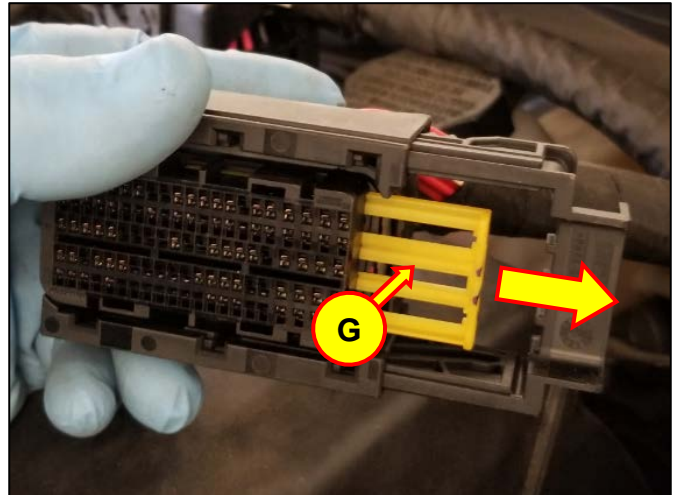
7. Fully remove the connector retaining clip from the connector by gently prying at (G) using a small flat head screwdriver.

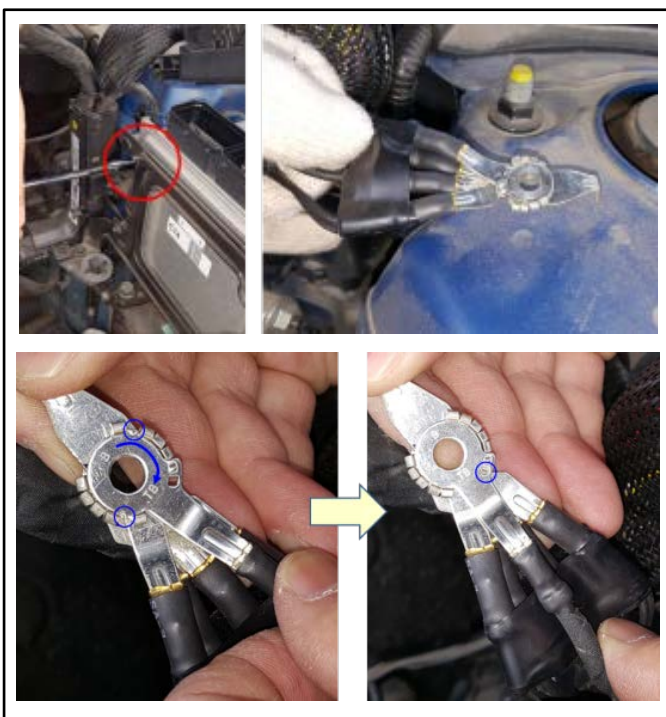
11. For 18-19MY Sonata 2.0T and 19MY Santa Fe 2.4L / 2.0T only:

- Loosen the ground bolt on the chassis.
- Connect the new extension wiring's ground terminal to the existing ground terminal. Rotate the new ground terminal clockwise as shown.
- Tighten the ground terminal to the chassis.

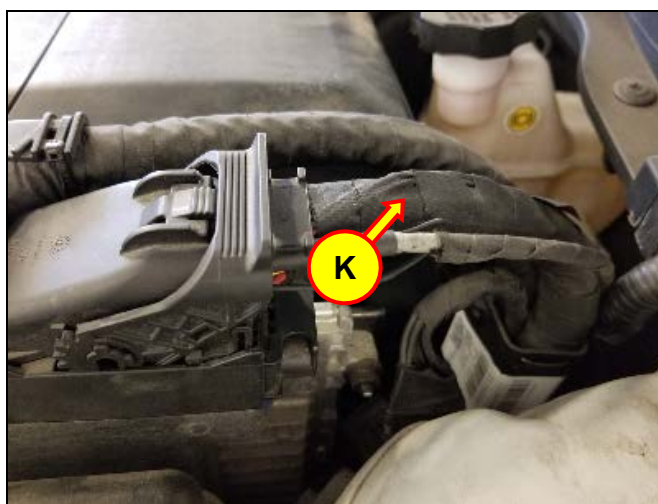
12. Cut off and discard the original terminals from the ECM connector and fold the original wires (K) back onto the original engine control wire harness and secure with tape. Secure any excess wire from the new wire harness extension onto the original engine control wire harness with tape.

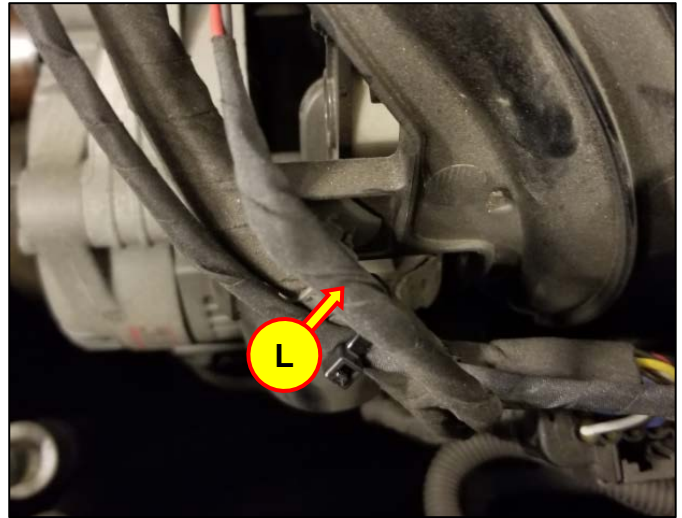
13. Cut off and discard the original knock sensor connector and fold the (2) original wires (L) from the original knock sensor connector back onto the original engine control wire harness and secure with tape.

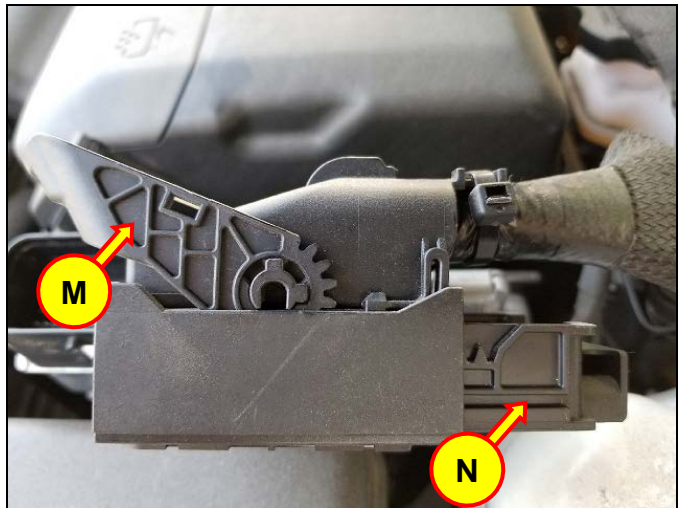
DO NOT use excessive force when reinstalling the ECM connector cover. The cover will easily snap onto the connector with minimal effort when properly aligned. Refer to original orientation of the lever (M) and slider (N) and slightly move slider (N) as necessary until the cover easily snaps onto the connector.
