NUMBER: 15-231-18R

SERVICE BULLETIN

SUBJECT: Harman Audio / Infotainment: Troubleshooting

Audio Related Concerns

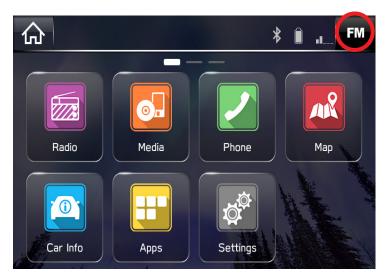
c. Check each audio source option. What source(s) do or do not have audio? (See figure below showing Audio Source Widget in the upper right corner). Does the audio widget in the top right corner of the screen show the correct source? Note the results for each as you confirm both the widget display and, if sound is produced.
