SERVICE PROGRAM BULLETIN

APPLICABILITY: 2018 MY Legacy
 2018 MY Outback
 2017-2018 MY Impreza
 2018 MY Crosstrek

NUMBER: WUA-86R

SUBJECT: Harman Kardon Head Unit Reprogramming

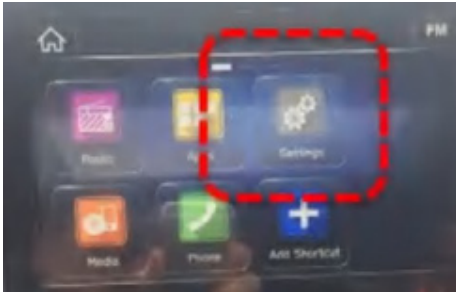
- After starting the engine, from the HOME screen, touch “Settings”.

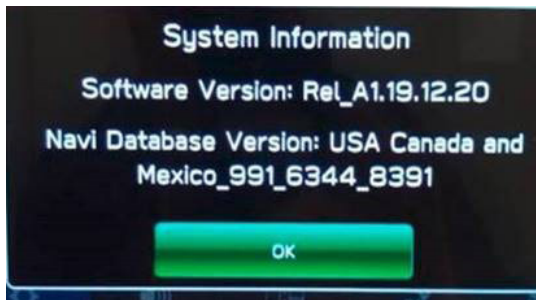
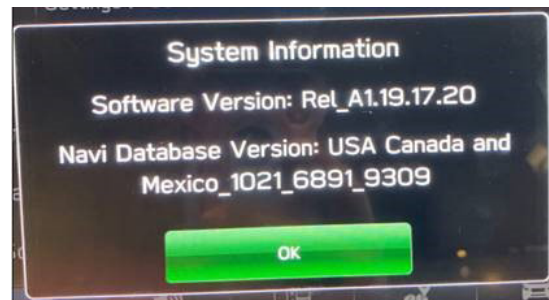
(EXAMPLE photos)

- Confirm the current Software Version ID. If the Current Version is **Rel_A1_19_17_20** or **Rel_A1_19_12_20**, **STOP** as the latest update has already been installed. Otherwise, proceed to **Step 2** below. Refer to TSB **15-211-17R** to see the latest software version information as well as a history of prior updates. Software versions Rel2.17.43.20 (or later) are acceptable to complete and close this recall.

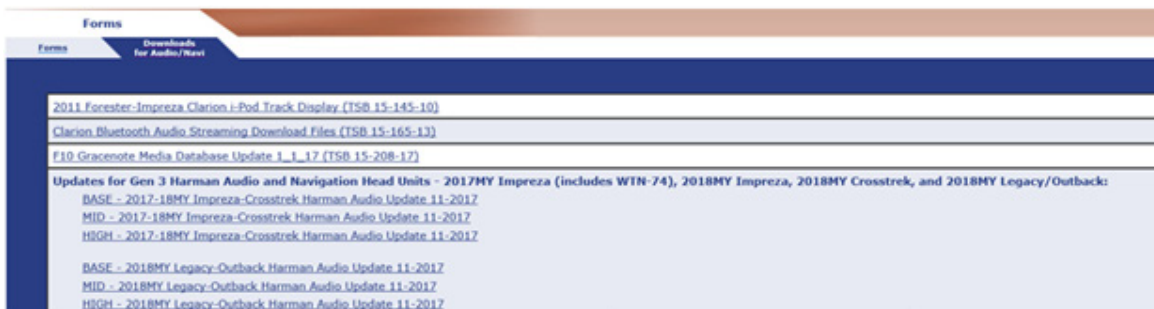
- If the files are being **downloaded from Subarunet**, they will be .zip files and must be unzipped before they can be used. An EXAMPLE image of the Subarunet links page is provided below.

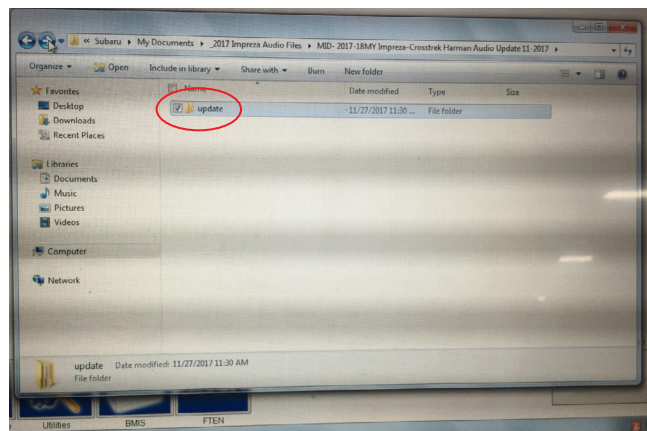
- Double-click on the required file (for this example, select the file entitled “BASE-17-18 Impreza-18 Crosstrek-18-Legacy-Outback-18-BRZ-HARMAN AUDIO UPDATE-NOVEMBER 2018”) and the Update file will display as shown.

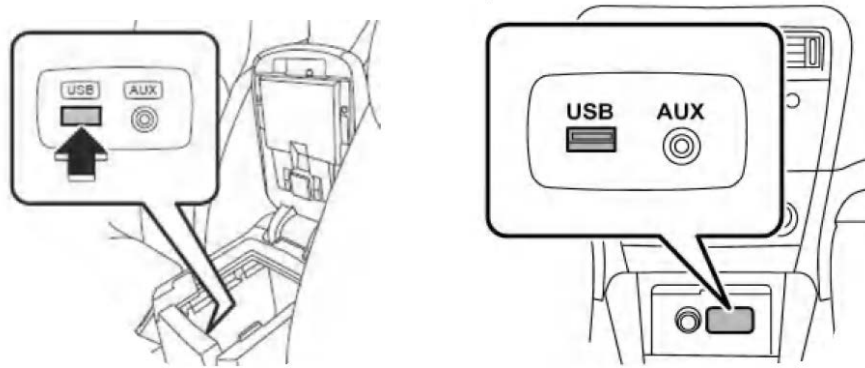
- With the engine idling (or GR8 connected), plug the flash drive into the USB Port.

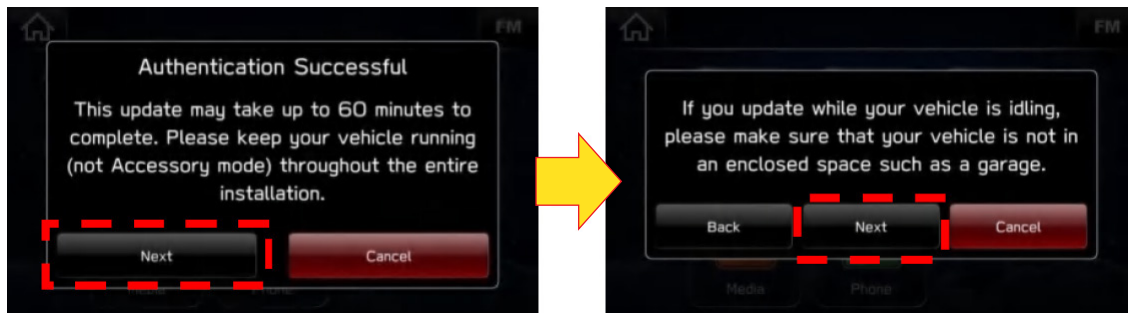
- After the unit “authenticates” the USB flash drive, press “Next” and after the second screen is displayed, press “Next” again.

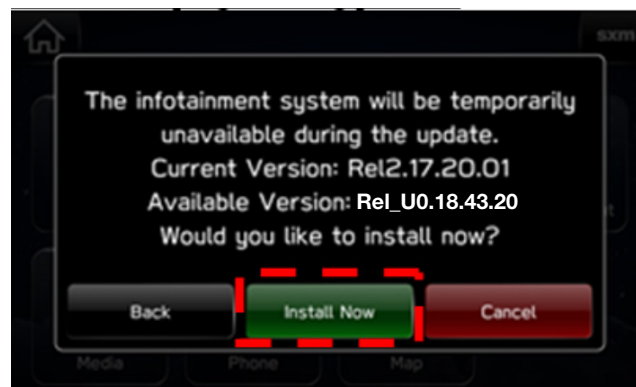
- The current and available software version information will be displayed. The Available Version I.D should be **Rel_U0.18.43.20** (see 15-211-17R for latest available software version).

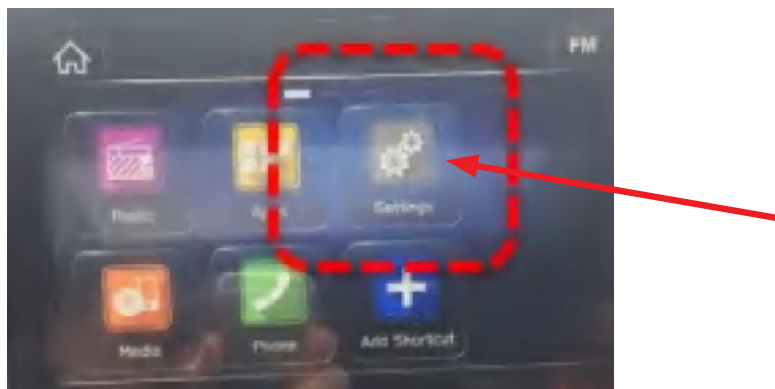
- Turn the ignition back ON. The STARLINK screen should be displayed. If the STARLINK screen is not displayed, perform **Step 5** again and be sure to **WAIT AT LEAST 3 MINUTES** before proceeding.
- In some cases, the radio presets may not appear initially.
- From the HOME screen, touch “Settings”.

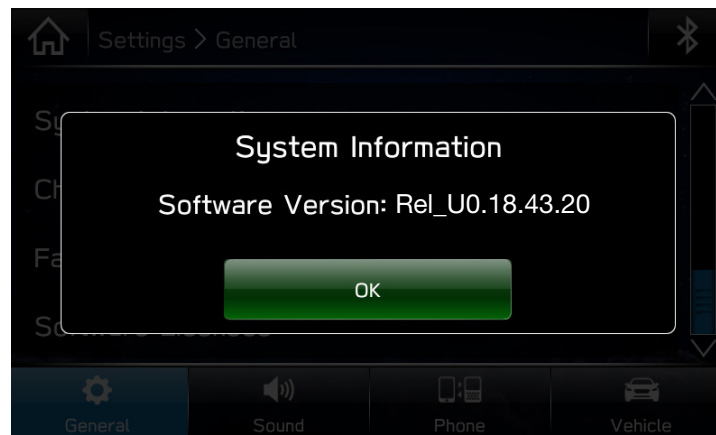
- Confirm Software Version is now “Rel_U0.18.43.20” (or latest software version as found in bulletin 15-211-17R).
