Title Mack Chassis - **Equipped With An MP8 Engine** - Diagnostic Trouble Code ( DTC ) P04DB - Crankcase Ventilation Disconnected; **US17+OBD16 And US17+OBD18 Emissions (Common Rail Fuel System), Model Years 2018 And 2019**

Cause No fault found ( NFF ) when diagnosing a GHG17 ( US17 ) chassis Diagnostic Trouble Code ( DTC ) P04DB - Crankcase Ventilation Disconnected with Premium Tech Tool ( PTT )

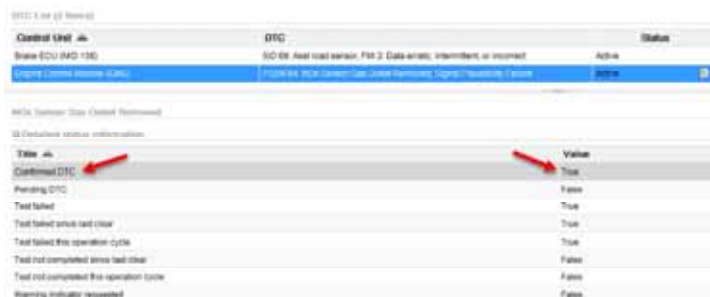
**Review the Detailed Status Information for the relevant code on the DTC Readout.**
