# Technical Service Bulletin

## 87 Various HVAC system malfunctions, DTC B11AF07 and/or B109207 stored in the climatronic module or the BCM 1

87 19 01 2055257/3 December 3, 2019. Supersedes Technical Service Bulletin Group 87 number 19-95 dated August 8, 2019 for reasons listed below.

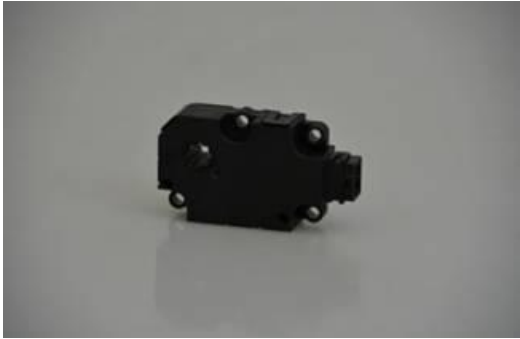
Always check with your Parts Department and/or ETKA for the latest information and parts bulletins.		
Part Number	Part Description	Quantity
4M0820511A

Motor for adjustment	As necessary
See ETKA	Fasteners, Bolts, Nuts, and Screws as needed per the Repair Manual	See ETKA/ELSA

In cases where the HVAC adjustment motor needs to be replaced, install the **Magna** HVAC adjustment motor with the part number 4M0 820 511 A.
