AEM-C Emissions Service Action - USA

Code: 23Z9

Subject	3.0L TDI Engine Gen 2.1 SUV – Approved Emissions Modification - Correction (AEM-C)								
Release Date	January 07, 2020								
Affected Vehicles	<table border="1"><thead><tr><th>Country</th><th>Beginning Model Year</th><th>Ending Model Year</th><th>Vehicle</th></tr></thead><tbody><tr><td>USA</td><td>2013</td><td>2015</td><td>Q7</td></tr></tbody></table> <p><i>Check Campaigns/Actions screen in Elsa on the day of repair to verify that a VIN qualifies for repair under this action. Elsa is the <u>only</u> valid campaign inquiry & verification source.</i></p> <ul style="list-style-type: none">✓ Campaign status must show “open.”✓ If Elsa shows other open action(s), inform your customer so that the work can also be completed at the same time the vehicle is in the workshop for this campaign.	Country	Beginning Model Year	Ending Model Year	Vehicle	USA	2013	2015	Q7
Country	Beginning Model Year	Ending Model Year	Vehicle						
USA	2013	2015	Q7						
Problem Description	Audi is releasing a software calibration update to the Approved Emissions Modification (AEM). This software calibration will include the following changes to the vehicle

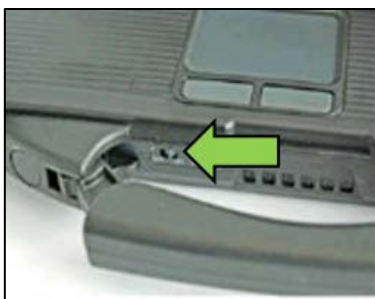
- ✓ **The Bluetooth function of the scan tool is physically switched off <see pictures below>.**

VAS 6150 & VAS 6150A
(Front panel behind handle)

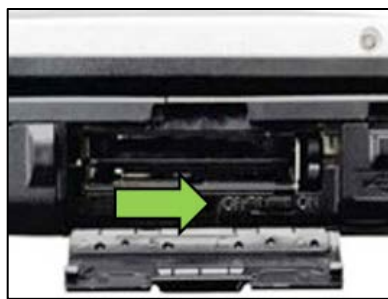
VAS 6150B
(Right side behind WIRELESS door)

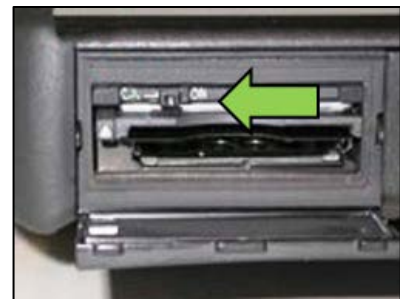
VAS 6150C
(Left side behind SC/EX door)

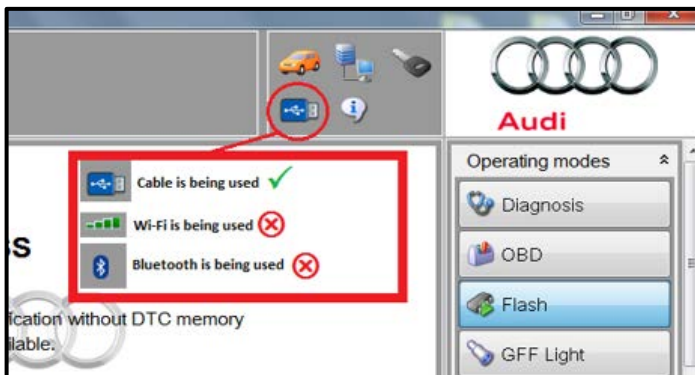
- Confirm that scan tool is communicating with the diagnostic head by USB cable.
 - If the Bluetooth or WiFi symbol is shown, then disconnect the diagnostic head from the vehicle and reconnect the USB cable to the diagnostic head and then reattach to the vehicle.

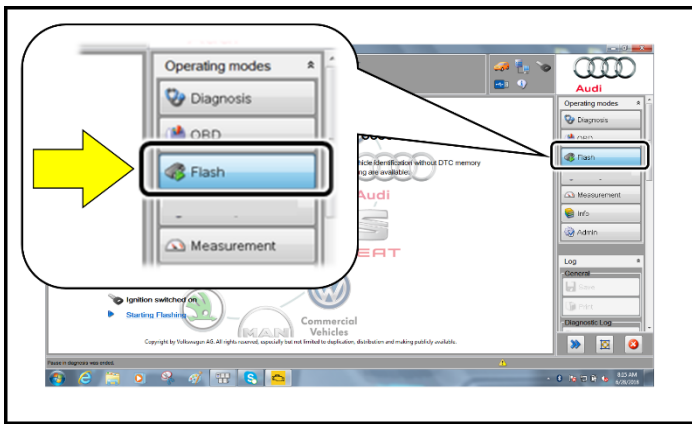
- From the home screen of the scan tool highlight “Flash” <1>.
- Follow the on-screen prompts.

NOTE
Operating mode “Flash” must be used.

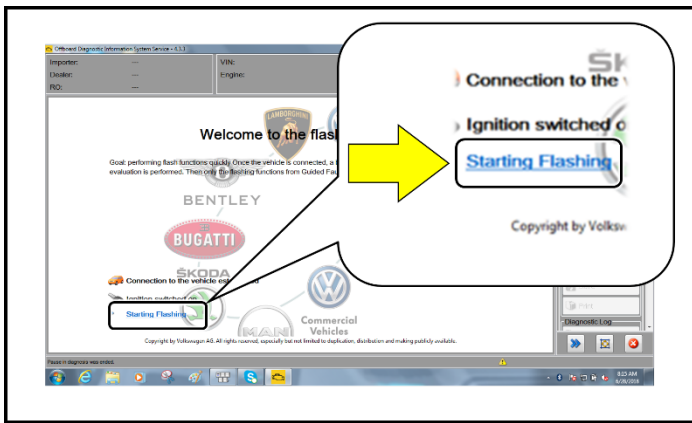
- Select “Starting Flashing” and follow the on-screen prompts.
