# Technical Service Bulletin

SUBJECT:		No: <b>TSB-12-13-005</b>	
<b>ECM REPROGRAMMING FOR FALSE MIL (DTC P0420)</b>		DATE: <b>November, 2012</b>	
		MODEL: <b>See below</b>	
CIRCULATE TO:	<input type="checkbox"/> GENERAL MANAGER	<input checked="" type="checkbox"/> PARTS MANAGER	<input checked="" type="checkbox"/> TECHNICIAN
<input checked="" type="checkbox"/> SERVICE ADVISOR	<input checked="" type="checkbox"/> SERVICE MANAGER	<input checked="" type="checkbox"/> WARRANTY PROCESSOR	<input type="checkbox"/> SALES MANAGER

Some affected vehicles may display an illuminated MIL with DTC P0420: Warm Up Catalyst Efficiency Below Threshold, recorded in the ECM. An incorrect parameter in the judgment criteria may cause a false MIL (mis-detection of a fault when an abnormal condition is not present).

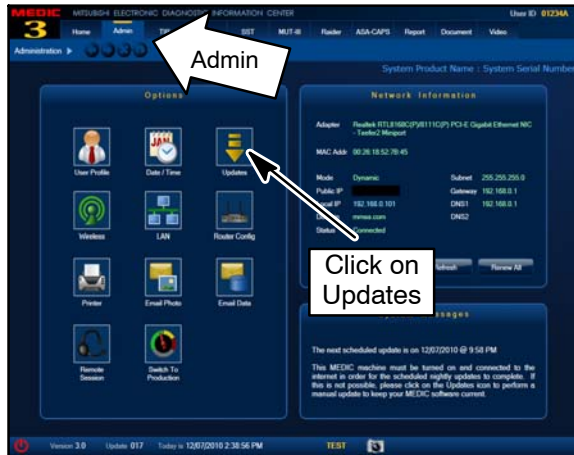
2. Verify the MEDIC 3 is at version 3.1 and at update **155 or higher**.

If your **MEDIC 3 update is at least 155**, continue with the Reprogramming Procedure on page 4.

If your **MEDIC 3 update is below 155**, update your MEDIC 3 as follows.

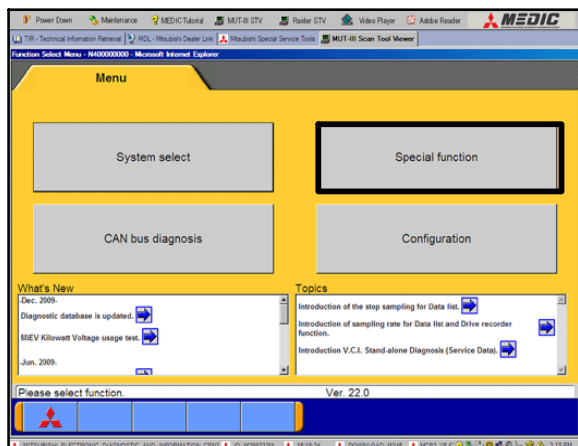
1. Conduct the following steps to reprogram the ECM.
  - a. Turn the ignition switch to the ON position. If the vehicle is equipped with the F.A.S.T. System, the transmitter must remain in the vehicle for the entire procedure.

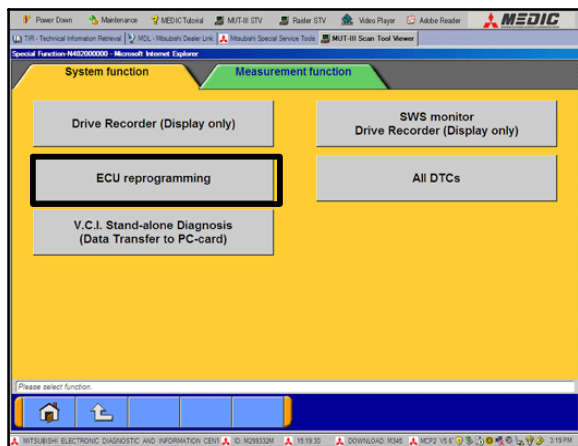
- b. If using MEDIC 3, from the main page, click the MUT-III STV icon at the top center of the screen.
  - c. From the MUT-III Main Menu, select "Special Function."

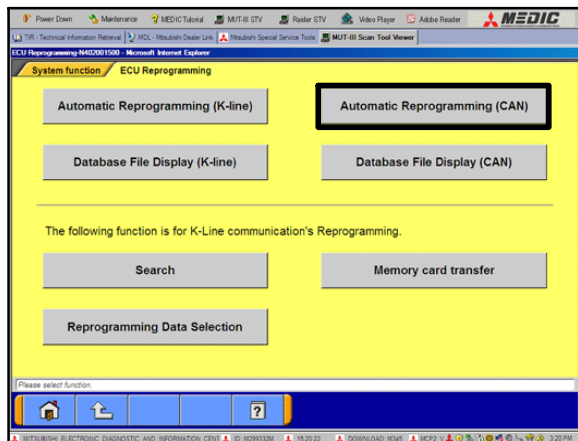
- d. Select "ECU reprogramming."

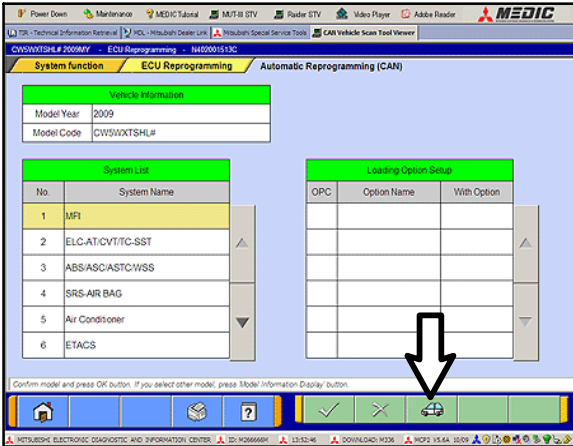
- e. Select "Automatic Reprogramming (CAN)."

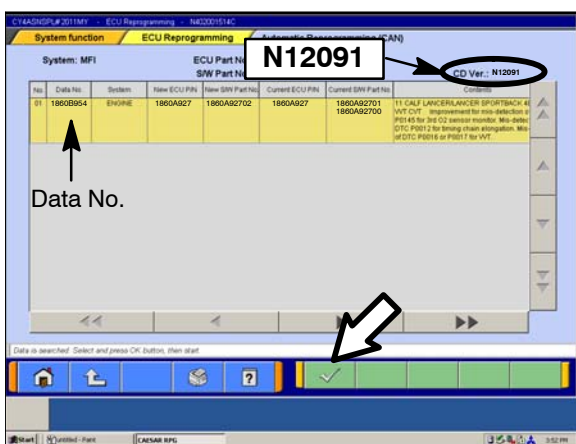
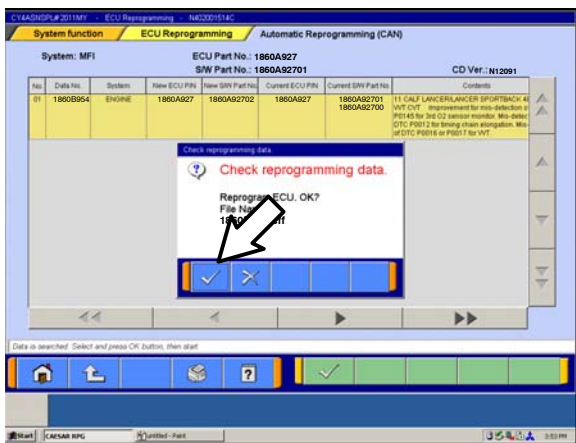
- l. The Automatic Reprogramming (CAN) database screen will display.

Confirm the database number at the top right of the table is **N12091** or higher.

If more than one row is displayed in the table, refer to the ECM Reprogramming Chart on page 2 to select the proper Data No. for this procedure and select the appropriate row.

Click the correct row to highlight it.

Click the check mark to continue.

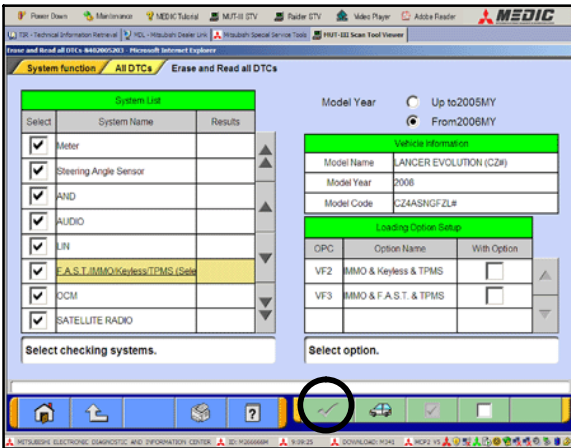
b. Select “All DTCS,” then select “ERASE AND READ ALL DTCS.”

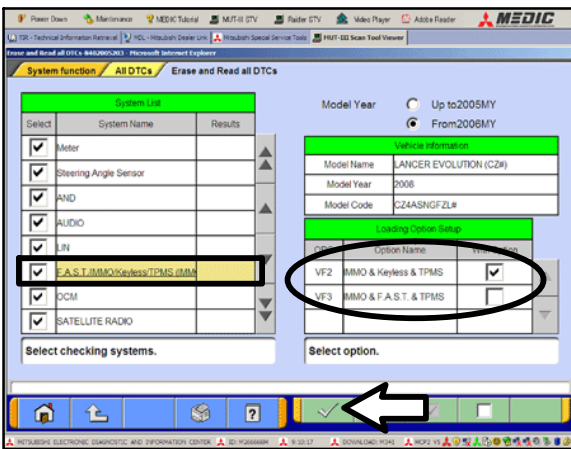
- c. The list on the left side of the screen (System List) will have all selections checked. Do not change these selections. DTCs may be set if the vehicle is equipped with options that are unchecked.

**NOTE:** The list on the RH side of the screen (Loading Option Setup) appears for Lancer based vehicles. For those models, the check mark at the bottom of the page is not highlighted (inactive) at this time.

- d. If the check mark at the bottom of the screen is highlighted (active), click it and proceed to step 4. If not proceed to step e.

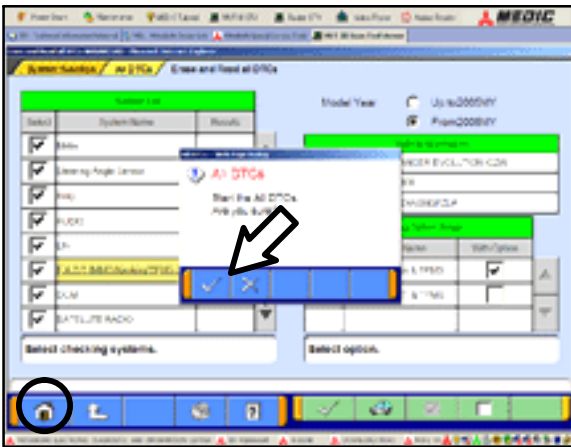
- e. In the System List, scroll to and click FAST/IMMOB/KEYLESS/TPMS. In the Loading Option Setup list, check the correct OPC (VF#).

- Vehicles with regular keyless entry (buttons on an integrated key), select VF2.
- Vehicles with F.A.S.T. key, select VF3.

- f. In the System List, scroll to and select METER. A window will display. Check the correct display type for the vehicle.

The check mark at the bottom of the page should be active. Click it to continue.
