SERVICE BULLETIN

NUMBER: 15-256-19R

SUBJECT: FOTA (Firmware Over-The-Air) Reprogramming
 Procedure to Optimize Harman Gen 3.1 Audio / Navigation

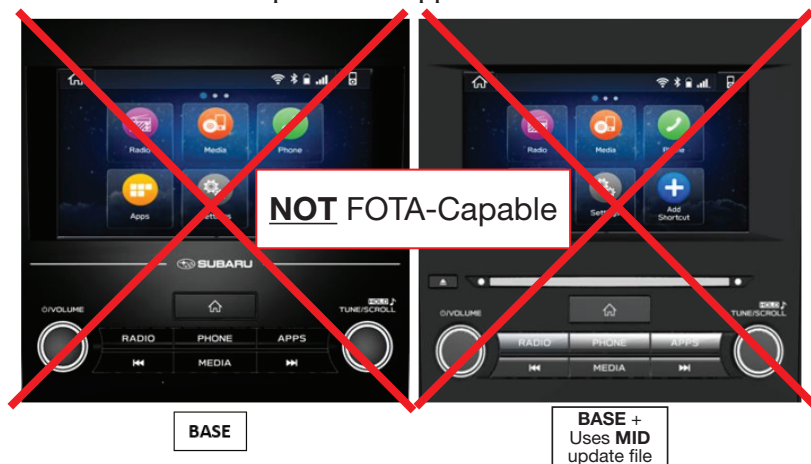
Multimedia System Type	Descriptive Features
6.5 Inch Display Audio System (Base)	No CD slot / Eject Button
6.5 Inch Display Audio System (Base +)	Equipped with CD Player and Eject Button
8.0 Inch Display Audio System (Mid)	Phone Button
8.0 Inch Audio / Navigation System (High)	Map Button but no Phone Button

Reference photos of each head unit faceplate are supplied below:

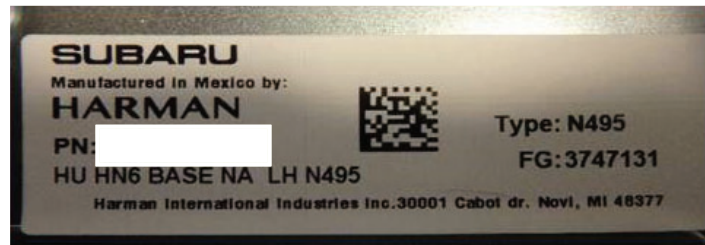
IMPORTANT NOTE: If the H/U needs to be removed for any reason, always confirm the part number shown on the unit matches the part number in the Electronic Parts Catalog (EPC) for the specific VIN being repaired. Example photos are provided below for reference.

IMPORTANT: If the H/U software cannot be updated using FOTA, update the H/U following the USB flash drive procedure outlined in TSB 15-236-18R. In such a case, a VIN/ H/U Serial Number mismatch may exist. If this occurs, the H/U must be removed and the serial number recorded as shown below. In these cases, the COMPLETE 28-digit serial number is required to be entered in the Miscellaneous Detail field during claim submission (no spaces or special characters). Also, capture a photo of the serial number label for reference in case any question arises about the serial number submitted. Examples of the serial number label are shown below.

VERY IMPORTANT: Always record **all 4** “segments” of the 28-digit H/U Serial Number. Take and retain a photo of this small label in case it is needed in the future for confirmation.

H/U Serial Number Identification			
①	②	③	④
N0030A0000	2909332	DJ2036	70080

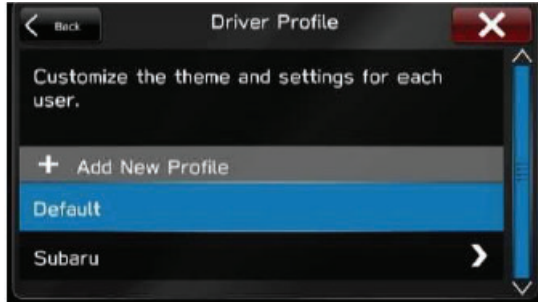
- 2-1-4) Change to next driver profile and repeat the actions above as necessary. (Example photo below shows other driver profiles. Be sure to note all the preset stations for each driver profile.)

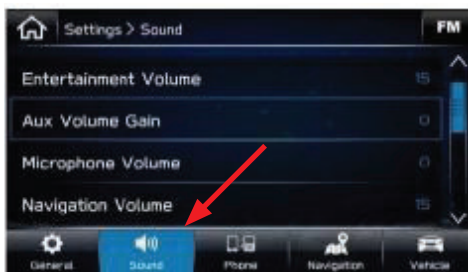
2-2-1) From the Settings > Sound screen, press the "Sound" button.

2-1-2) Record each volume setting for: Entertainment Volume, AUX Volume Gain, Microphone Volume, and Navigation Volume.

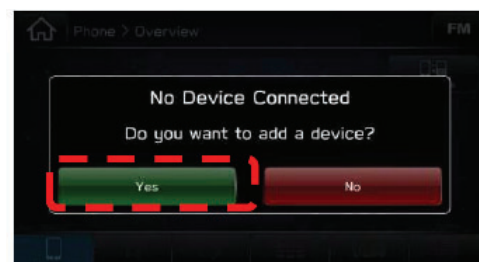
1.2.2) Select Yes on “No Device Connected” pop-up.

NOTE: If H/U display does not show the pop-up, please select “Add device” from the Phone Overview.

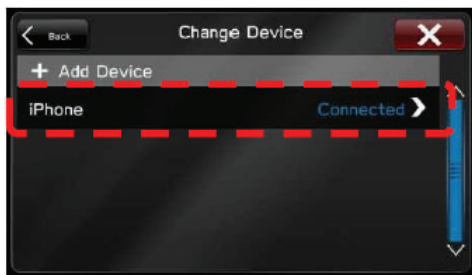
1.3.1) On the “Change Device” screen, identify the most recently paired device (iPhone is shown here).

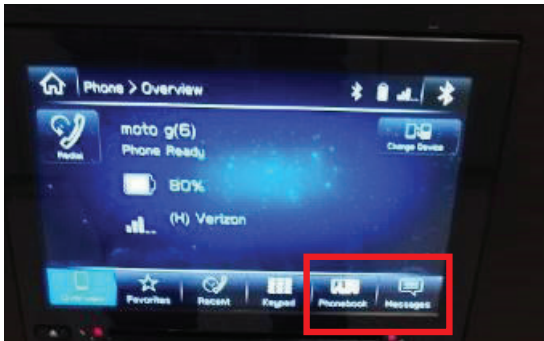
1.3.7) Confirm both the Phonebook and Messages buttons on the display are highlighted (activated) as shown below.

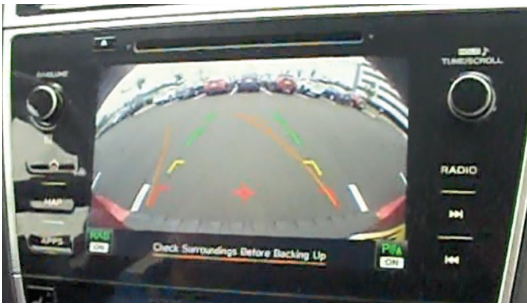
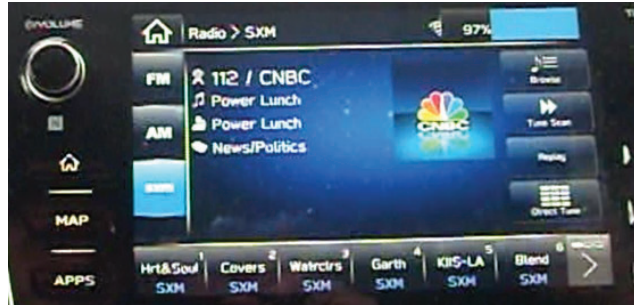
1.6.1) Wait until the download progress reaches 100%. During the software download, the H/U is fully functional. **NOTE:** It is normal for the progress to hang at some points for 1-2 minutes. This does not indicate a concern. **BE PATIENT.**

NOTE: When downloading via Wi-Fi, it may take anywhere from 5 to 20 minutes for the update to complete depending on the provider transfer rate signal strength.

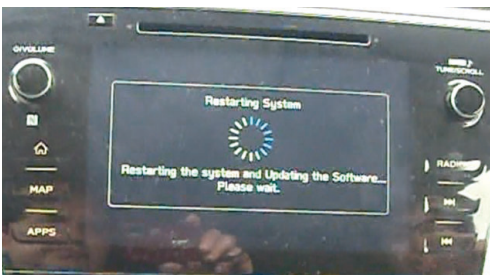
1.6.5) The H/U will automatically shut down and restart after the installation completes.

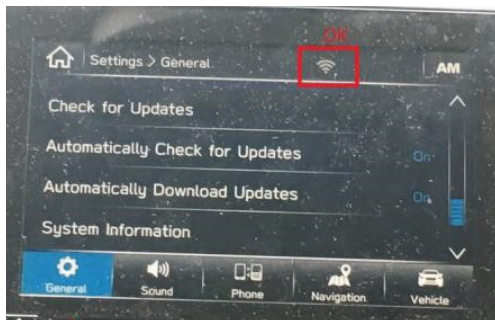
2.6) Select “Connect” and input the password of the Wi-Fi device to be used. When a connection is established, the screen will display a Wi-Fi icon on top bar.
