SERVICE BULLETIN

Classification: EL19-071	Reference: NTB20-001	Date: January 7, 2020
-----------------------------	-------------------------	--------------------------

2016-2017 LEAF; 40 KWH HIGH VOLTAGE SERVICE BATTERY PACK

APPLIED VEHICLES: 2016-2017 LEAF® (ZE0)
APPLIED VIN: Only VINs starting with 1N4BZ0...

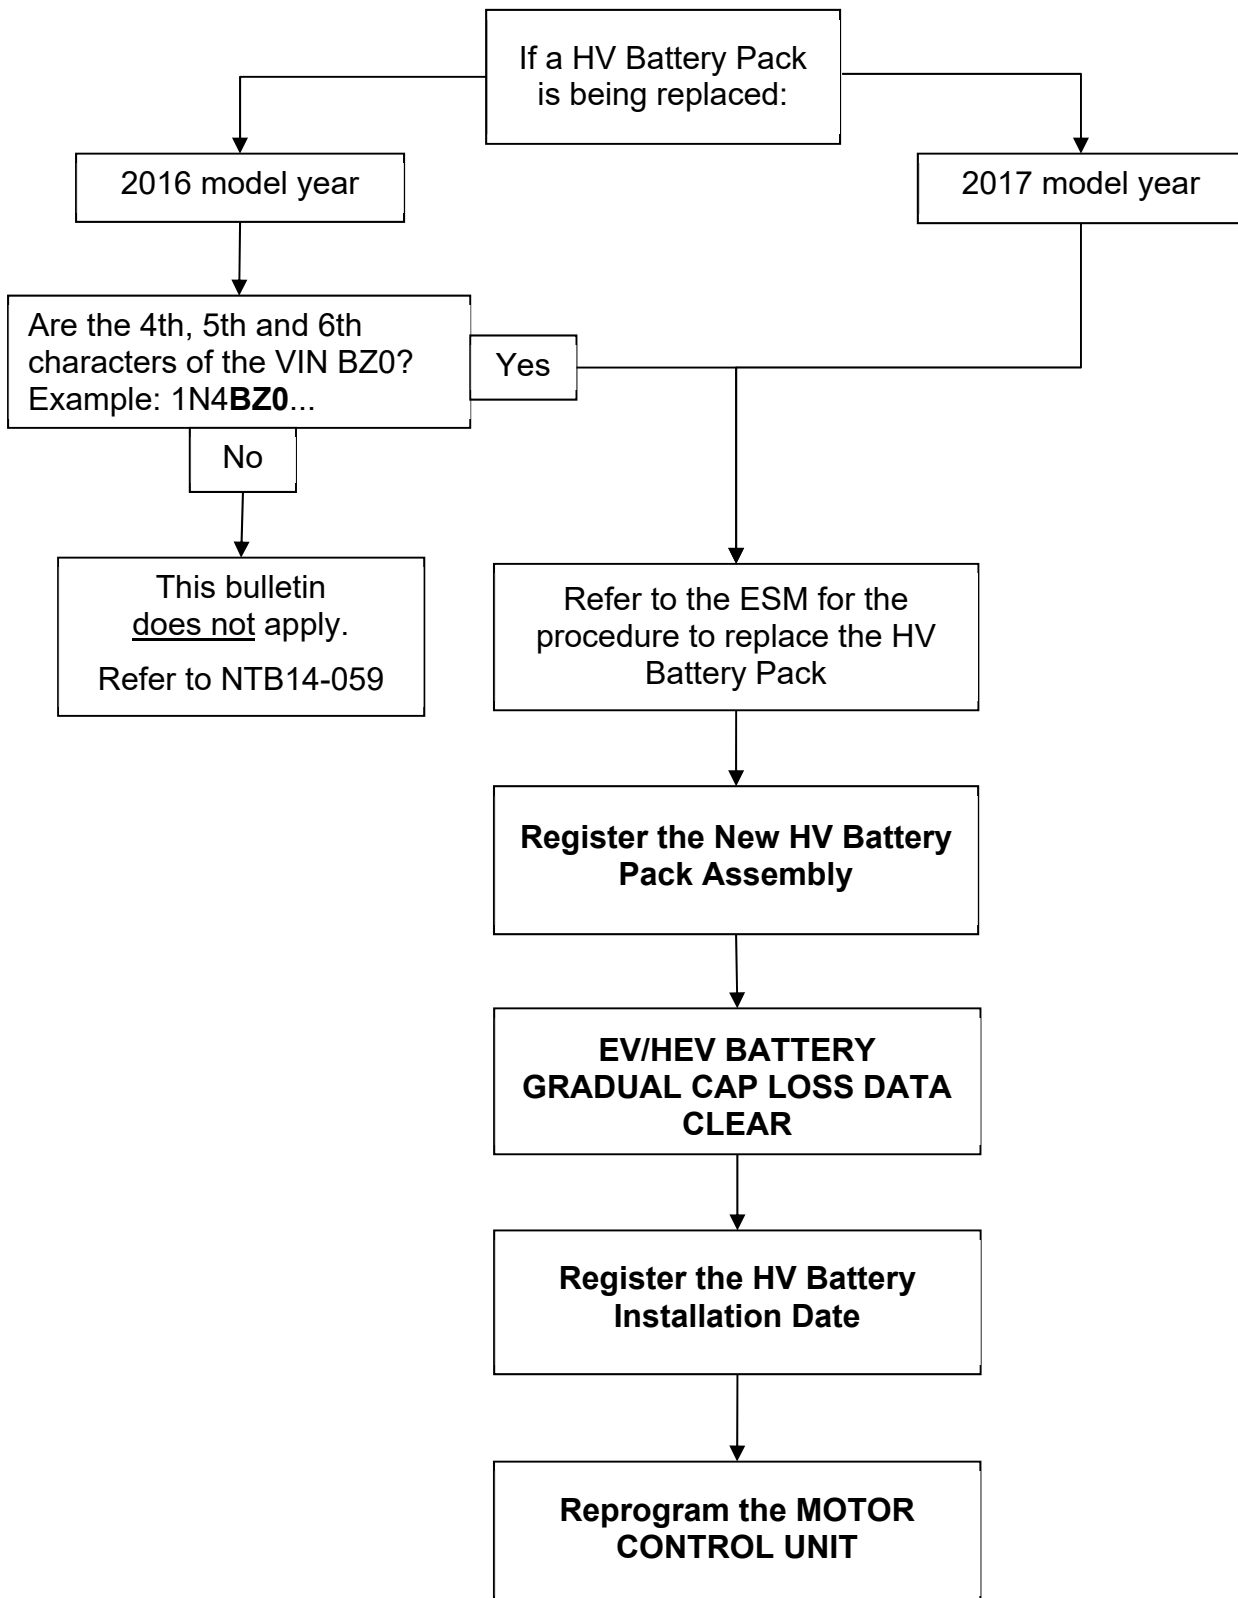
Service Information Overview

- Refer to the applicable Electronic Service Manual (ESM) section **EVB – EV Battery System** for the procedure to replace the HV Battery Pack.
- Refer to **Service Information Overview** on page 2 for additional services required when replacing the HV Battery Pack.

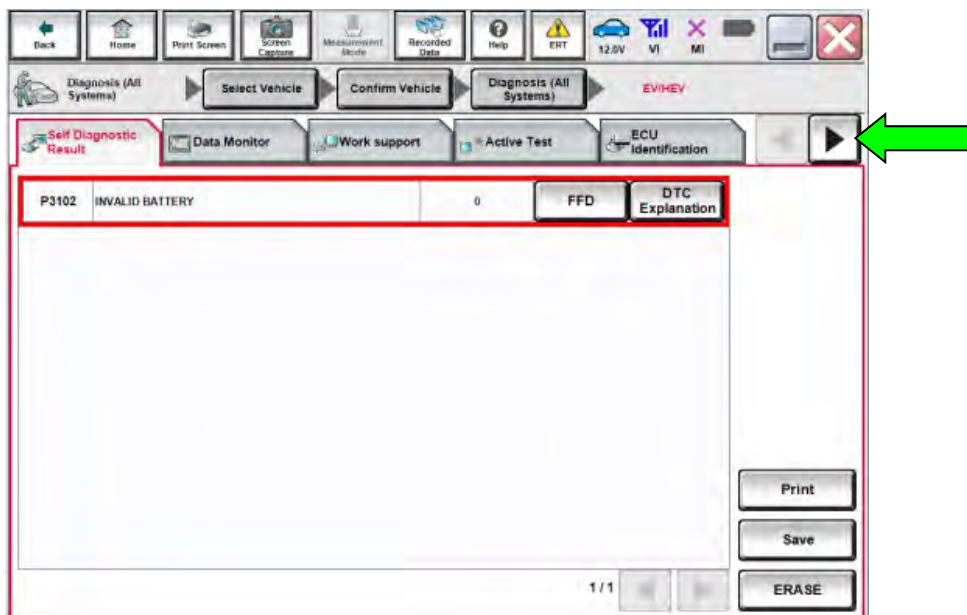
11. Select the “right arrow” (Figure 6).

HINT: This arrow will only be available if the HV Battery registration card is installed in the CONSULT PC.

- The card must be installed before opening C-III plus.
- If the card is installed, but the arrow in Figure 6 is not available, reboot the CONSULT PC and restart the procedure from step 3.

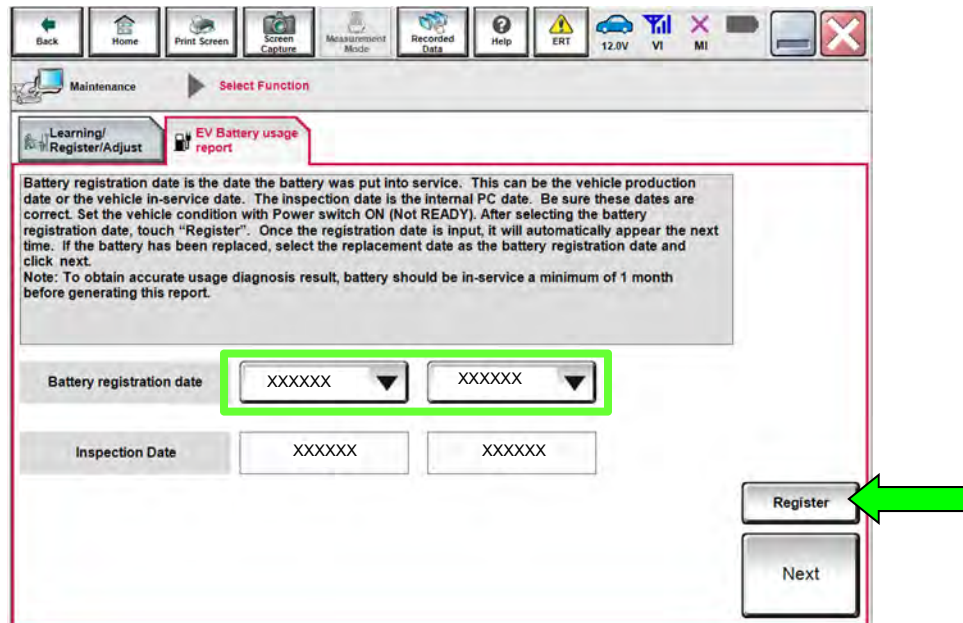
Figure 16

25. Input the correct "Battery registration date" (see Figure 16).

26. Select **Register**.

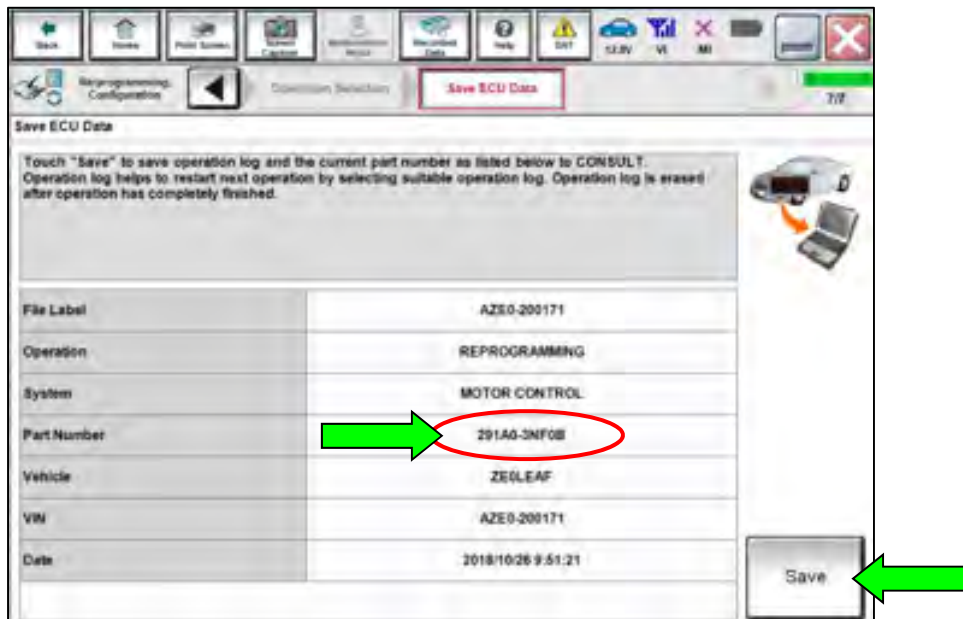
Figure 23

37. When you get to the screen shown in Figure 23, find the **MOTOR CONTROL Part Number** and write it on the repair order.

HINT: This is the current MOTOR CONTROL Part Number (P/N).

- If the current MOTOR CONTROL Part Number is 291A0-3NF0E, proceed to step 52.
- If the current MOTOR CONTROL Part Number is not 291A0-3NF0E, continue to step 38.

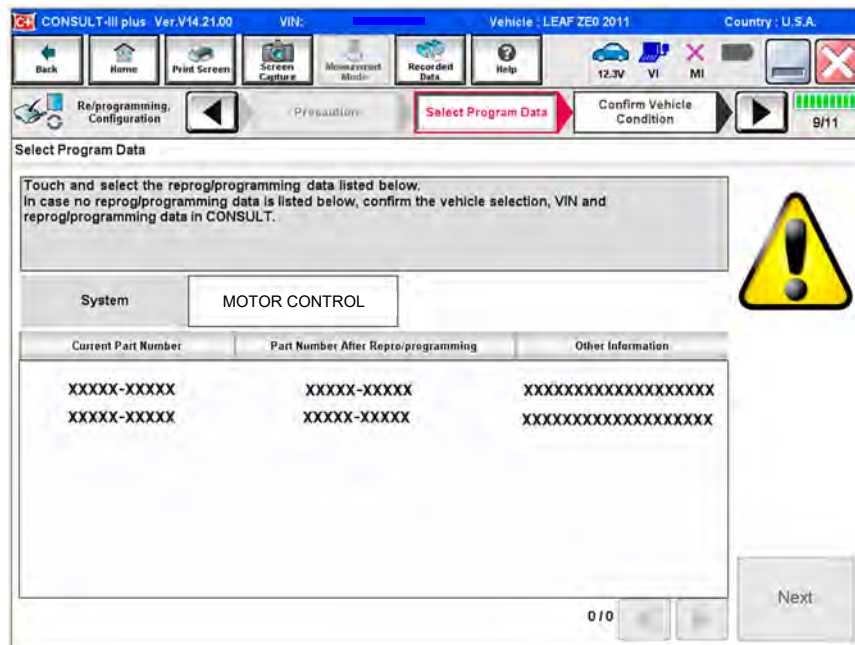
HINT:

- In some cases, more than one new P/N for reprogramming is available.
 - If more than one P/N is available, the screen in Figure 26 will display. Select and use the reprogramming option that **does not** have the message “Caution! Use ONLY with NTBXX-XXX”.
 - If you get this screen and it is blank (no reprogramming listed), it means there is no reprogramming available for this vehicle.

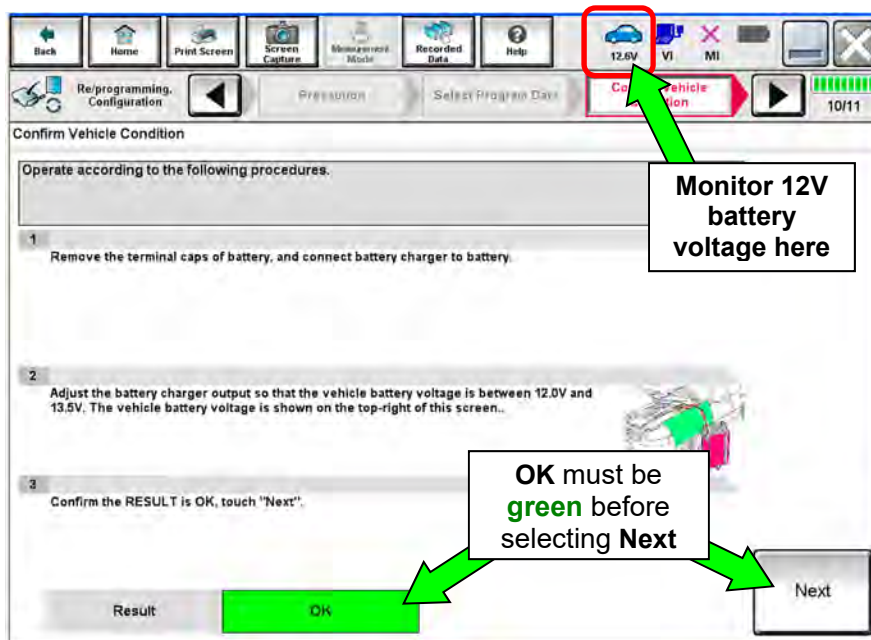
Figure 28

44. Confirm the battery voltage is correct, and then select **Next**.

- Battery voltage must stay within specified range to make the indicator turn **green**.

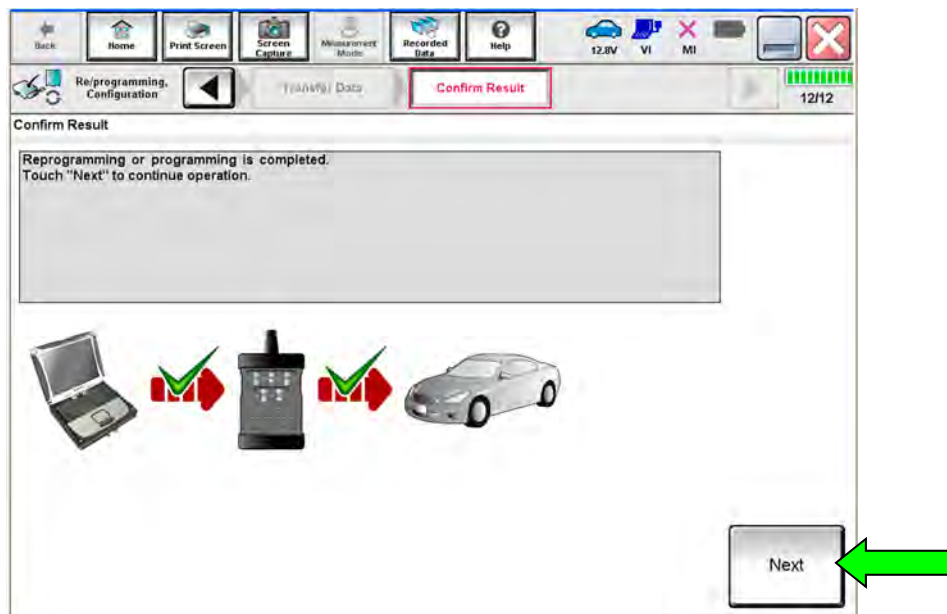
47. When the screen in Figure 31 displays, reprogramming is complete.
- Select **Next**, and then wait for System Call to complete.
 - Proceed to step 48 on page 22.

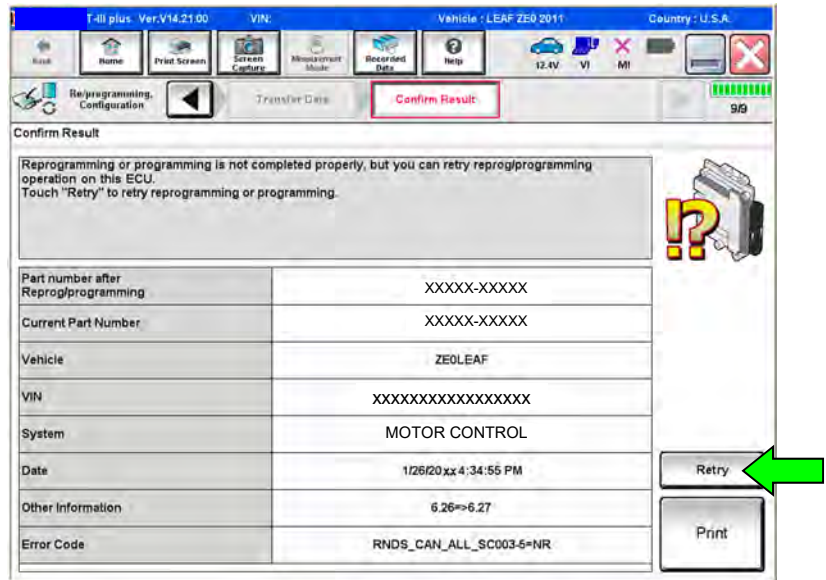
Figure 32

HINT: If reprogramming does not complete and the **!?** displays as shown in Figure 32:

- Check battery voltage (12.0 - 13.5V).
- Ignition is ON, Ready Mode is OFF.
- External Bluetooth® devices are OFF.
- All electrical loads are OFF.
- **Select Retry and follow the on screen instructions.**
- Retry may not go through on the first attempt and can be selected more than once.

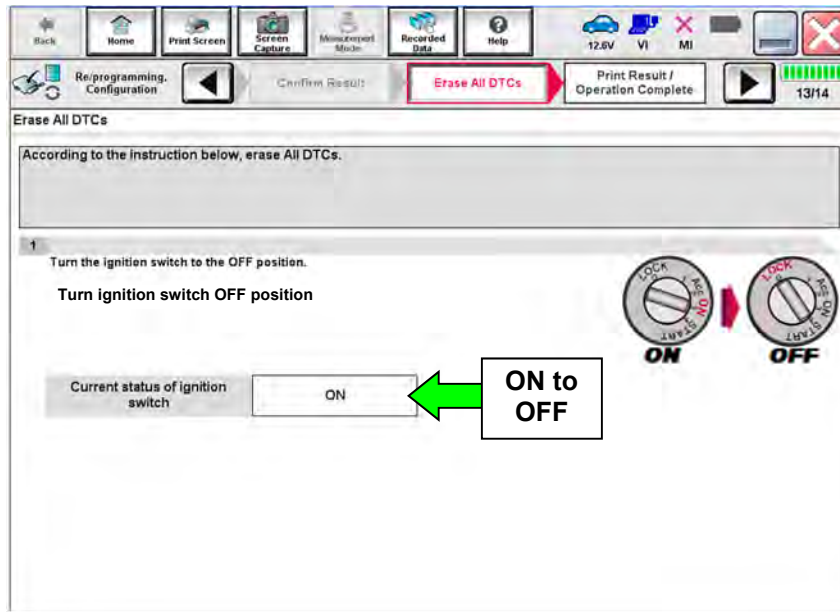
- a. Turn the “ignition” off by depressing the power switch once.
 - The screen in Figure 34 will read **OFF** after pressing the power switch once.

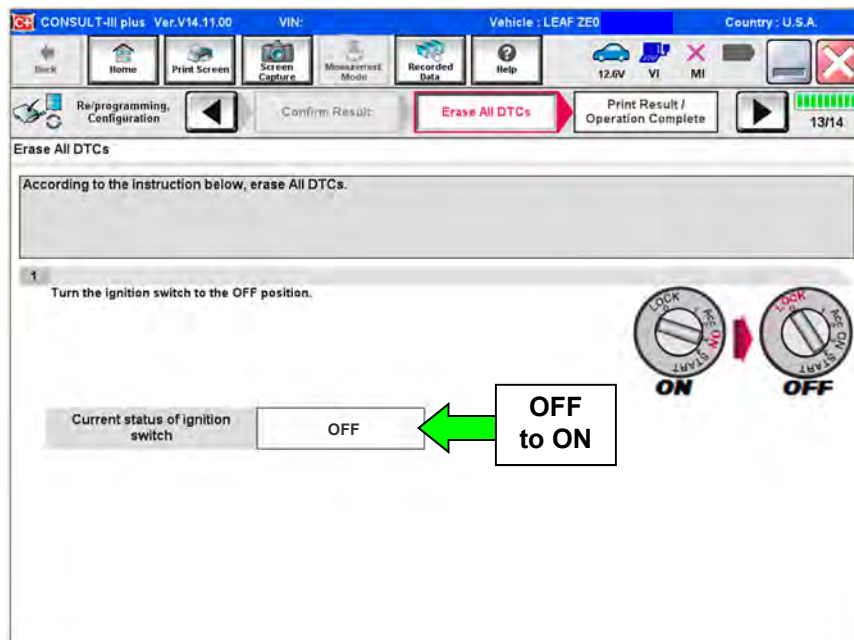
- b. Wait 1 minute with the ignition OFF.
- c. Turn the “ignition” ON by depressing the power switch twice (not Ready mode).
 - Do not step on the brake pedal when depressing the power switch.
 - The screen in Figure 35 will read **ON** after pressing the power switch twice.

HINT: Do not be confused by any screen messages. At this point, simply turn the “ignition” ON.

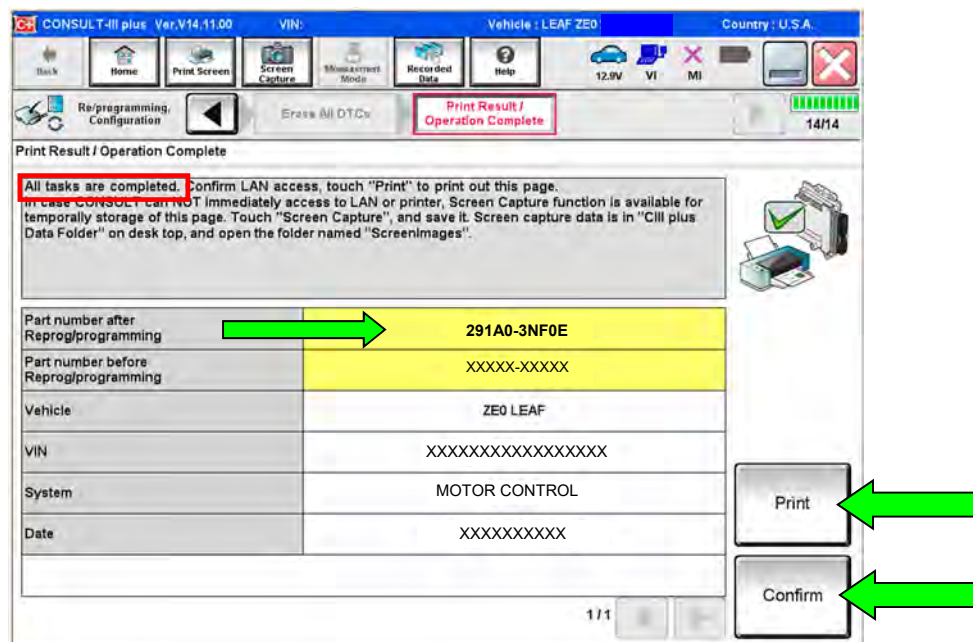
Figure 37

49. Verify that the **Part number after Reprog/programming** has changed to 291A0-3NF0E.

50. Print a copy of this screen (Figure 37) and attach it to the repair order.

51. Select **Confirm**.

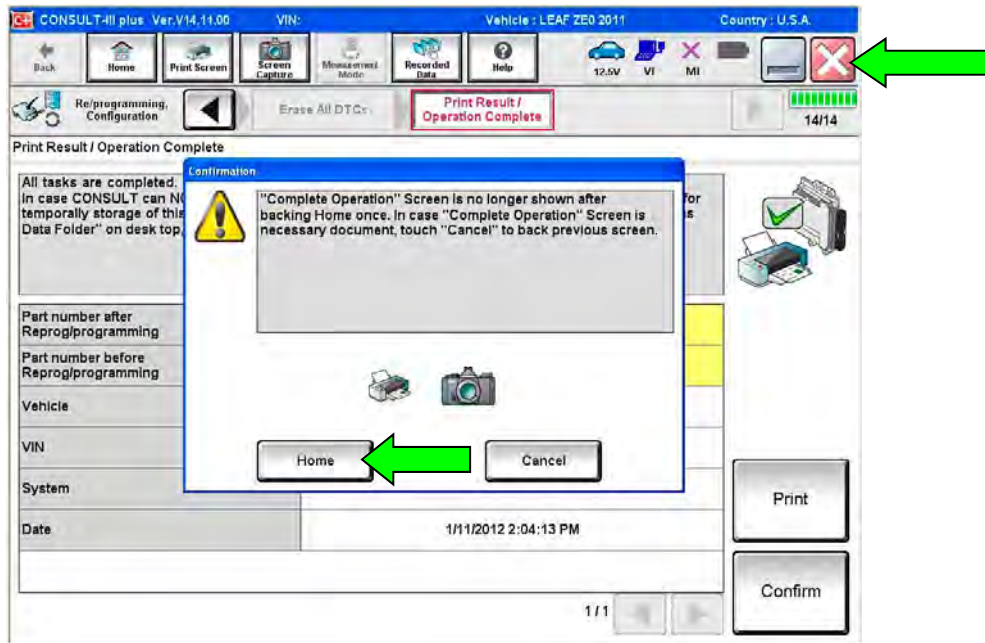
Figure 38

53. Close C-III plus by selecting "X" (see Figure 38).
