Audio Head Unit Software Update (Denso-Ten)

Service Category Audio/Visual/Telematics

Section Navigation/Multi Info Display

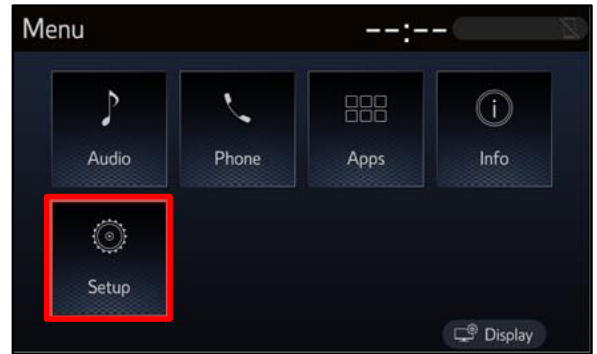
Figure 1.

1. Turn the ignition ON.
2. Press the Menu button on the radio faceplate, then select Setup.

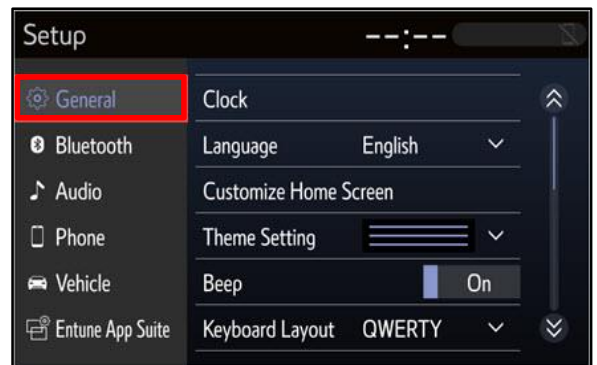
Figure 2.

3. Select General on the Setup screen.

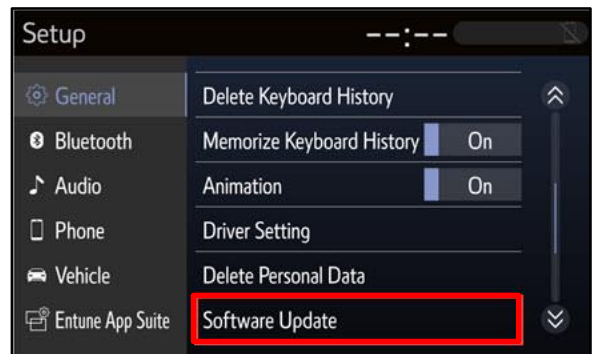
Figure 3.

4. Scroll down and select Software Update.

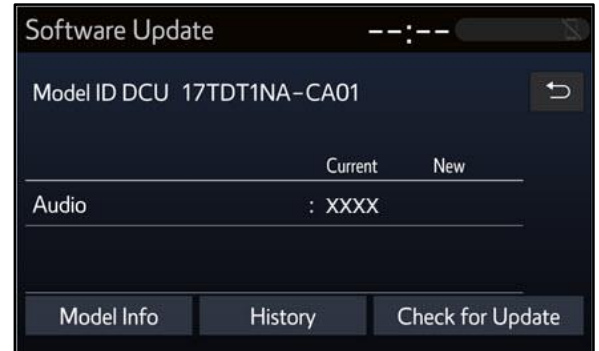
Figure 4.

- Verify that the software version is the same or earlier than indicated in the Introduction.

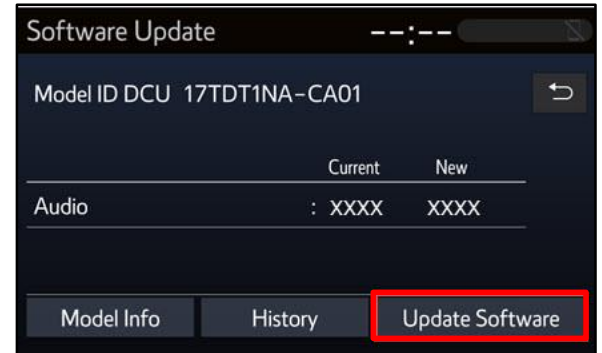
Figure 5.

9. Select the Update Software button in the lower right-hand corner.

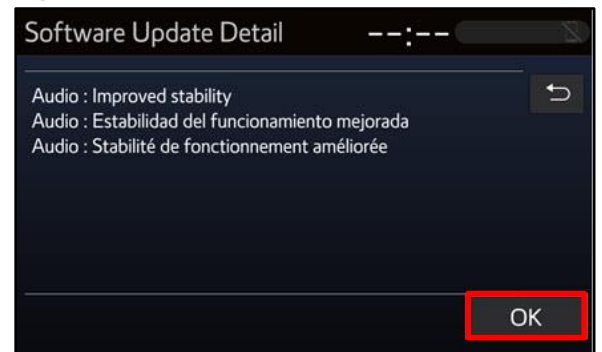
Figure 6.

10. Select OK on the Software Update Detail screen.

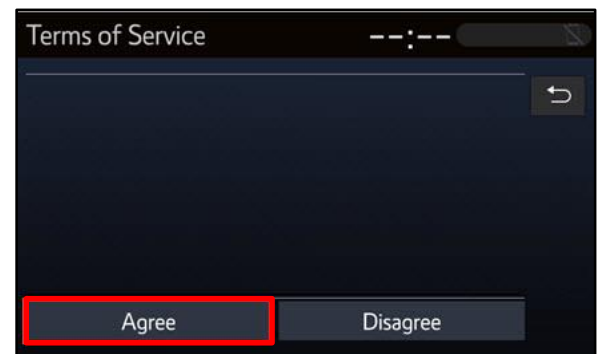
Figure 7.

11. Select Agree on the Terms of Service screen.

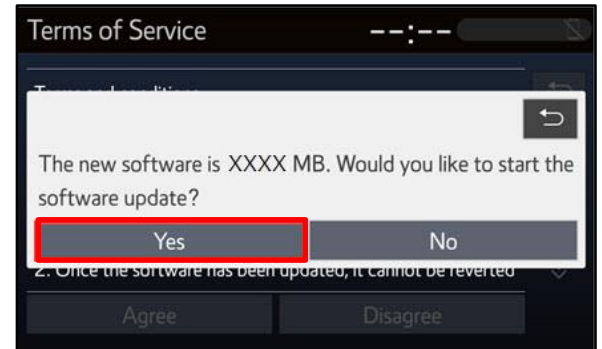
Figure 8.

12. Select Yes on the “Would you like to start the software update?” pop-up.

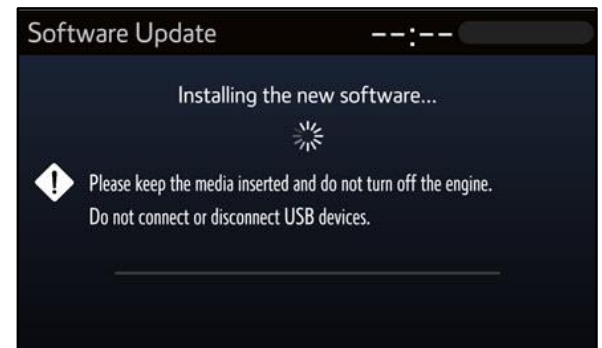
Figure 9.

13. Once the head unit begins installation, the update will take approximately 10 minutes.

- Do NOT turn OFF the ignition or ACC BEFORE the software is ready for updating.
- Do NOT remove the USB flash drive until instructed in step 17.

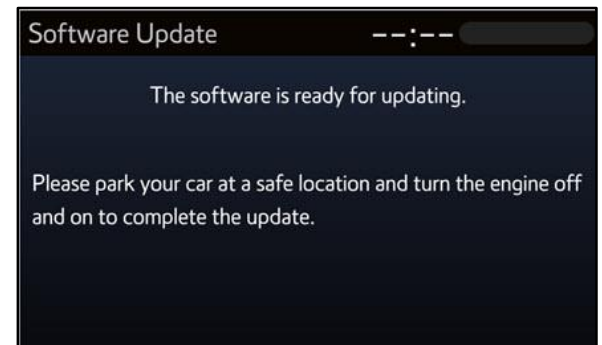
Figure 10.

14. When the “The software is ready for updating” screen appears, turn OFF the ignition.

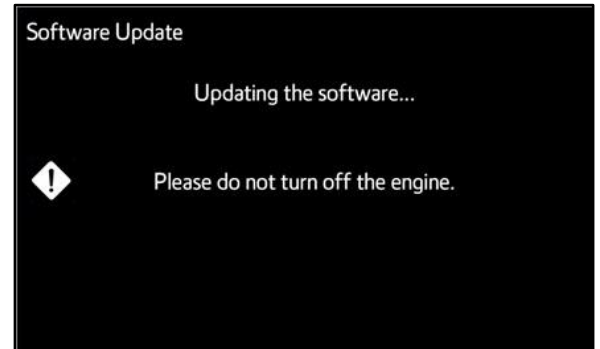
Figure 11.

16. AFTER turning the ignition ON, the Software Update screen will appear. Do NOT turn OFF the ignition or remove the USB flash drive. The head unit will reboot during this time.

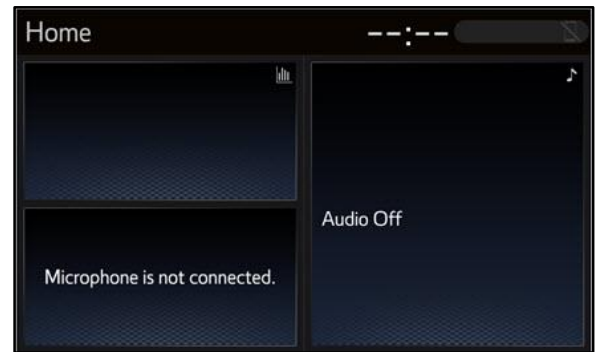
Figure 12.

17. Once the software update is complete and the Home screen appears, remove the USB flash drive.

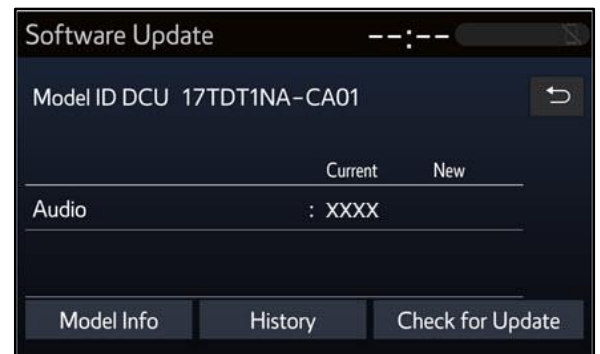
Figure 13.

18. Perform steps 3 – 6 to verify the software version matches the current software version information table below.
