NUMBER  
1802 (Rev 9, 02/14/2020)

SUBJECT: KNOCK SENSOR DETECTION SYSTEM - ECU  
LOGIC IMPROVEMENT (PI1802)

This bulletin provides information related to a software update to the Engine Control Unit (ECU) to install the Knock Sensor Detection System (KSDS) in order to protect the engine from excessive connecting rod bearing damage. This update is for:

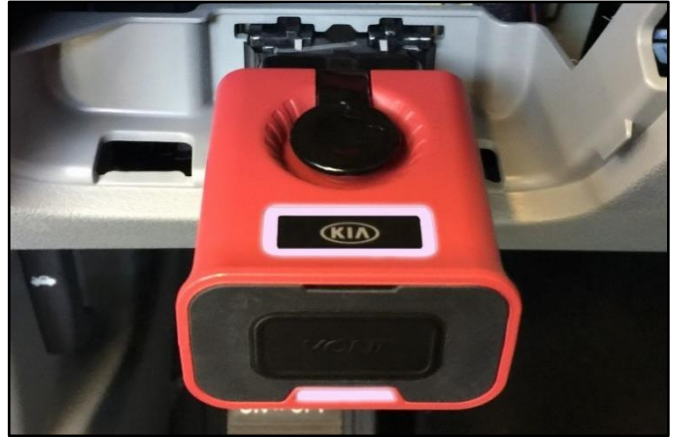
The ECU upgrade function on KDS operates wirelessly. It is not necessary to perform the upgrade via USB cable.

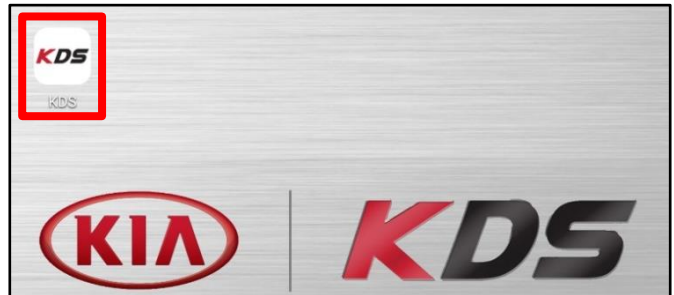
2. With the ignition ON, turn ON the KDS tablet. Select **KDS** from the home screen.

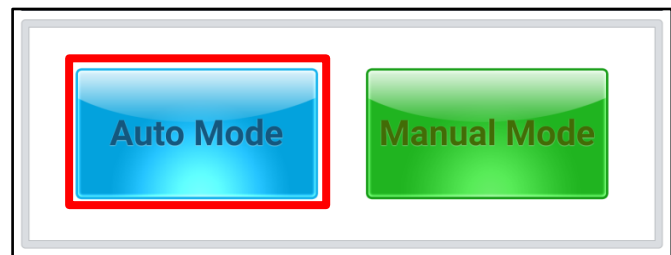
Do NOT attempt to perform a Manual Mode upgrade UNLESS Auto Mode fails. Always follow the instructions given on the KDS in either Auto or Manual mode.

- Select the **ENGINE** system under the System selection menu.

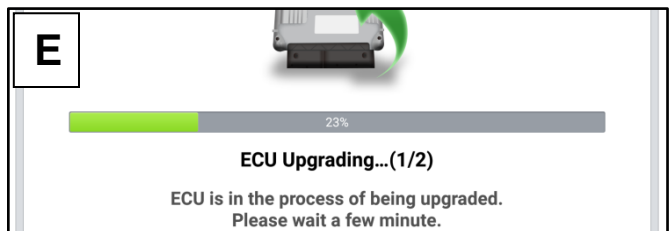
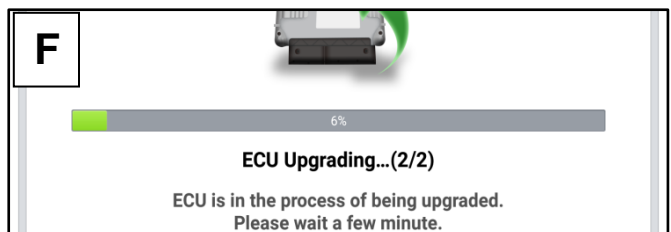
- The ECU upgrade will begin and the progress of the upgrade will appear on the bar graph. Upgrade part (1/2) (E) will download the upgrade event to the VCI-II. Upgrade part (2/2) (F) will upgrade the ECU.
