<b>GROUP</b> <b>Product Improvement</b>	<b>MODEL</b> <b>2011-2014MY Optima (QF/TF)</b> <b>2012-2014MY Sorento (XMa)</b> <b>2011-2013MY Sportage (SL)</b>
	<b>NUMBER</b> <b>1803 (Rev 5, 03/16/2020)</b>	<b>DATE</b> <b>November 2018</b>

**SUBJECT: KNOCK SENSOR DETECTION SYSTEM - ECU  
LOGIC IMPROVEMENT (PI1803)**

This bulletin provides information related to a software update to the Engine Control Unit (ECU) to install the Knock Sensor Detection System (KSDS) in order to protect the engine from excessive connecting rod bearing damage. This update is for:

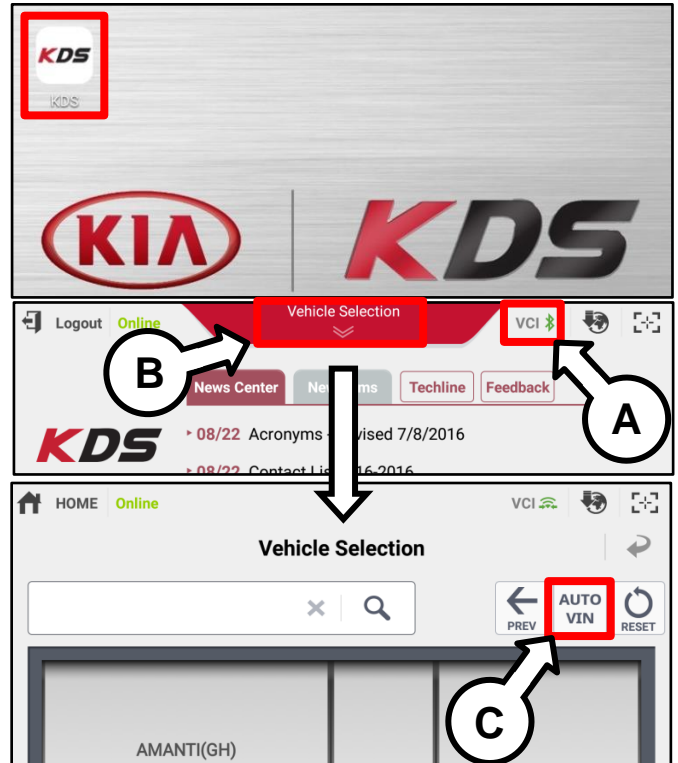
2. With the ignition ON, turn ON the KDS tablet. Select **KDS** from the home screen.
3. Confirm communication with VCI (A) and then configure the vehicle (B) using the **AUTO VIN** (C) feature.

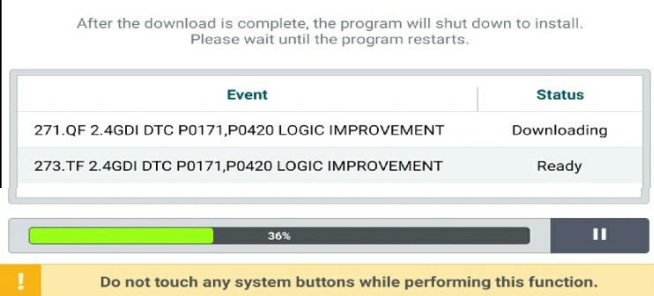
The vehicle must be identified in Vehicle Selection to download an Event for that vehicle.

After the download is complete, the program will shut down to install.  
Please wait until the program restarts.

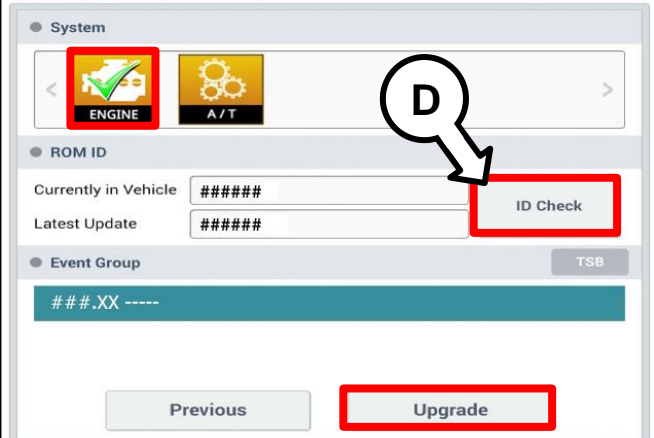
Touch **ID Check** (D) and confirm that the latest update is available.

Select **Upgrade Event #452 (XMa), #453 (TF), #454 (QF), or #455 (SL)** and select **Upgrade** to continue.

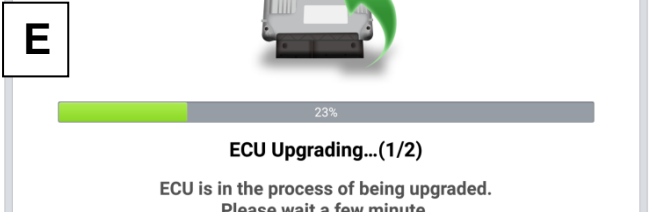
E

- The ECU upgrade will begin and the progress of the upgrade will appear on the bar graph. Upgrade part (1/2) (E) will download the upgrade event to the VCI-II. Upgrade part (2/2) (F) will upgrade the ECU.

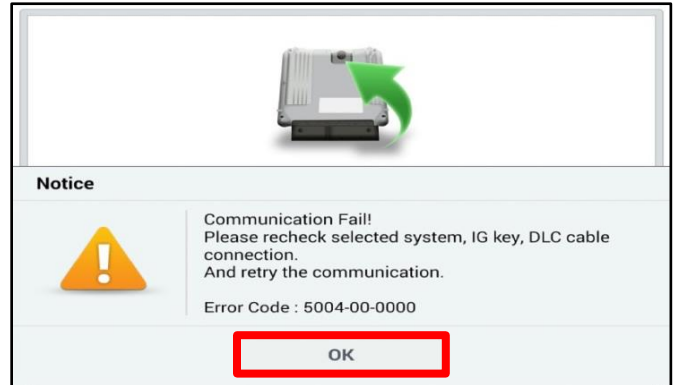
9. If a “Communication Fail” screen appears, verify that the VCI-II and KDS are communicating properly. Touch **OK** and restart the procedure from step 4.

**If an error notice continues to appear or if the upgrade cannot be performed, DO NOT disconnect the KDS/VCI-II. Contact GIT America Help Desk at (888) 542-4371 or Techline.**

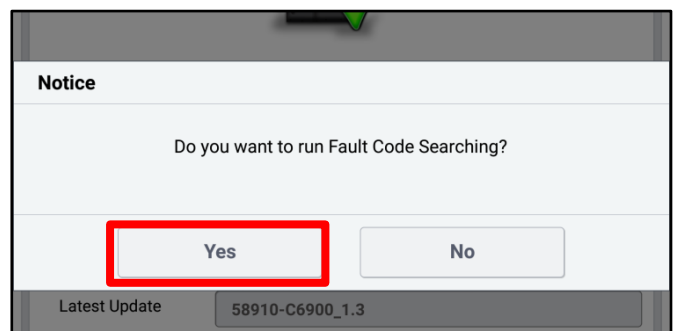
12. When prompted, select **YES** to check for Diagnostic Trouble Codes (DTC) and erase any DTCs stored such as EPS, ESC, and TPMS that may have been set during the upgrade.
