MODEL
**2019MY
Sorento (UMa)
Optima (JFa)
Sportage (QL)**

NUMBER
1805 (Rev 2, 03/18/2020)

**KNOCK SENSOR DETECTION SYSTEM (KSDS)
LOGIC IMPROVEMENT (PI1805)**

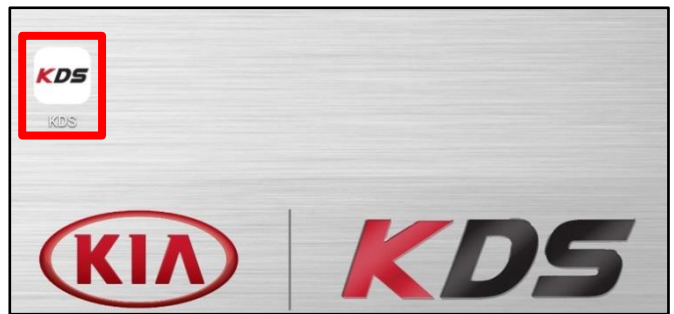
2. With the ignition ON, turn ON the KDS tablet. Select **KDS** from the home screen.

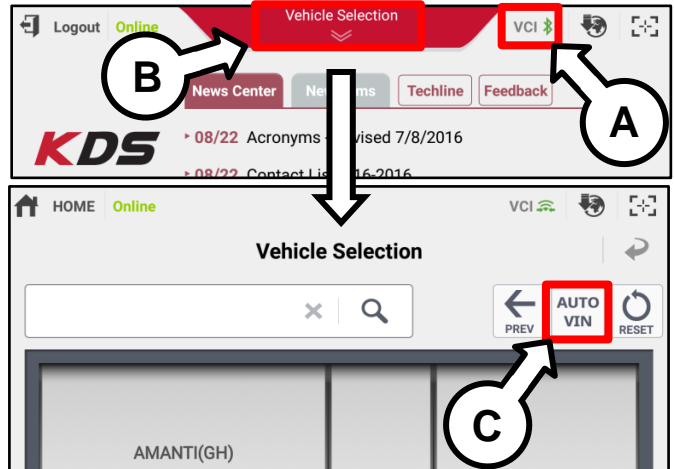
3. Confirm communication with VCI (A) and then configure the vehicle (B) using the **AUTO VIN** (C) feature.

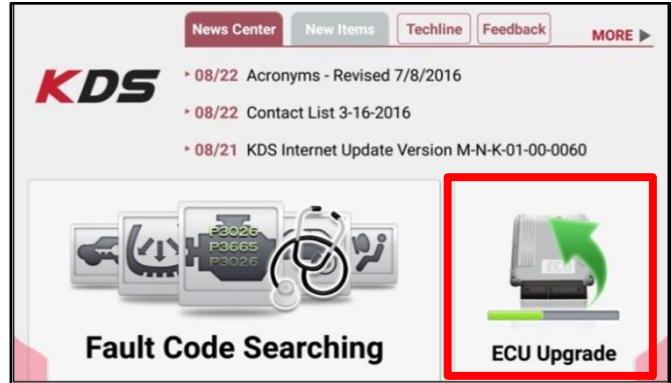
4. Select **ECU Upgrade**.

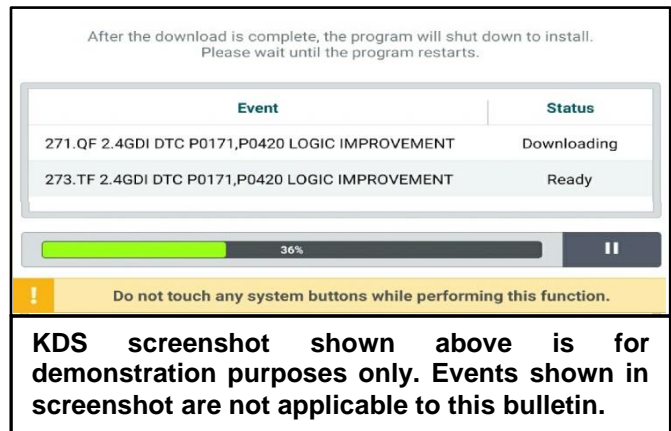
5. The KDS will check the server for recently uploaded Events and then automatically download **Upgrade Event #479 (UMa) or, #458 / #481 (JFa) or #459 / #482 (QL)**.

The vehicle must be identified in Vehicle Selection to download an Event for that vehicle.

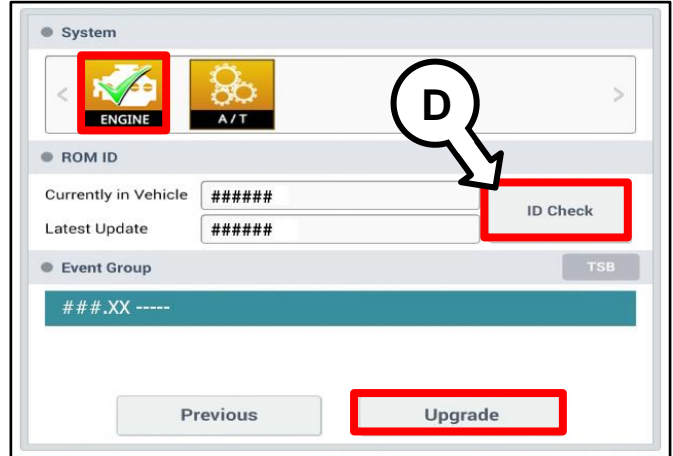
- Select the **ENGINE** system under the System selection menu.

Touch **ID Check** (D) and confirm that the latest update is available.

Select **Upgrade Event #479 (UMa)** or, **#458 / #481 (JFa)** or **#459 / #482 (QL)** and select **Upgrade** to continue.

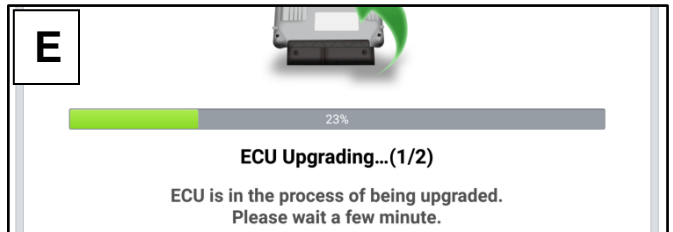
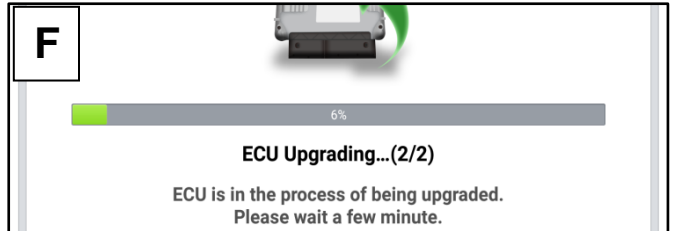
- The ECU upgrade will begin and the progress of the upgrade will appear on the bar graph. Upgrade part (1/2) (E) will download the upgrade event to the VCI-II. Upgrade part (2/2) (F) will upgrade the ECU.

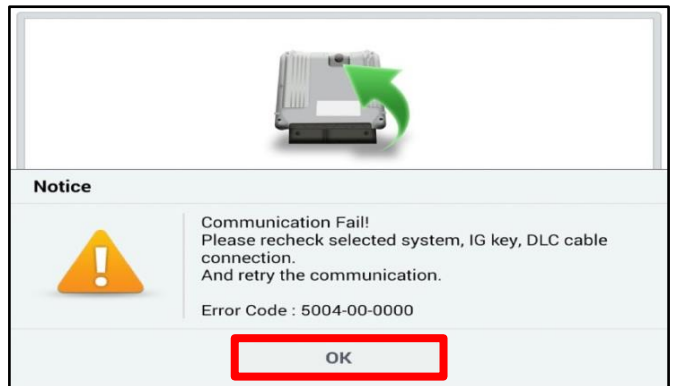
- If a "Communication Fail" screen appears, verify that the VCI-II and KDS are communicating properly. Touch **OK** and restart the procedure from step 4.

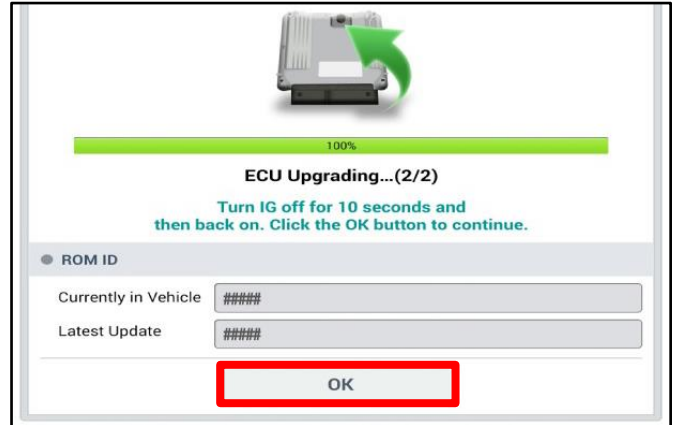
10. When instructed on the KDS, turn the ignition **OFF** for ten (10) seconds then back on. Touch **OK** to continue.

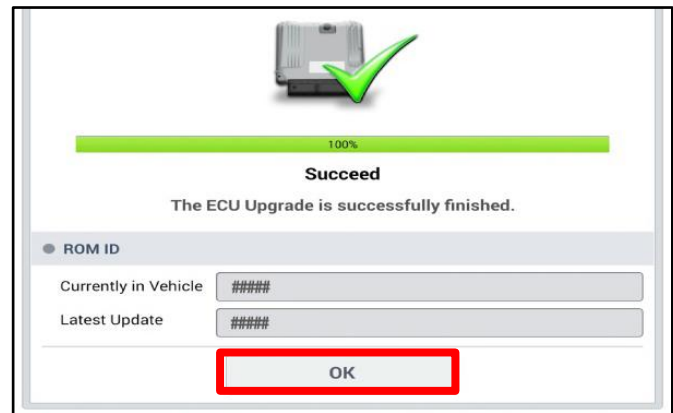
11. Once the upgrade is complete, touch **OK** to finalize the procedure.

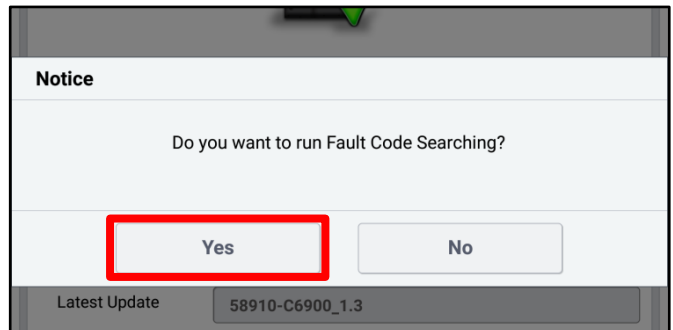
12. When prompted, select **YES** to check for Diagnostic Trouble Codes (DTC) and erase any DTCs stored such as EPS, ESC, and TPMS that may have been set during the upgrade.
