# SERVICE CAMPAIGN BULLETIN

SUBJECT:			No: <b>SC-13-004</b>
<b>ECM REPROGRAMMING FOR MIL ILLUMINATES, DTC P1241 OR P061A STORED IN ECM</b>			DATE: <b>December, 2013</b>
			MODEL: <b>See below</b>
CIRCULATE TO:	<input type="checkbox"/> GENERAL MANAGER	<input checked="" type="checkbox"/> PARTS MANAGER	<input checked="" type="checkbox"/> TECHNICIAN
<input checked="" type="checkbox"/> SERVICE ADVISOR	<input checked="" type="checkbox"/> SERVICE MANAGER	<input checked="" type="checkbox"/> WARRANTY PROCESSOR	<input type="checkbox"/> SALES MANAGER

## PURPOSE

For some vehicles, normal Electric Throttle Valve (ETV) fluctuations may cause actual torque to exceed Permitted Torque at low engine speeds. An improper Permitted Torque threshold may then cause false MIL illumination. A software update optimizes the Permitted Torque threshold value to minimize false MIL illumination.

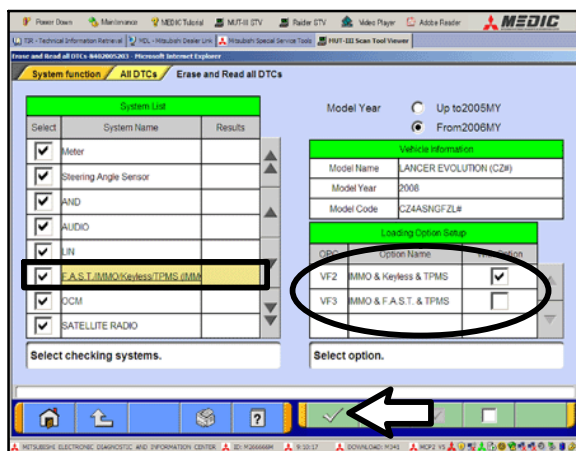
e. In the left column, scroll to and click FAST/IMMOB/KEYLESS/TPMS. In the right column, check the correct option code (VF#) from the Loading Options Setup list. This will activate the check mark at the bottom of the page.

- Vehicles with regular keyless entry (buttons on a multi-function key), select VF2.
- Vehicles with F.A.S.T. Key, select VF3.
