Service Bulletin

Bulletin No.: 18-NA-355

Subject: Shake and/or Shudder During Light Throttle Acceleration Between 25 and 80 MPH (40 and 128 KM/H) at Steady Speed

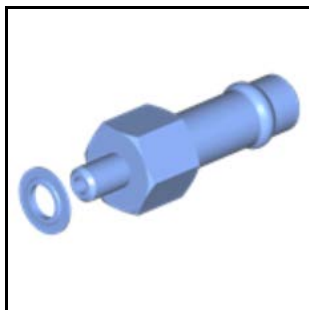
3763203

DT-52263 Transmission Fluid Exchange Kit:

- DT-52263-1 Block Assembly (includes fluid drain hose, spring clamp)
- DT-52263-2 Cooler Line Plug (qty 3) (use with rear differential cooler and Camaro V8 non rear differential cooler)
- DT-52263-3 1/2" Cooler Line Flush Adapter for 2019 Silverado and Sierra
- DT-52263-4 3/8" Hose Adapter (6" long with 2 hose clamps)
- DT-52263-5 Radiator Cooler Drain Adapter

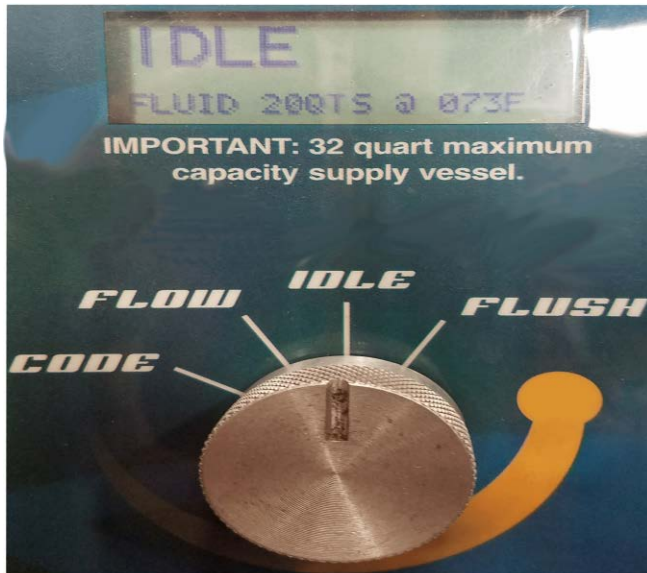
5180884

1. Connect the TransFlow adapter DT-45096-31 to the supply line of the DT-45096 TransFlow machine.

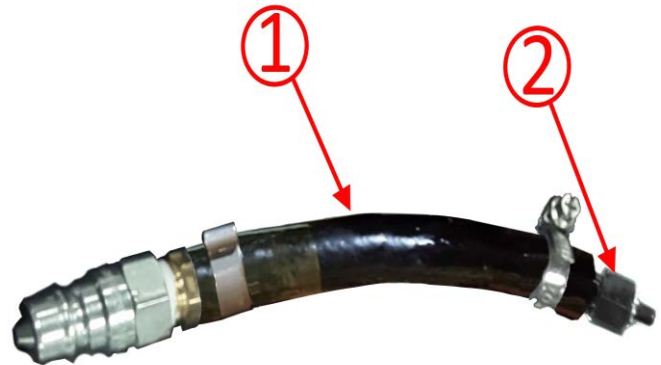
5182541

3. Install the DT-45096-31 TransFlow adapter (1) to the DT-51190 fluid fill adapter (2).

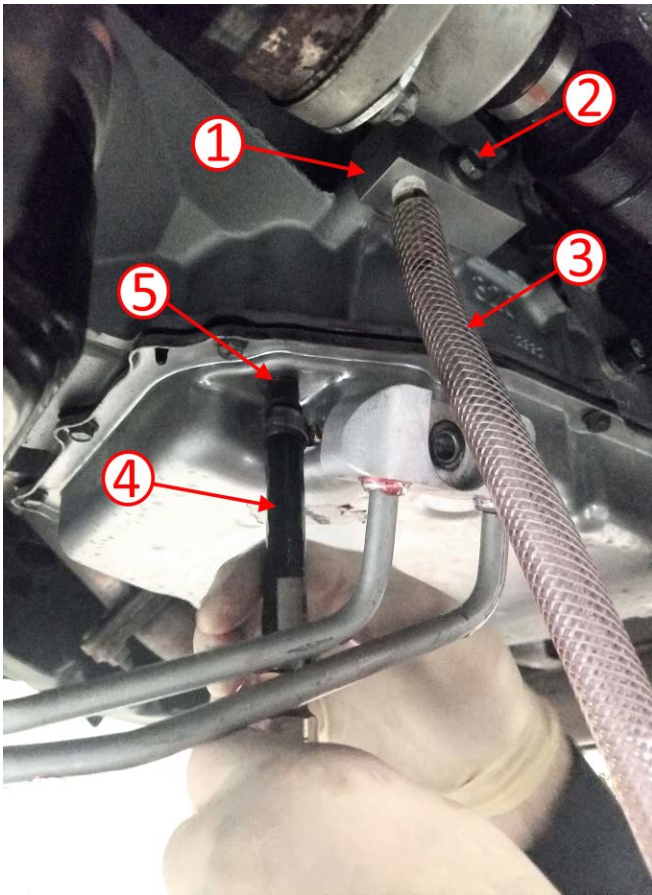
5180563

4. Remove the transmission oil cooler pipe assembly from the transmission.
5. Install the DT-52263-1 Adapter Block Assembly (1), reusing the seal from the transmission oil cooler pipe assembly.
6. Tighten the bolt (2) to 22 N•m (16 lb ft).
7. Place the hose (3) in the GE-47716-2 Graduated Measuring Bucket, utilizing a Spring Clamp to retain the hose.

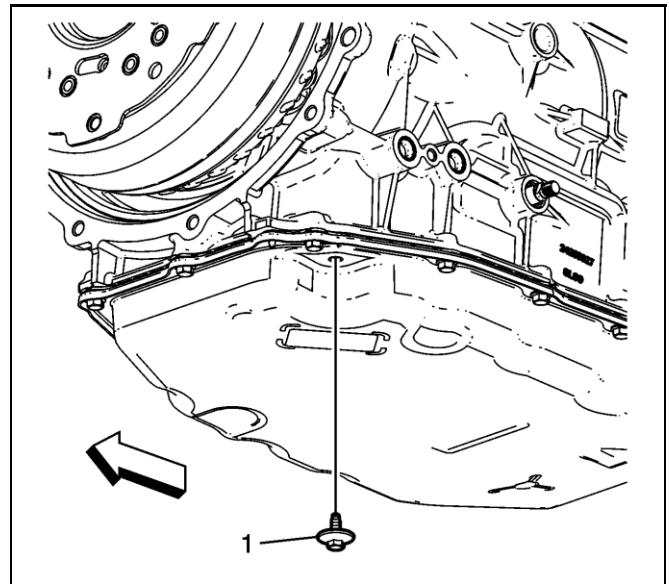
3723844

8. Remove the level set plug (1) from the transmission.

Important: DO NOT over tighten the DT-51190 as it can be damaged by excessive torque. **DO NOT** exceed 9 N•m (80 lb in).

9. Install the DT-51190/DT-45096-31 assembly and hand tighten as shown in the graphic above.

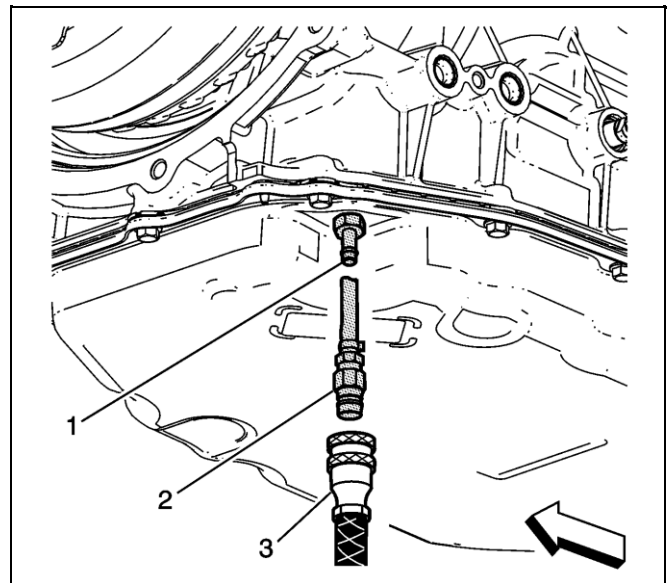
3723839

10. Connect the TransFlow fluid feed (supply) line (3) to the DT-45096-31 adapter (2).
11. Lower the vehicle.

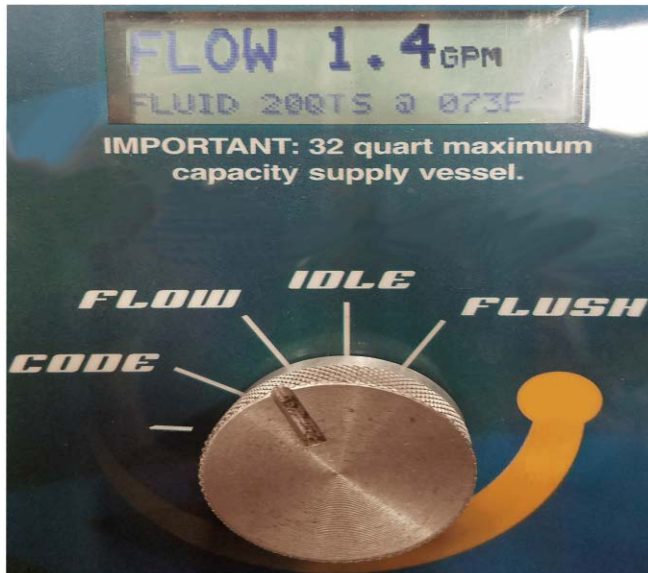
5181027

12. Utilizing the graduated bucket, start the engine and run 30- 45 seconds until 3 quarts of fluid is expelled.
13. Shut the engine off immediately.
14. Connect the DT-45096 to the vehicle battery 12 volts and connect shop air to the air connection.

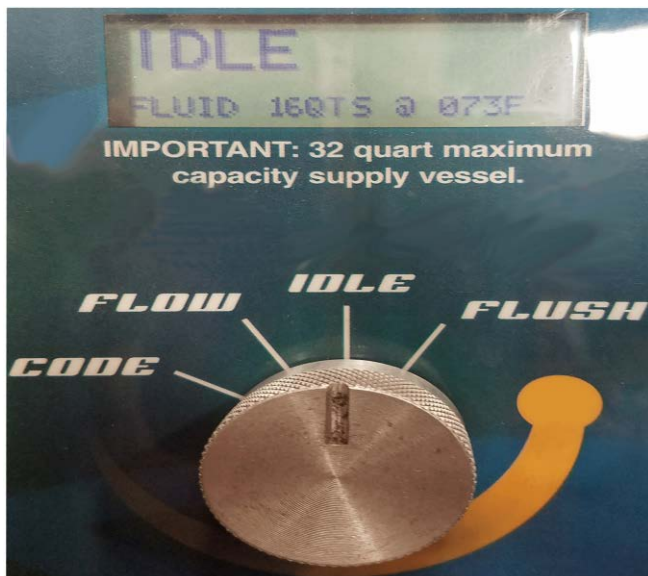
5181020

15. Switch the DT-45096 TransFlow to Flow and add 4 quarts of HP to the transmission.

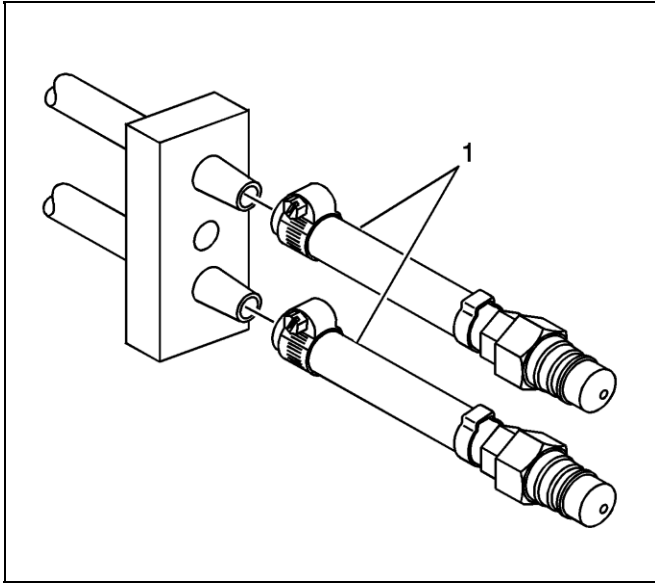
1762577

25. Install DT-45096-31 adapters (1) to the transmission oil cooler lines.
26. Connect the DT-45096 TransFlow to the DT-45096-31 adapters.

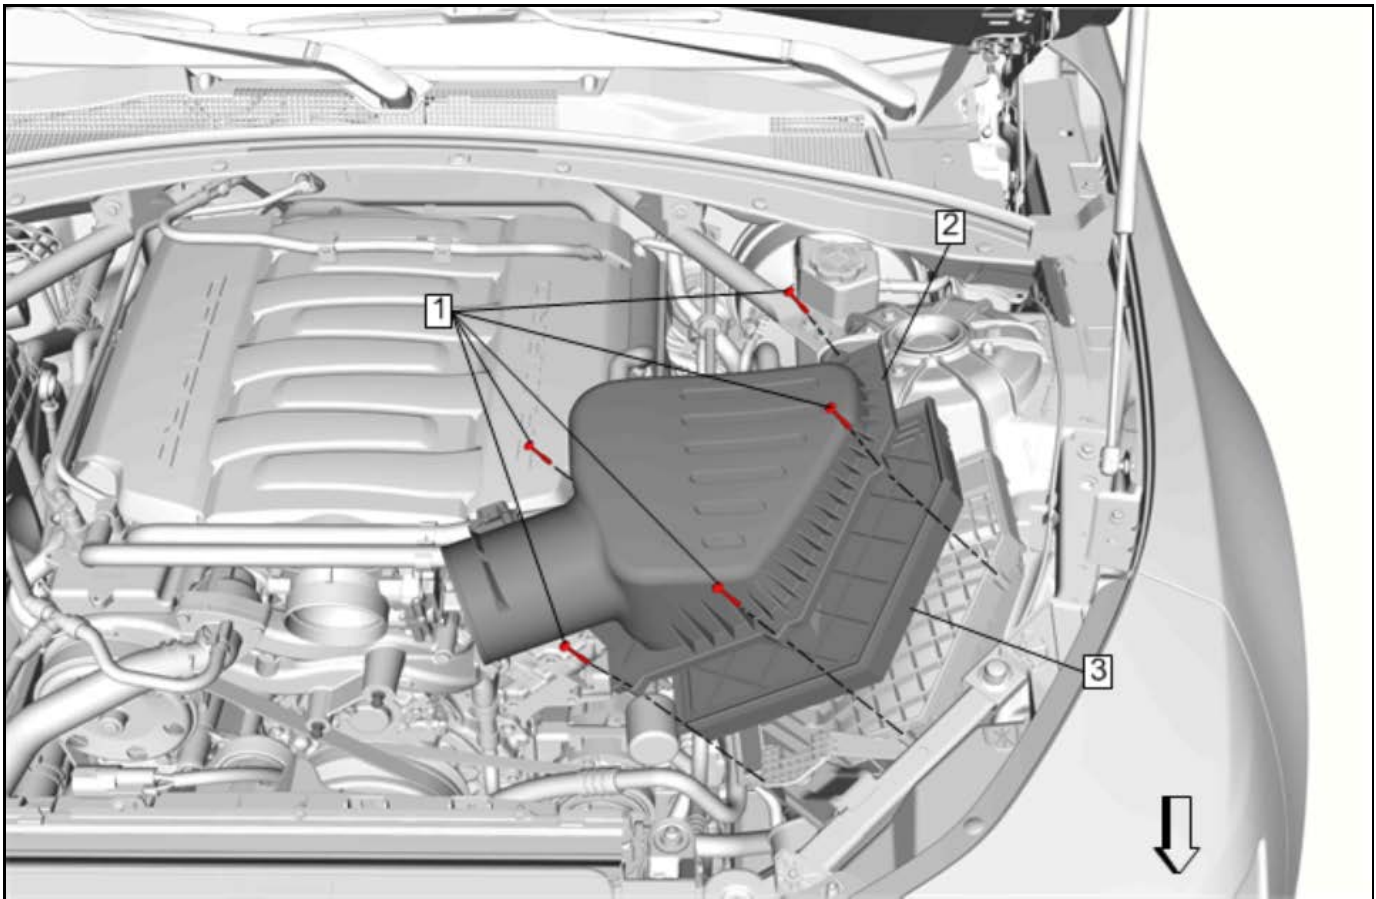
4194576

Note: The MAF sensor must stay connected so that no DTCs will set.

2. Separate the engine upper air filter box (1) from the lower air filter housing to gain access to the upper transmission oil cooler line.

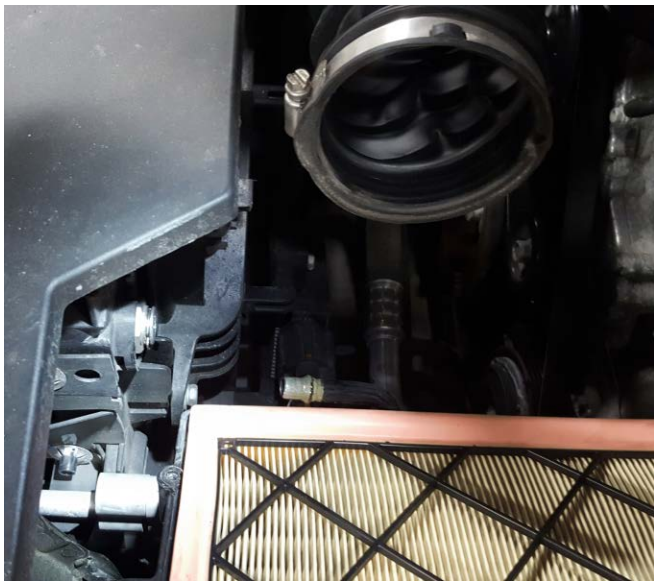
5181307

Note: Upper air filter box removed for clarity.

3. Remove the cooler line from the transmission oil cooler.

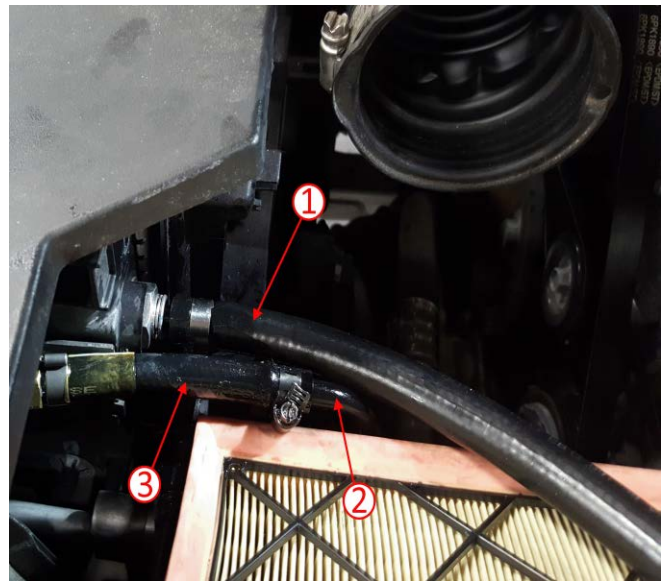
5181322

4. Install end of the DT-52263-5 Radiator Cooler Drain Adapter (1) to the DT-52263-1 Block Assembly.
5. Install the DT-52263-5 Radiator Cooler Drain Adapter into the upper transmission oil cooler line port of the transmission oil cooler.
6. Install the DT-45096-31 adapter (3) over the removed transmission oil cooler line (2) to prevent any fluid spillage.

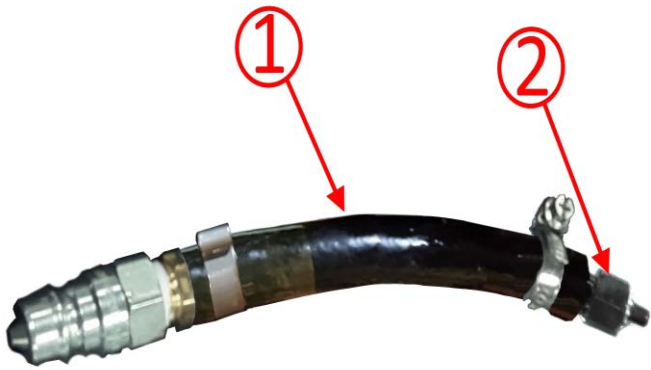
5182541

9. Install the DT-45096-31 adapter (1) to the DT-51190 fluid fill adapter (2).

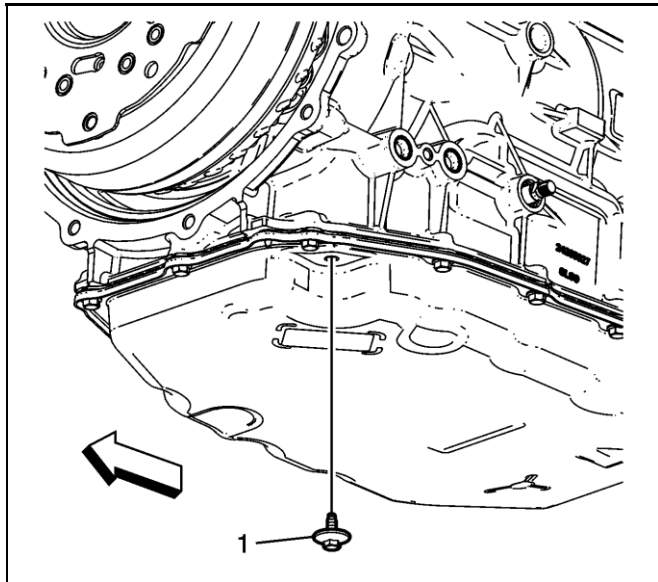
3723844

10. Remove the level set plug (1) from the transmission oil pan.

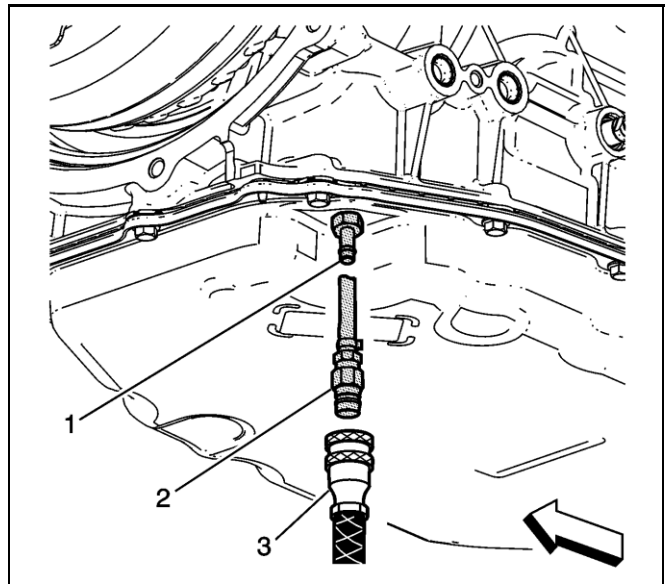
3723839

Important: DO NOT overtighten the DT-51190 as it can be damaged by excessive torque. Do not exceed 9 N•m (80 lb in).

11. Install the DT-51190/DT-45096-31 assembly and hand tighten.
12. Connect the TransFlow fluid feed (supply) line (3) to the DT-45096-31 adapter (2).
13. Lower the vehicle.

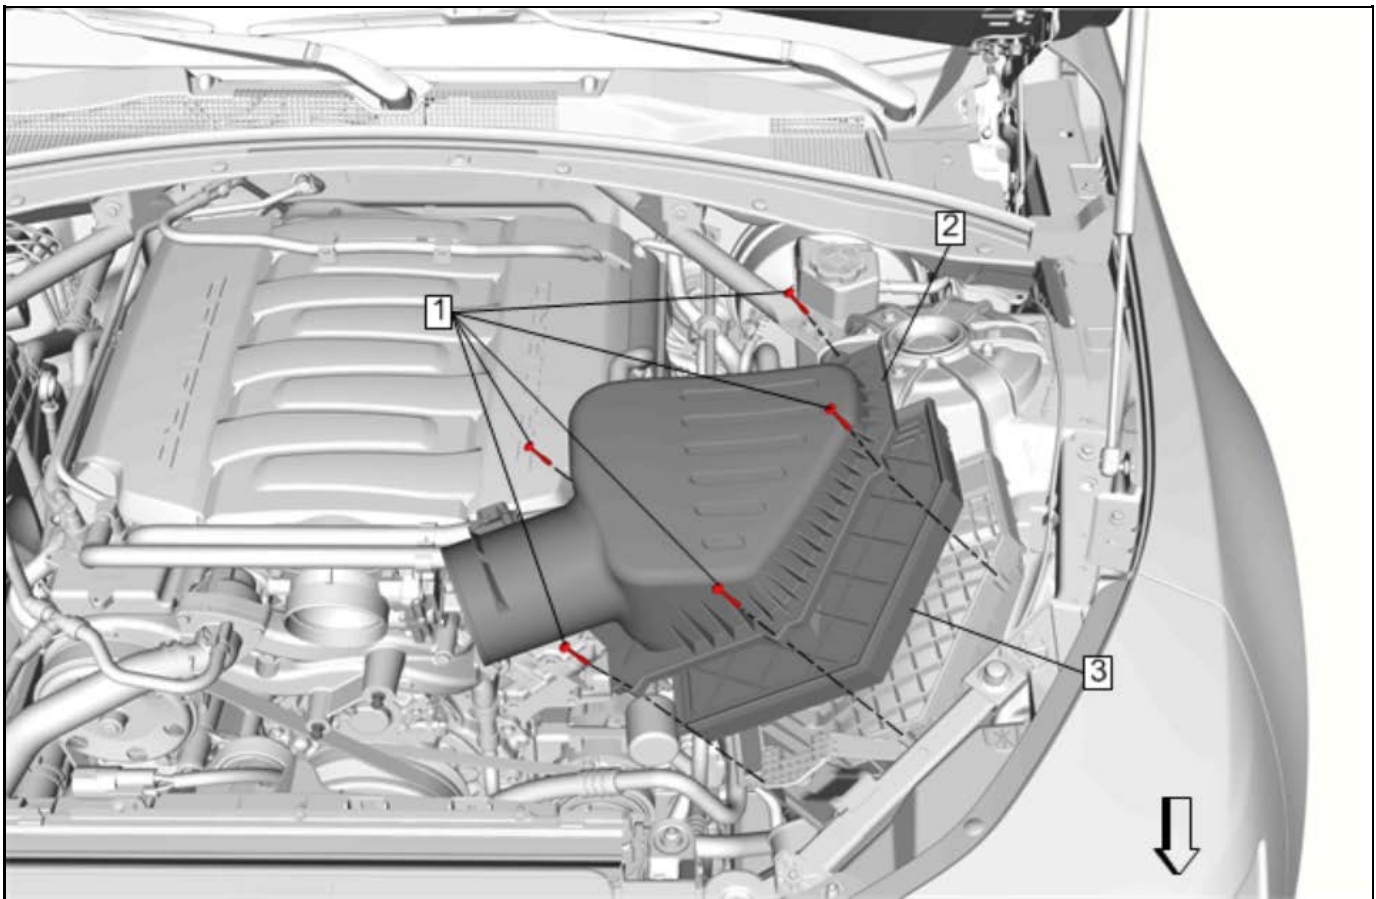
4194576

Note: The MAF sensor must stay connected so that no DTCs will set.

2. Separate the engine upper air filter box (1) from the lower air filter housing to gain access to the upper transmission oil cooler line.

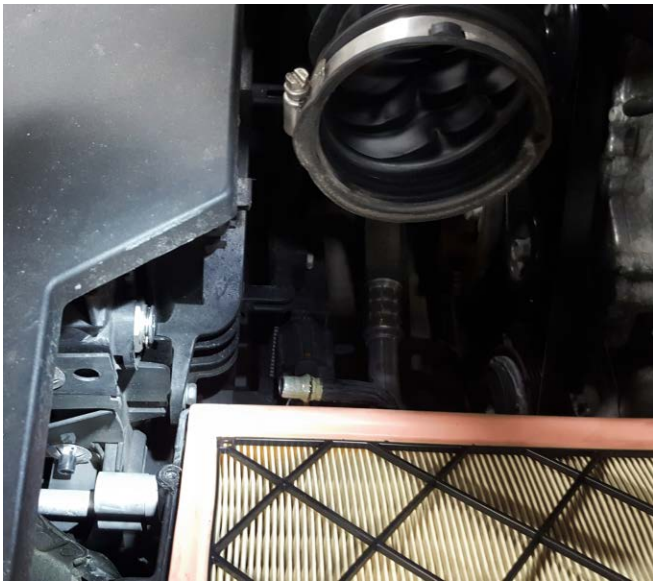
5181307

Note: Upper air filter box removed for clarity.

3. Remove the upper cooler line from the transmission oil cooler.
4. Install the DT-52263-2 Cooler Line Plug into the radiator cooler.
5. Install the DT-52263-4 Hose onto DT-52263-1 Block Assembly install the DT-52263-4 onto the removed transmission oil cooler line.
6. Place the hose of the DT-52263-1 in the GE-47716-2 Graduated Measuring Bucket, utilizing a Spring Clamp to retain the hose.
7. Raise the vehicle.

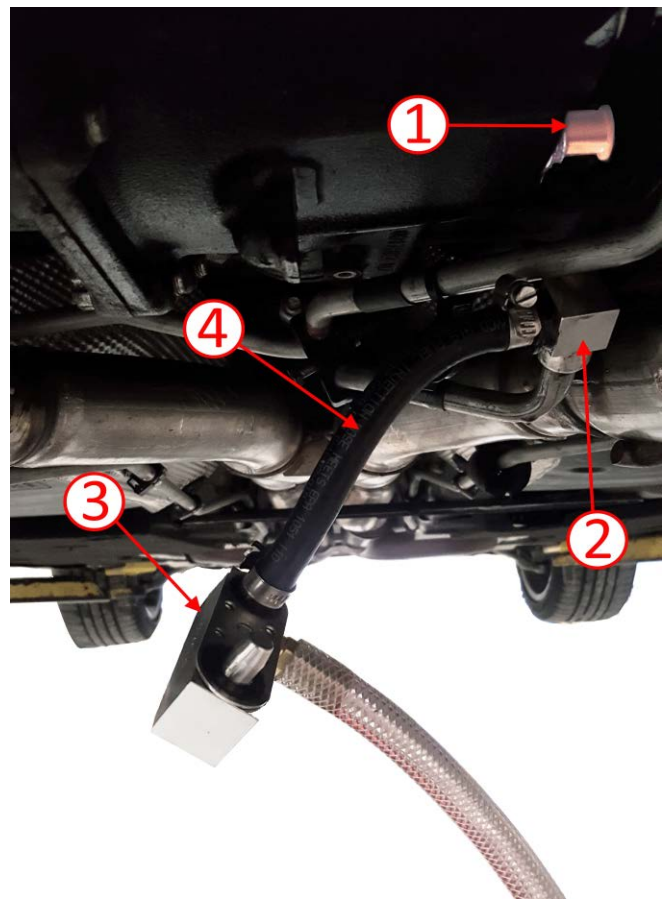
5182245

3. Remove the lower/front transmission oil cooler line (2) at the rear differential.
4. Install the DT-52263-2 Cooler Line Plug (1) into the rear differential to prevent fluid loss.
5. Install one end of the DT-52263-4 hose (4) to the open port of the DT-52263-1 Block Assembly (3).
6. Install the other end of the DT-52263-4 hose to the transmission oil cooler line.
7. Place the hose in the GE-47716-2 Graduated Measuring Bucket, utilizing a Spring Clamp to retain the hose.

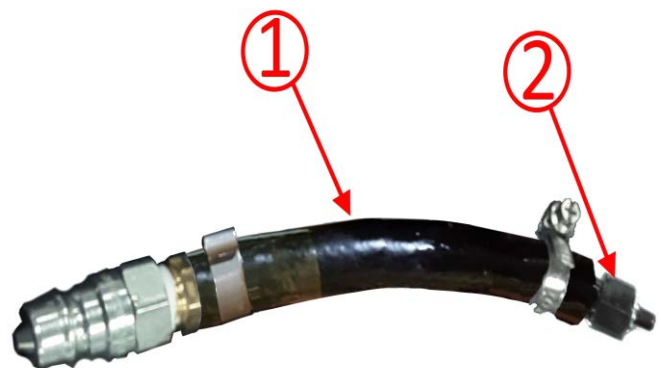
5182541

8. Install the DT-45096-31 adapter (1) to the DT-51190 fluid fill adapter (2).

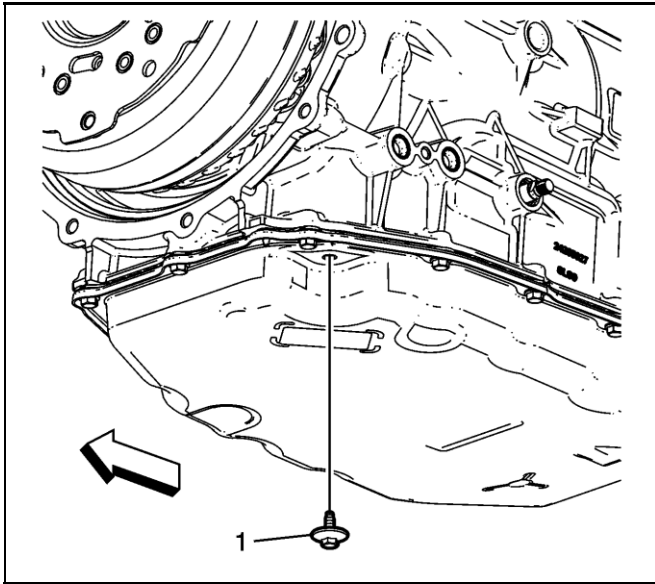
3723844

9. Remove the level set plug (1) from the transmission oil pan.

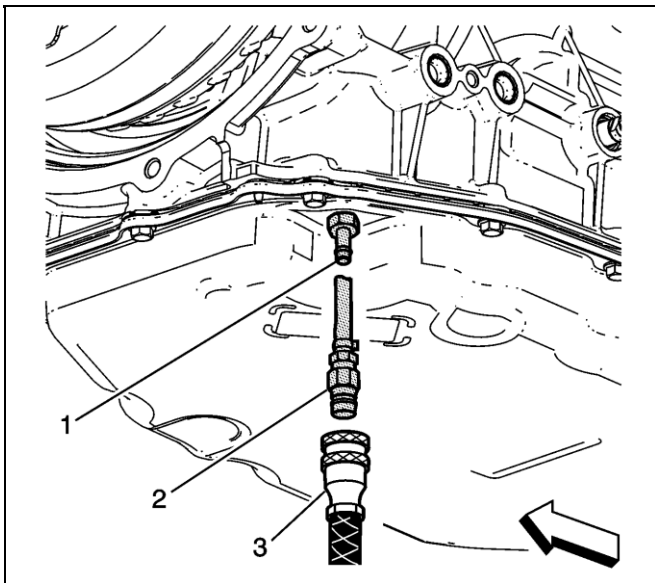
3723839

Important: DO NOT over tighten the DT-51190 as it can be damaged by excessive torque. Do not exceed 9 N•m (80 lb in).

10. Install the DT-51190/DT-45096-31 assembly and hand tighten.
 11. Connect the TransFlow fluid feed (supply) line (3) to the DT-45096-31 adapter (2).

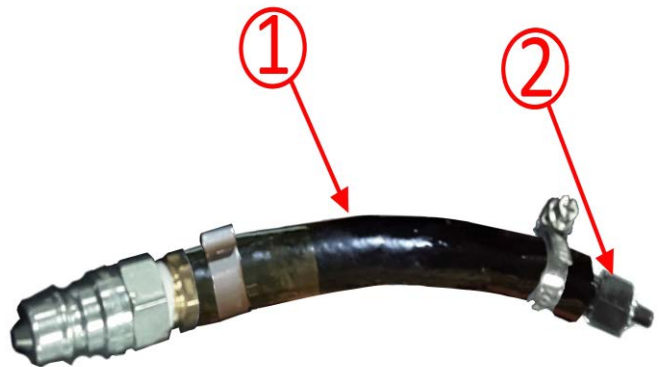
5182541

5. Install the DT-45096-31 adapter (1) to the DT-51190 fluid fill adapter (2).

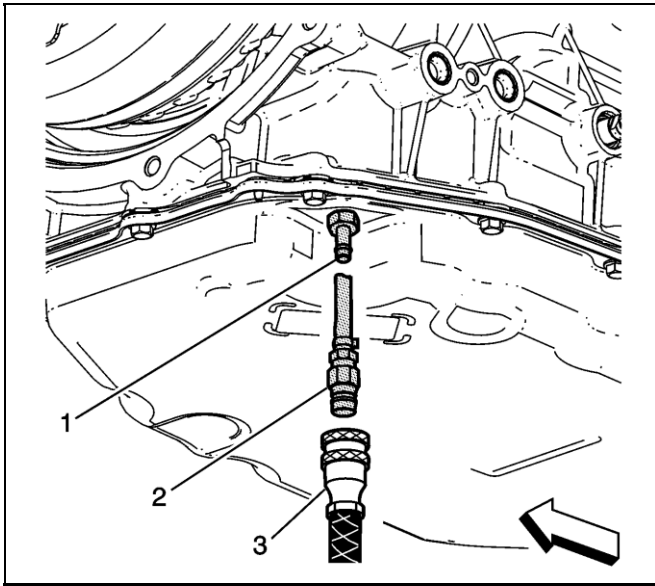
3723839

6. Remove the level set plug (1) from the transmission oil pan.
