Subject: A202302140 - Service Update
Engine Oil Pressure Sensor Performance Error

Models: 2020 Buick Encore GX
2021 Chevrolet Trailblazer
Equipped with 1.2L Turbo Engine (RPO LIH)

A202302140 Engine Oil Pressure Sensor Performance Error

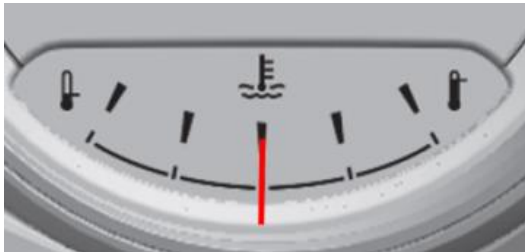
3. Start and run engine for minimum 15 minutes until the coolant temperature gauge needle is centered in the gauge.

4. Raise the engine speed to 2,000 rpm for 30 seconds.
5. Rev up the engine rpm to 4,000 rpm limit and hold for 15 seconds.
6. Release the acceleration pedal to go down rpm to idle and wait for 15 seconds.

Important: One test cycle is from steps 4 to 6.
