Audio Head Unit Software Update (Denso)

Applicability

YEAR(S)	MODEL(S)	ADDITIONAL INFORMATION
2017 - 2020	Prius Prime	
2019 - 2020	Prius

Introduction

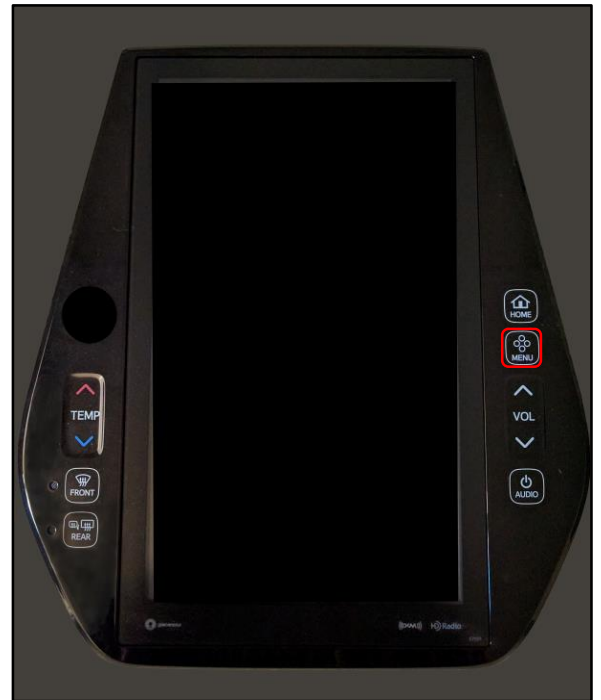
Figure 2.

3. Download the correct multimedia software update file for the vehicle and install it onto a USB flash drive.
4. Ready ON the vehicle.
5. Insert the USB flash drive with the downloaded multimedia software update file into the vehicle's USB port.
6. Select Menu.

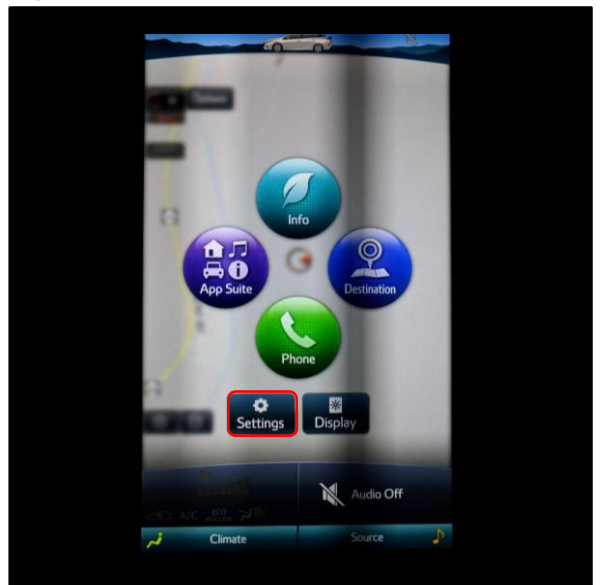
Figure 3.

7. Select Settings.

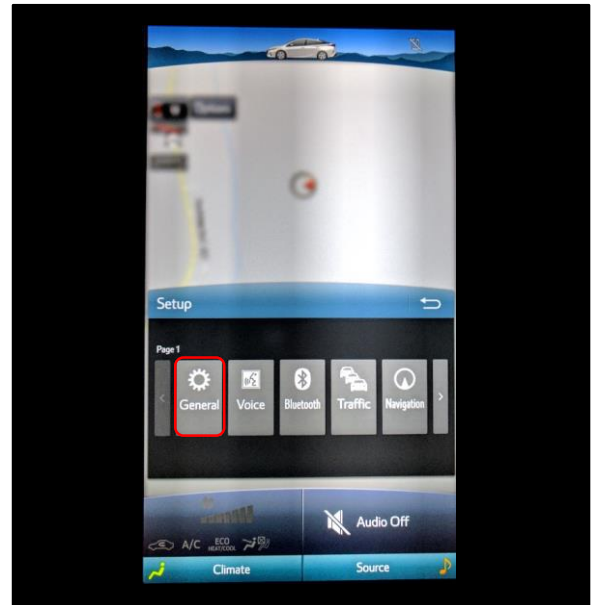
Figure 4.

8. Select General.

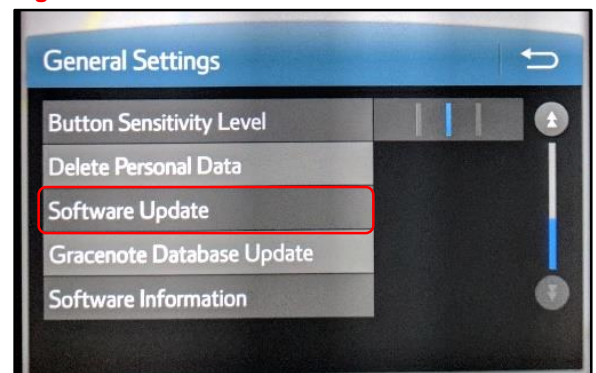
Figure 5.

9. Scroll down and select Software Update.

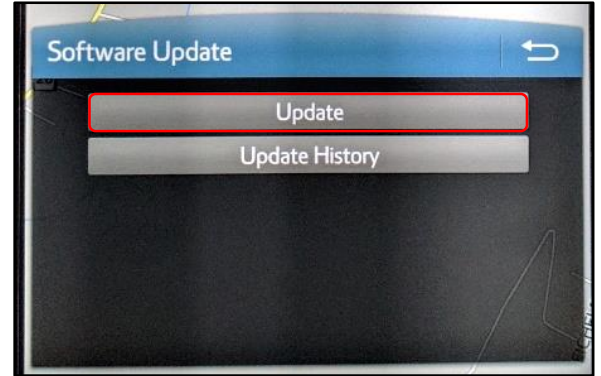
Figure 6.

10. Select Update.

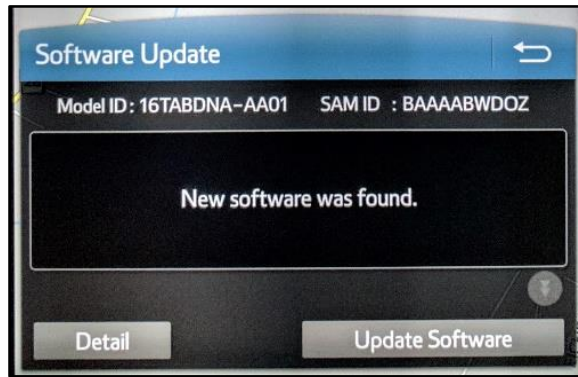
Figure 7.

If the software is detected properly, a “New software was found” pop-up will display.

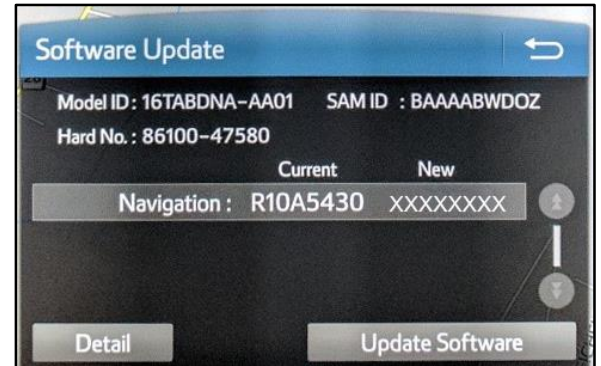
Figure 8.

11. Verify that the NEW software is the most up to date by referring to the Software Version Information table below.

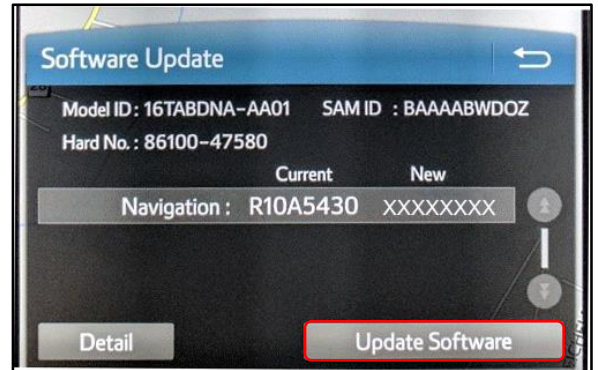
Figure 9.

12. Select Update Software on the Software Update screen.

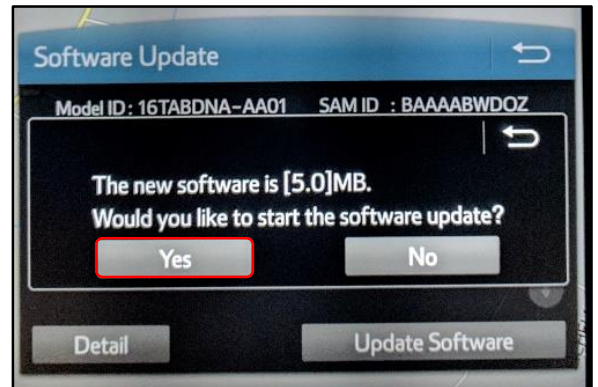
Figure 10.

13. Select Yes on the Software Update screen.

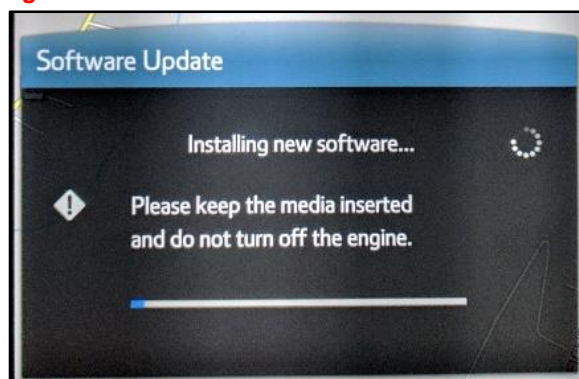
Figure 11.

14. Once the head unit begins the installation, the update will take about 10 minutes to complete.

- Do NOT turn OFF the ignition or Ready OFF the vehicle BEFORE the software is ready for updating.
- Do NOT pull the USB flash drive out of the vehicle's USB port.

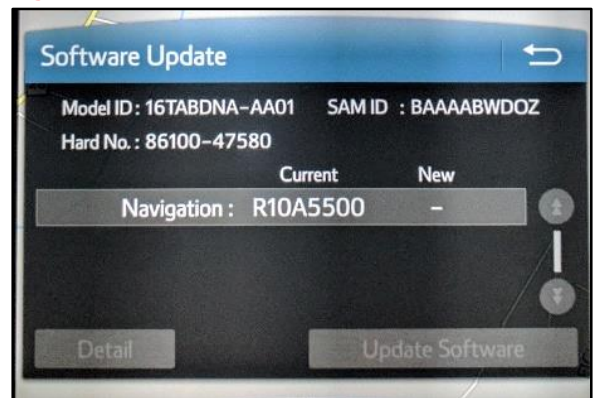
Figure 13.

- Perform steps 6 – 11 of the Multimedia Software Update Procedure to reenter the Software Update screen.
- Verify that the multimedia software information is updated on the Software Update screen.
