SERVICE PROGRAM BULLETIN

APPLICABILITY: 2018 MY Legacy
 2018 MY Outback
 2017-2018 MY Impreza
 2018 MY Crosstrek

NUMBER: WUA-86R

SUBJECT: Harman Kardon Head Unit Reprogramming

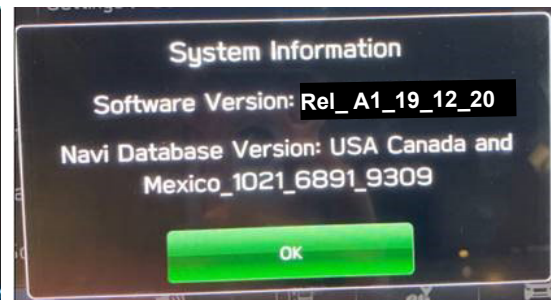
(EXAMPLE photos)

- Confirm the current Software Version ID. If the Current Version is **Rel_A1_19_12_20** or **Rel_A1_19_45_20**, **STOP** as the latest update has already been installed. Otherwise, proceed to **Step 2** below. Refer to TSB 15-211-17R to see the latest software version information as well as a history of prior updates. Software versions **Rel_U0.18.43.20** (or later) are acceptable to complete and close this recall.

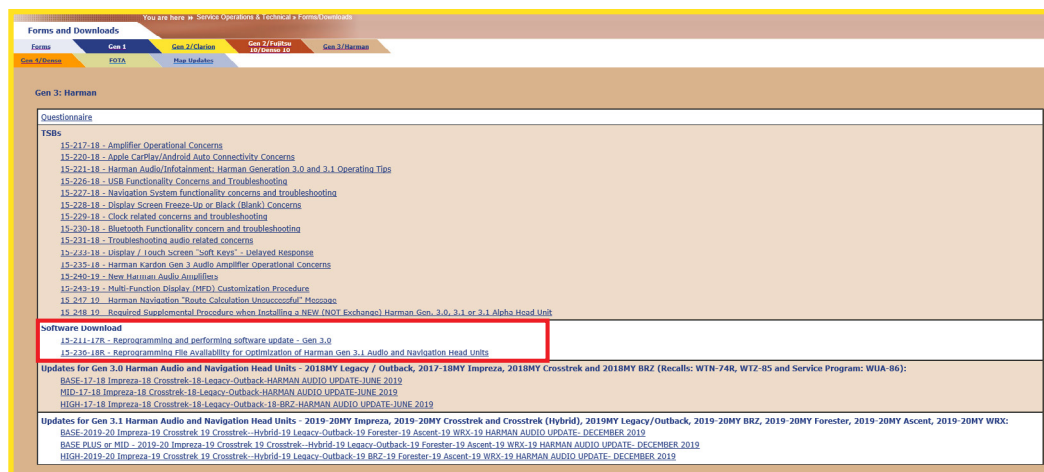
- If the files are being **downloaded from Subarunet**, they will be .zip files and must be unzipped before they can be used. An EXAMPLE image of the Subarunet links page is provided below.

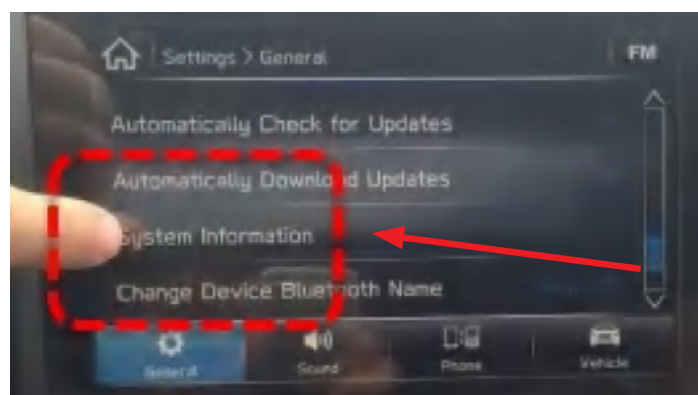
- From the Settings > General screen, scroll down to and then touch “System Information”.
