**\*\* SOLUTION \*\***

Title Frame Or Cab Lean - **Gen II Chassis**

**Cause** Frame lean can be caused by several seemingly isolated possibilities. The two most common are suspension and frame assembly issues.

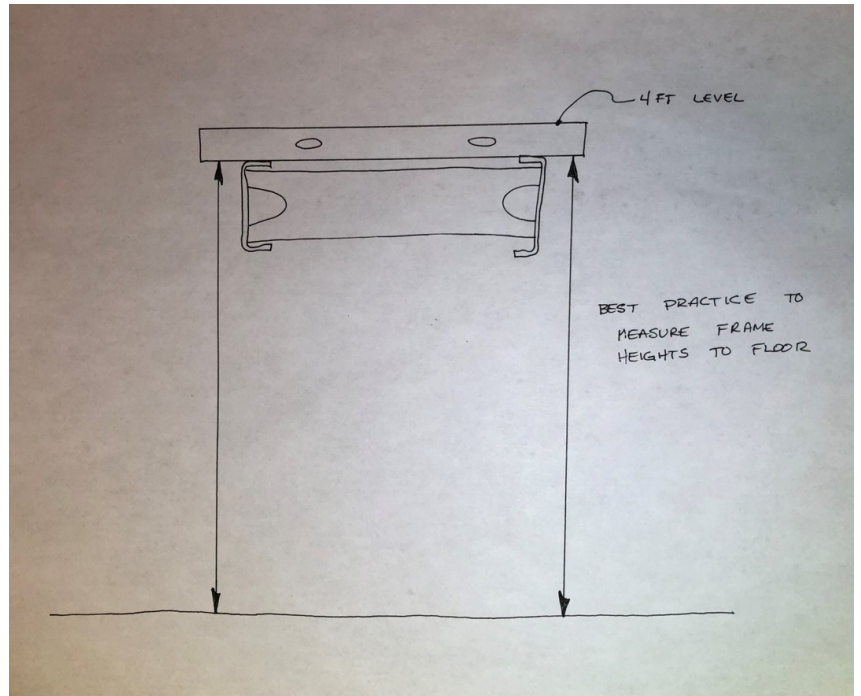
**Best Practice For Frame Measurements**

Use a 4 ft level across the upper frame flanges and

measure from the underside to the floor.

This eliminates issues in the flange bends.

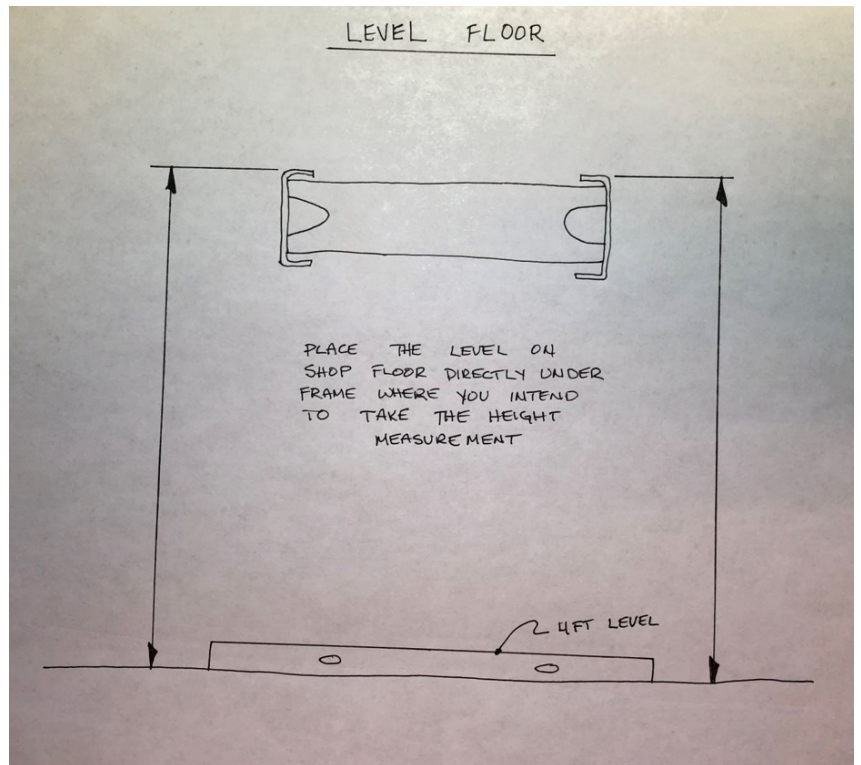
### Checking shop floor for level when measuring frame for level

Use the 4 ft level on the shop floor directly under the frame where you will be taking each measurement.

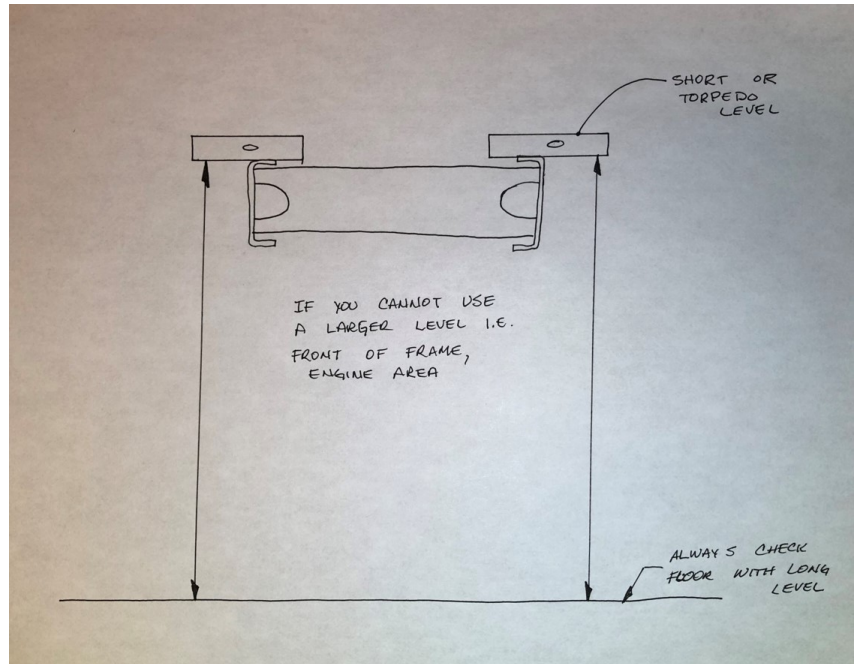
### Measuring frame height where a 4 ft level will not work.

Use a smaller level or a torpedo level where the longer level will not work, i.e. engine compartment, front of frame.

Again , check the shop floor at each measurement location.

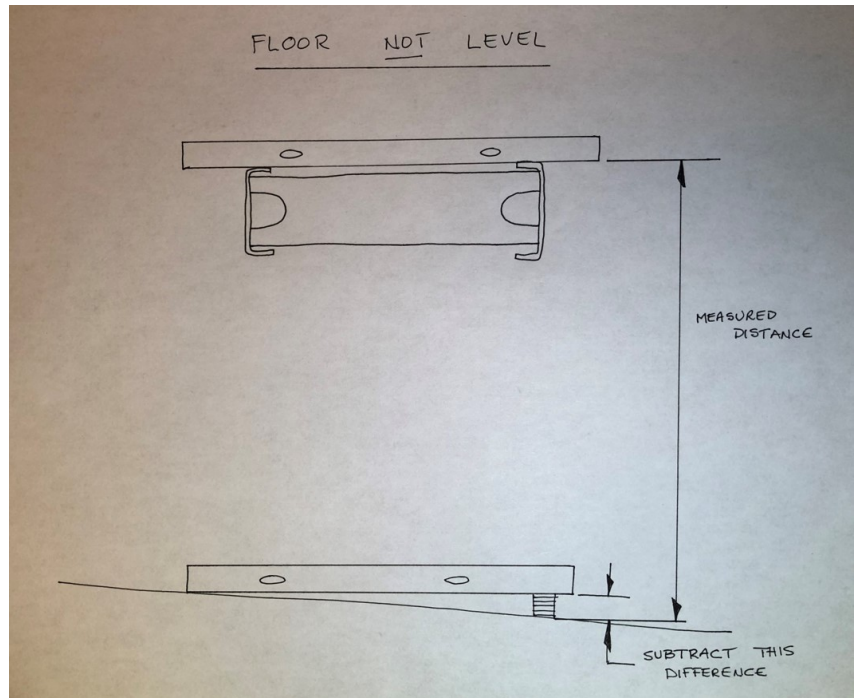
### Floor out of level at measurement location

Where the shop floor is NOT level, shim the 4 ft level and then subtract the difference from the measurement at that location specifically
