153/19 ENU 2796

Symptom - Body Exterior - Hybrid Vehicle Cannot be Charged Using 208 V Main Power Supply. Install New Software on Porsche Mobile Charger (2nd generation). (SY 153/19)

Vehicle Type: Panamera Hybrid (971)

Cayenne Hybrid (9YA/9YB)

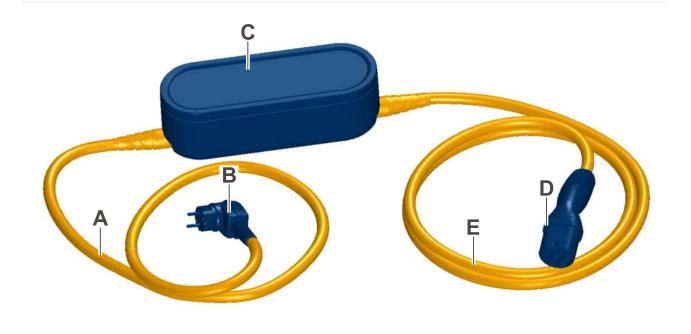
Individual parts of Porsche mobile charger

- **A** Power cable
- **B** Power plug (connector for connecting to mains power supply)
- C Operator control unit
- D Vehicle plug (plug connection for the vehicle)
- Vehicle cable
