MODEL
2019-2021
Multiple Models
with IVT

TECHNICAL SERVICE BULLETIN

**SUBJECT: SERVICE ACTION: IVT SOFTWARE LOGIC
IMPROVEMENT AND/OR IVT REPLACEMENT (SA424)**

This bulletin provides the procedure to improve the Transmission Control Module (TCM) logic and if necessary, replace the Intelligent Variable Transmission (IVT) on 2019-2021MY vehicles which may exhibit a MIL with the DTC(s) listed below. The production ranges of the vehicles within the scope of this bulletin are listed in the table below. To correct this concern, apply the improved logic to the CVT system using the KDS ECU Upgrade function as described in this bulletin and/or replace the IVT assembly. For confirmation that the latest reflash has been applied to a vehicle you are working on, verify the ROM ID using the table on page 4. Before conducting the procedure, verify the vehicle is included in the list of affected VINs.

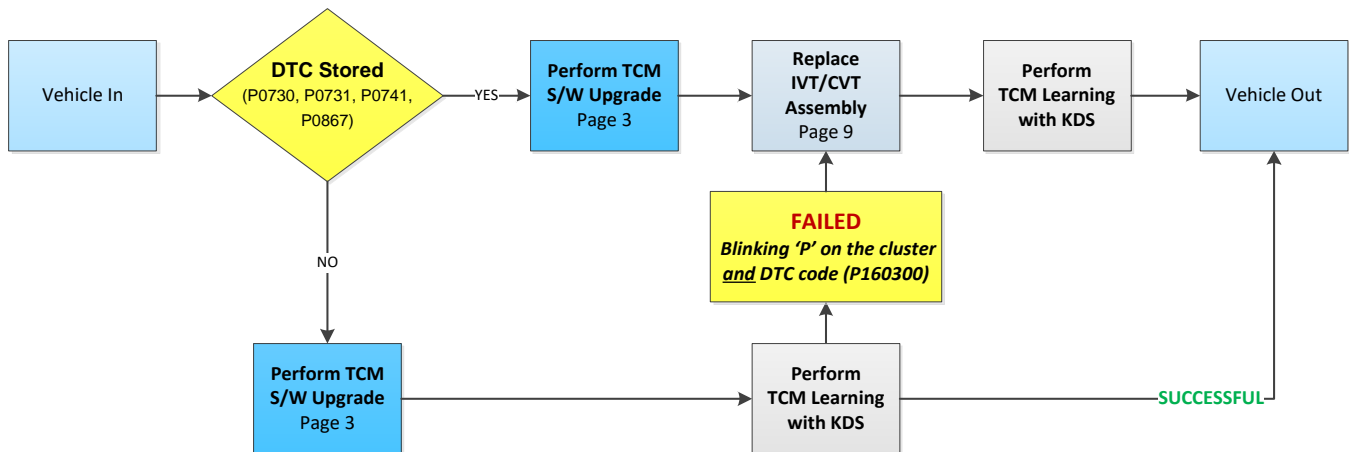
Flowchart:

**Vehicle In DTC(s):**

- P0730 – Incorrect Gear Ratio
- P0731 – Gear 1 Incorrect Ratio
- P0741 – Torque Converter Clutch Circuit Performance or Stuck Off
- P0867 – Transmission fluid pressure

After performing TCM Learning DTC:

- P160300 – Internal Control Module Memory Check Sum Error

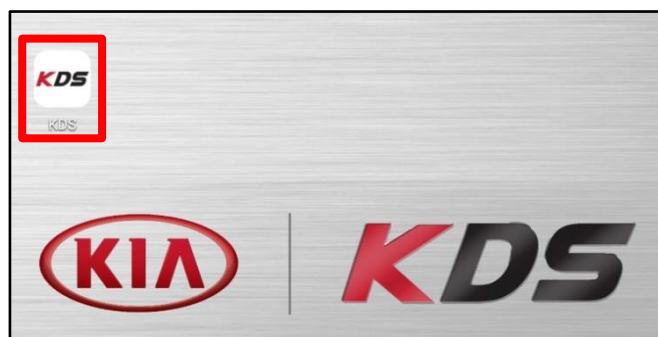
3. Confirm communication with VCI (A) and then configure the vehicle (B) using the **AUTO VIN** (C) feature.
