MODEL
**2019-2020MY
Sorento (UMa)**

NUMBER
220

TECHNICAL SERVICE BULLETIN

**LAMBDA 3.3L GDI ENGINE HESITATION
AT HIGH ALTITUDES LOGIC IMPROVEMENT**

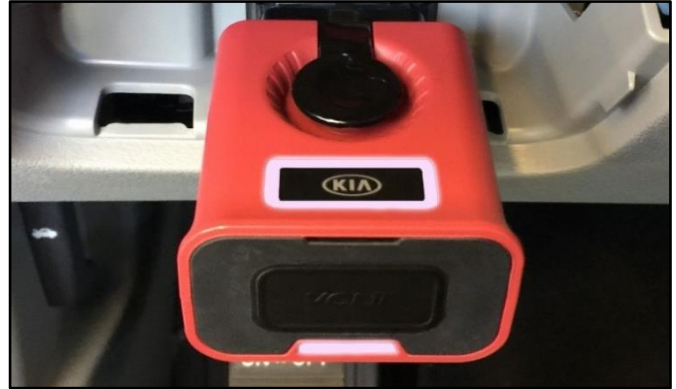
1. Connect the VCI-II to the OBD-II connector, located under the driver's side of the instrument panel.

The ECU upgrade function on KDS operates wirelessly. It is not necessary to perform the upgrade via USB cable.

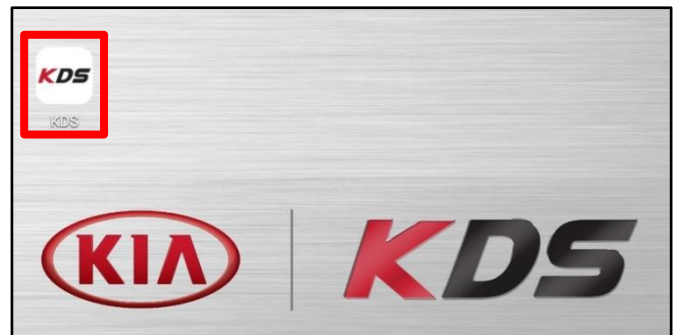
2. With the ignition ON, turn ON the KDS tablet. Select **KDS** from the home screen.

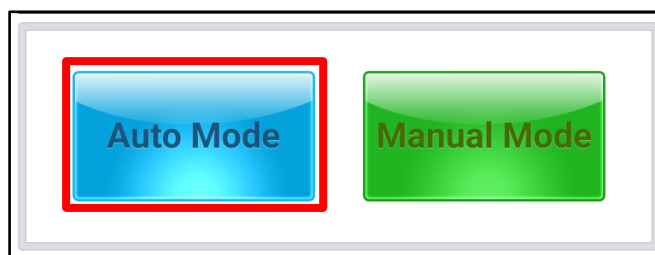
- Select **Auto Mode**.

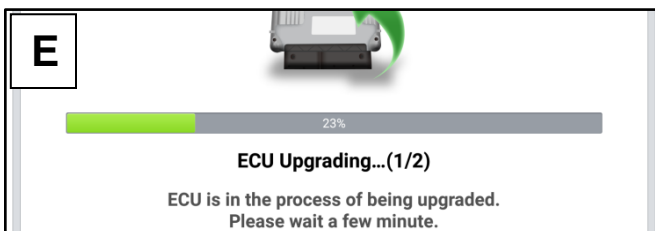
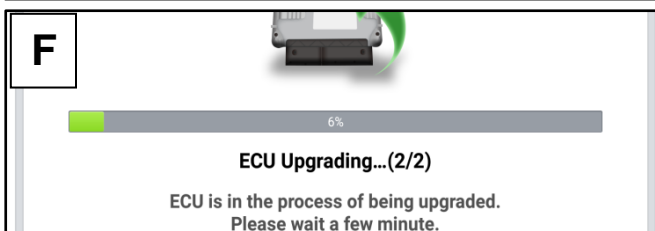
- The ECU upgrade will begin and the progress of the upgrade will appear on the bar graph. Upgrade part (1/2) (E) will download the upgrade event to the VCI-II. Upgrade part (2/2) (F) will upgrade the ECU.

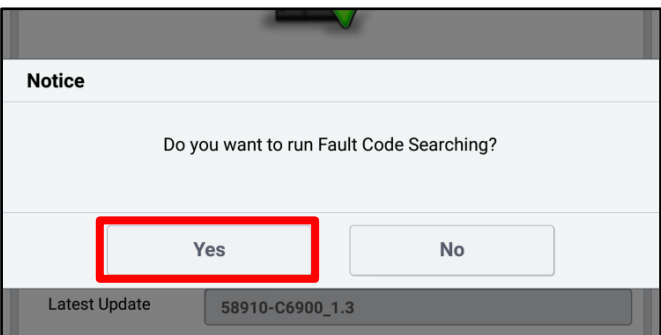
- When prompted, select **YES** to check for Diagnostic Trouble Codes (DTC) and erase any DTCs stored such as EPS, ESC, and TPMS that may have been set during the upgrade.
