TECHNICAL INSTRUCTIONS
FOR
LIMITED SERVICE CAMPAIGN K0P
CUSTOMER SUPPORT PROGRAM 19TE12

SAFETY CONNECT SYSTEM – VEHICLE LOCATION INACCURATE

CERTAIN
2013 – 2019 MODEL YEAR 4RUNNER
2011 – 2017 MODEL YEAR LAND CRUISER
2013 – 2017 MODEL YEAR PRIUS
2012 – 2017 MODEL YEAR PRIUS V
2016 – 2017 MODEL YEAR MIRAI

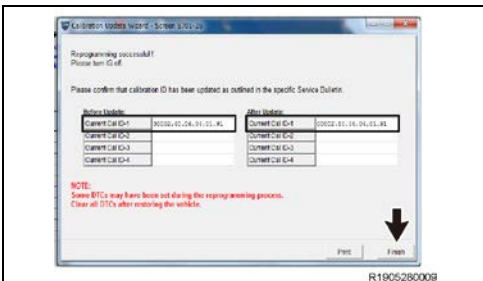
i) Click the “Next” button.

NOTE: It is *NOT* necessary to follow the instructions on the screen of Techstream.

j) After reprogramming, make sure that the "After update "Current Cal ID" is correct.
