Service Action

Code: 90o8

Subject MyAudi Software Update – USA ONLY

Release Date September 17, 2020

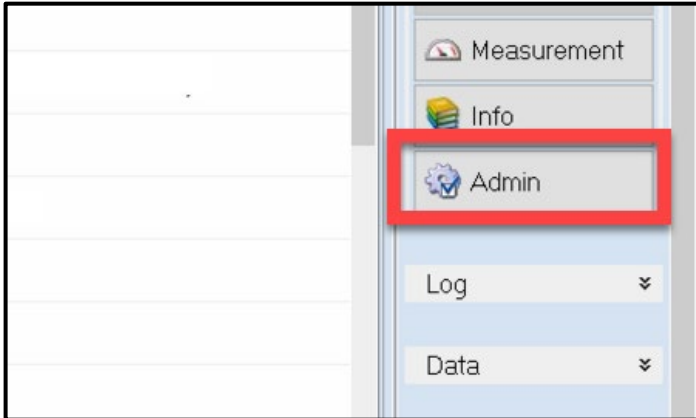
Changing the communication path to “Only allow DoIP communication” MUST be performed to ensure consistent success of this software update. The software update will fail if these steps are not followed.

- From the home screen of the scan tool, select “Admin.”

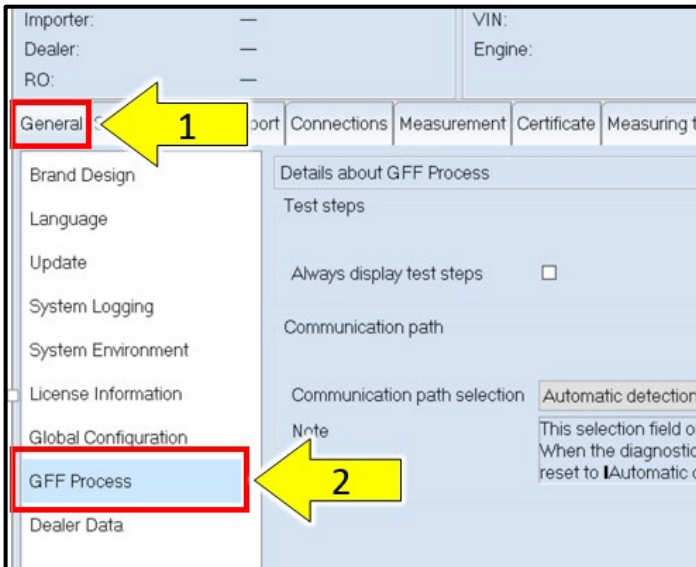
- From the “General” tab <arrow 1>, select “GFF Process” <arrow 2>.

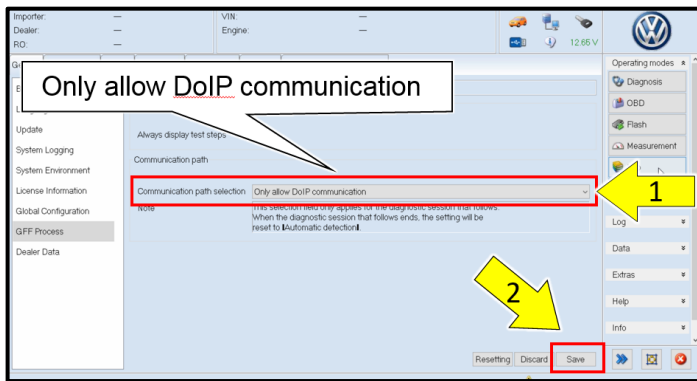
- From the “Communication path selection,” select “Only allow DoIP communication” <arrow 1>.
- Select “Save” <arrow 2>.

As stated in the Note on the scan tool, “This selection field only applies for the diagnostic session that follows. When the diagnostic session that follows ends, the setting will be reset to “Automatic detection.”

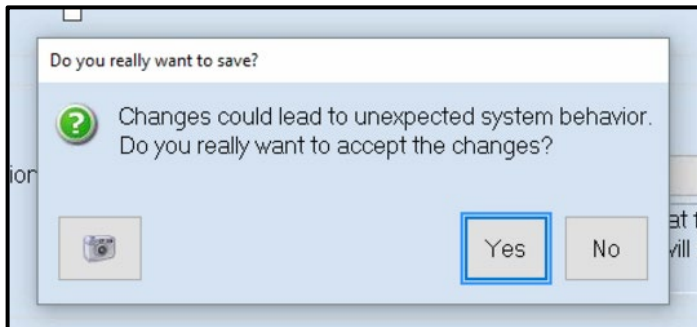
- Select “Yes” when prompted, “Do you really want to save?”
- Return to the home screen of the scan tool.

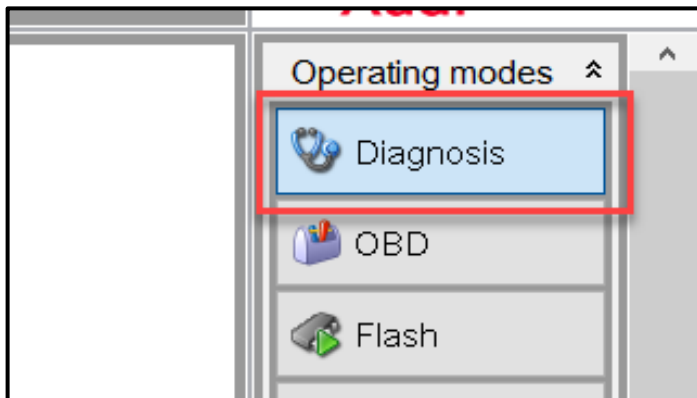
- From the home screen of the scan tool highlight “Diagnosis” and perform a full GFF diagnostic scan.
- Follow the on-screen prompts.

Operating mode “Diagnosis” must be used. Some models will not allow the update to start after changing the communication path to DoIP using operating mode “Flash.”

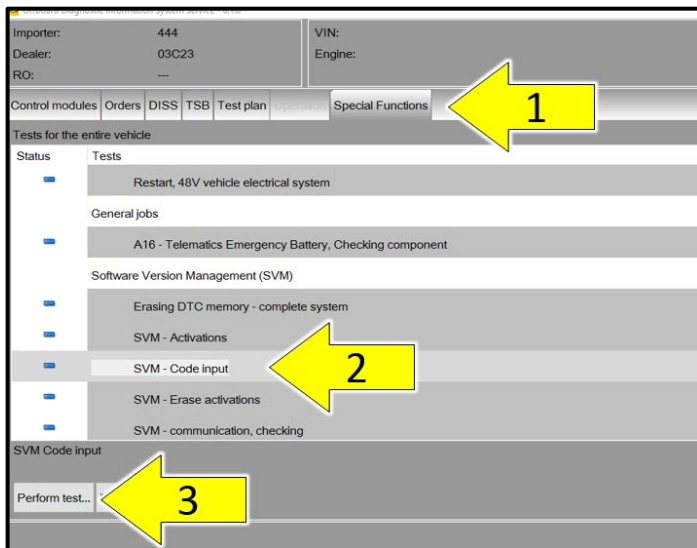
- After the diagnostic scan is complete:
 - Select the “Special Functions” tab <1>.
 - Select “SVM Code Input” <2>.
 - Select “Perform test...” <3>.
- Follow the on screen prompts.

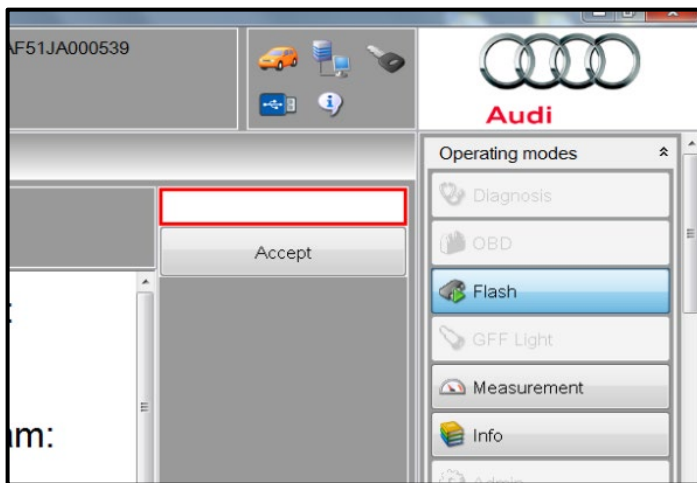
- Enter the corrective action code (SVM code) as listed below.

SVM code
90O8A108
(uppercase letter O)
