Service Bulletin

Bulletin No.: 20-NA-174

Subject: Malfunction Indicator Lamp (MIL) Illuminated with DTC P037C

Brand:	Model:	Model Year:		VIN:		Engine:	Transmission:
		from	to	from	to		
Cadillac	CT4	2020	2020	—	—	2.7L Turbo (L3B)	All

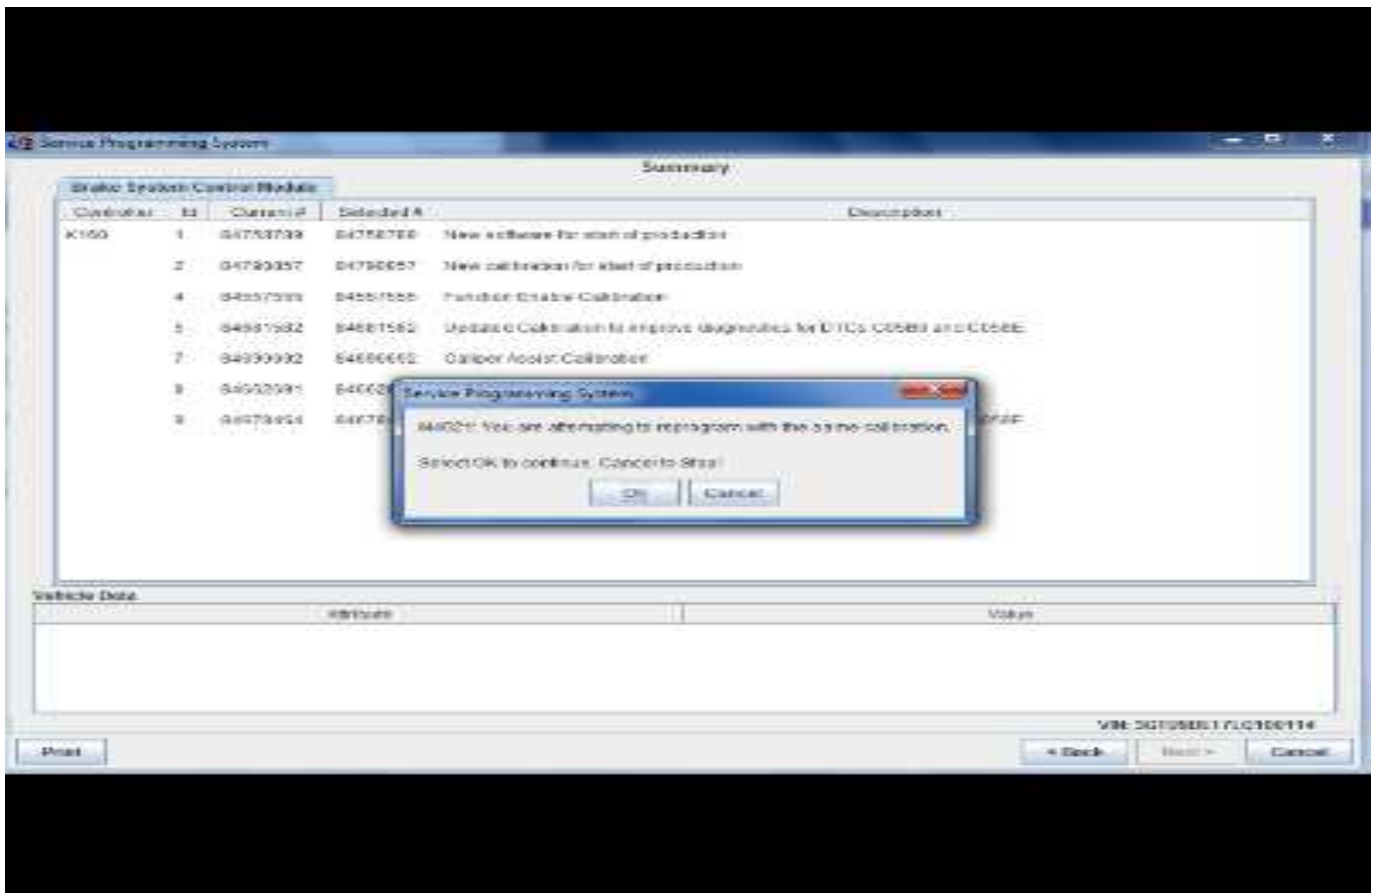
5431207

Important: Techline Connect and TIS2WEB screens shown above.

Important: If the Same Calibration/Software Warning is noted on the TLC or SPS Summary screen, select OK and follow screen instructions. After a successful programming event, the WCC is located in the Service Programming System dialogue box of the SPS Summary screen. No further action is required. Refer to the Warranty Information section of this bulletin.
