Audio Head Unit Software Update (Denso-Ten)

Service Category Audio/Visual/Telematics

Section Navigation/Multi Info Display

Market USA

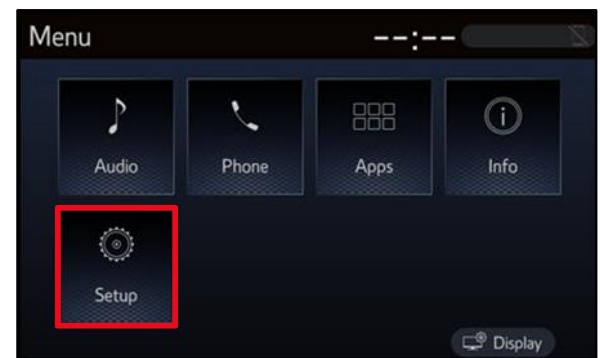
Figure 1.

1. Turn the ignition ON.
2. Press the Menu button on the radio faceplate, then select Setup.

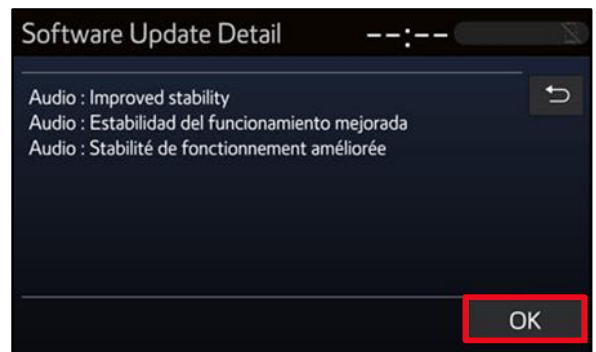
Figure 6.

10. Select OK on the Software Update Detail screen.

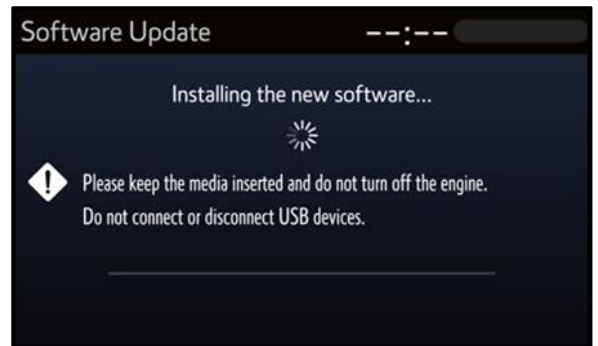
Figure 9.

13. Once the head unit begins installation, the update will take approximately 10 minutes.

- Do NOT turn off the ignition or ACC BEFORE the software is ready for updating.
- Do NOT remove the USB flash drive until instructed in step 17.

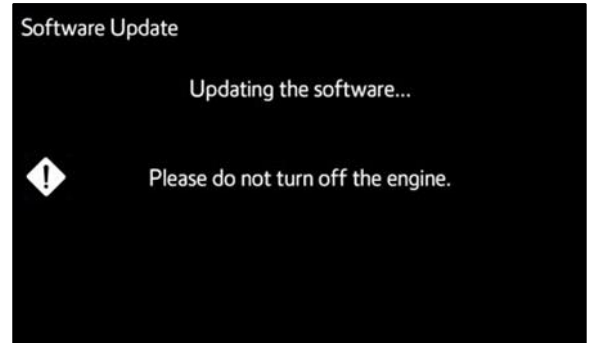
Figure 11.

16. AFTER turning the ignition ON, the Software Update screen will appear. Do NOT turn off the ignition or remove the USB flash drive. The head unit will reboot during this time.
