NUMBER  
PI1802Y/Z (Rev 4, 11/12/2020)

## PRODUCT IMPROVEMENT CAMPAIGN

**SUBJECT: ENGINE REPLACEMENT INSTRUCTIONS  
FOR DTC P1326 (PI1802Y/Z)**

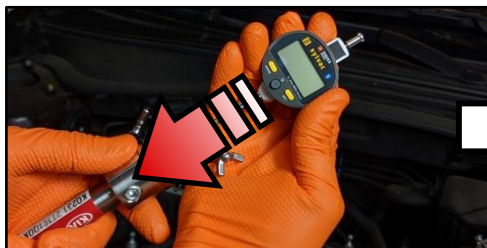
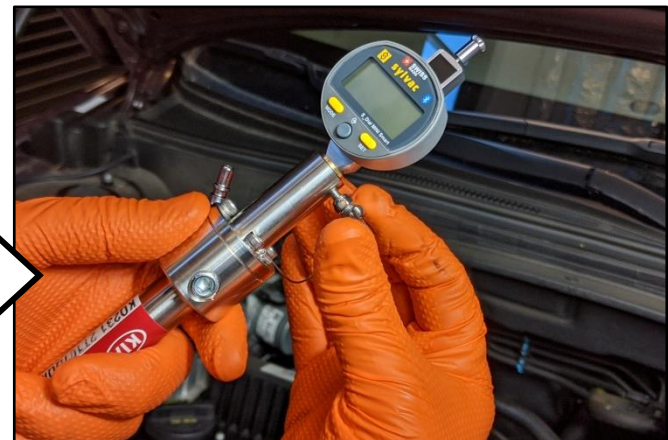
- 7. Install the Dial Gauge fully into the Probe Rod and secure together by hand tightening the locking wingnut.

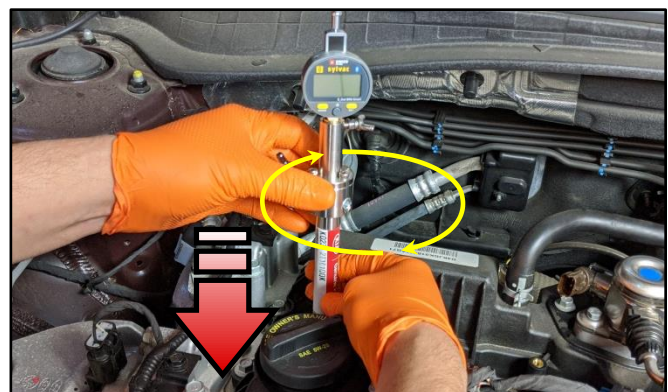
- 8. **Carefully**, insert the assembled SST Probe Rod and Dial Gauge into the Cylinder 1 spark plug hole and **carefully** turn the SST Crankshaft Rotator **by hand** clockwise until hand tight.

**CAUTION**  
**Damage to cylinder head can occur if spark plug hole is cross-threaded. DO NOT use a wrench to tighten the SST rod.**

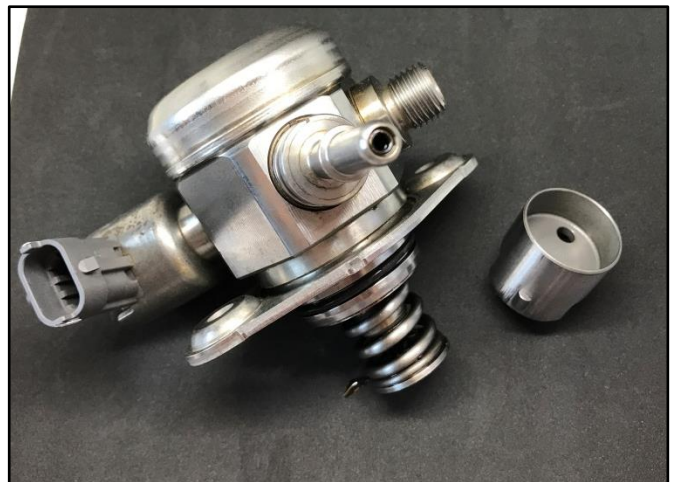
High Pressure Pump & Roller Tappet:

- Refer to [TSB ENG083](#) for special attention and handling procedures of GDI-specific components.
- When installing the high pressure pump and roller tappet onto the new engine, apply engine oil to the roller tappet, and O-rings of the high pressure pump.

**Tightening torques of pump bolts:  
9.4 – 10.9 lb.ft (12.8 – 14.7 N.m,  
1.3 – 1.5 kgf.m)**

**Tightening torques of pipe flare nut:  
19.5 – 23.9 lb.ft (26.5 – 32.4 N.m,  
2.7 – 3.3 kgf.m)**

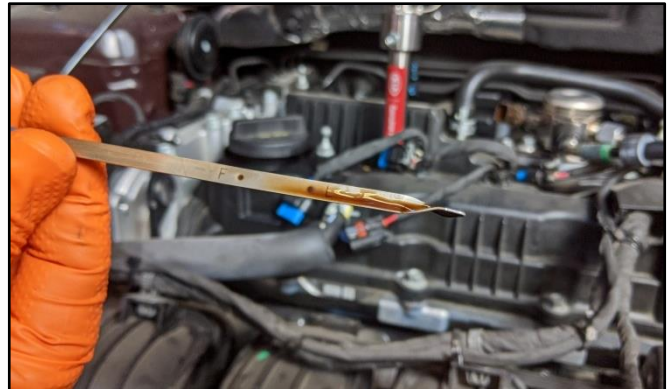
### Oil Level Check: (Applies to all Flowcharts B and C)

1. Measure and record oil dip stick level.
2. Note oil dip stick reading on the RO.

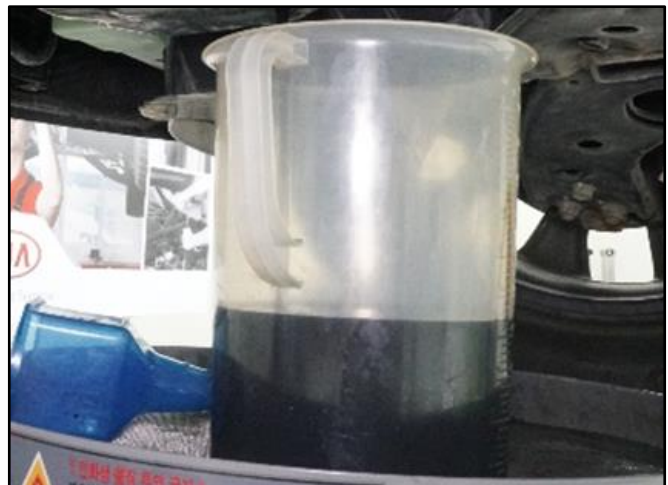
### Oil Level Measurement: (Flowchart C)

1. Remove oil filler cap, remove oil drain plug and drain oil into the supplied measuring container SST067BUCK and check oil level.
2. Record oil level reading.
3. Take photo of the oil level using KDS.

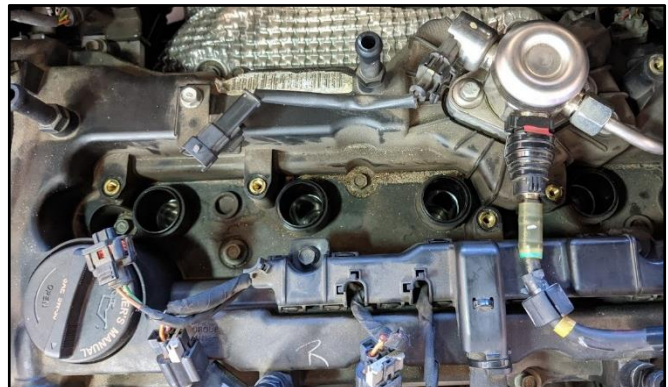
4. Show the empty spark plug holes from the engine.

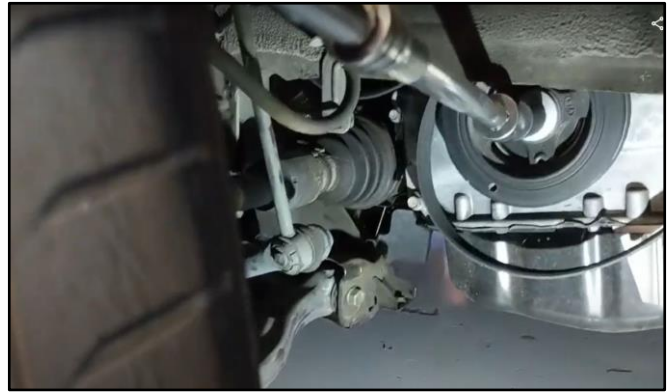
5. Show the removed drive belt and attached torque wrench to crank bolt.

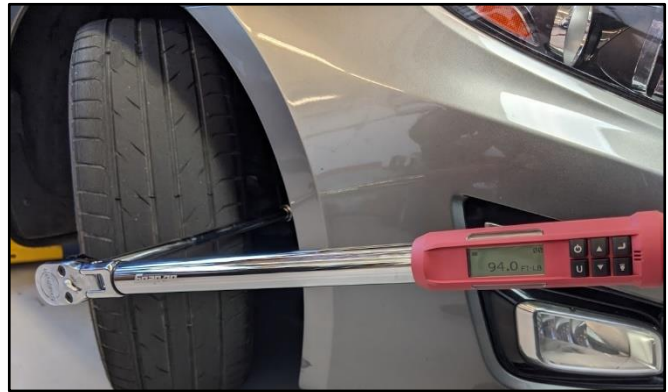
6. Show the engine being cranked and torque specification exceeding 94 lb.ft. torque.
