# Technical Service Bulletin

| SUBJECT: <b>STARTER DOES NOT ENGAGE WHEN TURNING<br/>IGNITION KEY / CHECK ENGINE LIGHT ILLUMINATES<br/>DTC P0014</b> | | | No: <b>TSB-20-13-002</b> |
| | | | MODEL: <b>Eclipse Cross</b> |

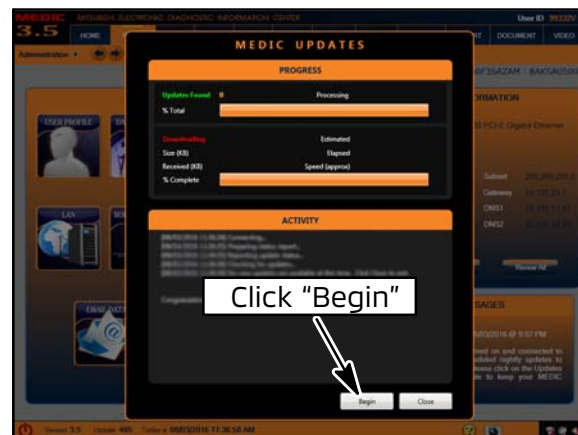
3. Select the MEDIC 3.5/4 Admin tab and click on "Updates."

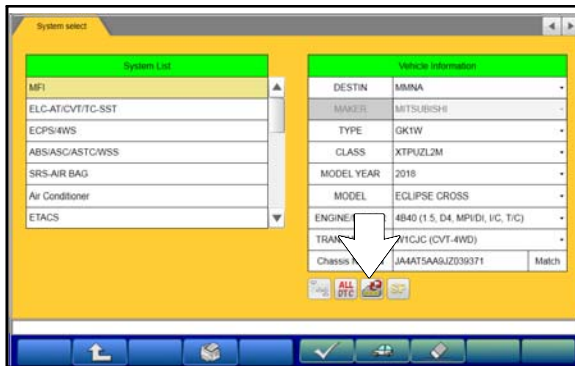
a. Click "STV."

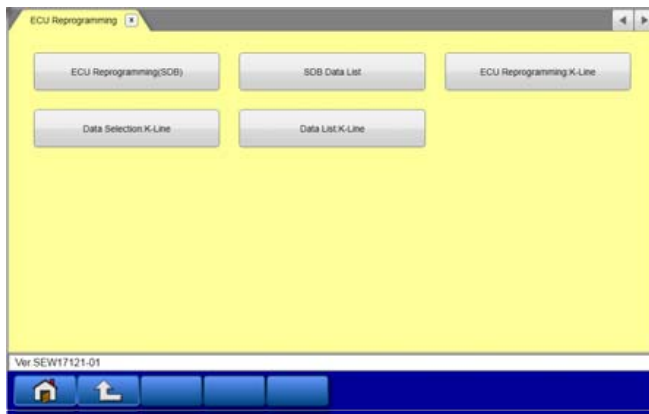
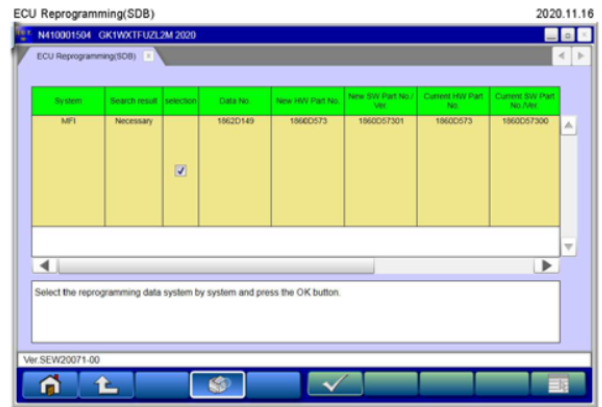
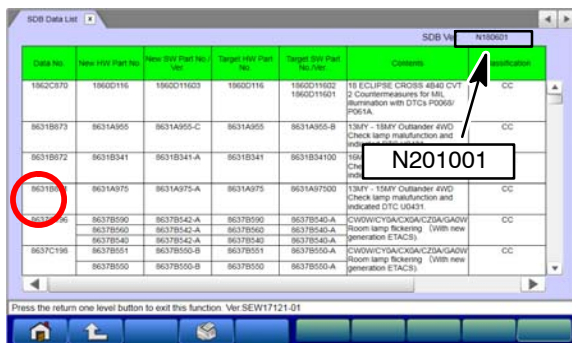
b. Click the "ECU Reprogramming" button.

c. Click "SDB Data List, select the reprogramming data system and press the OK button"

d. Confirm that the database number displayed in the upper right above the chart is **N201001 or higher**

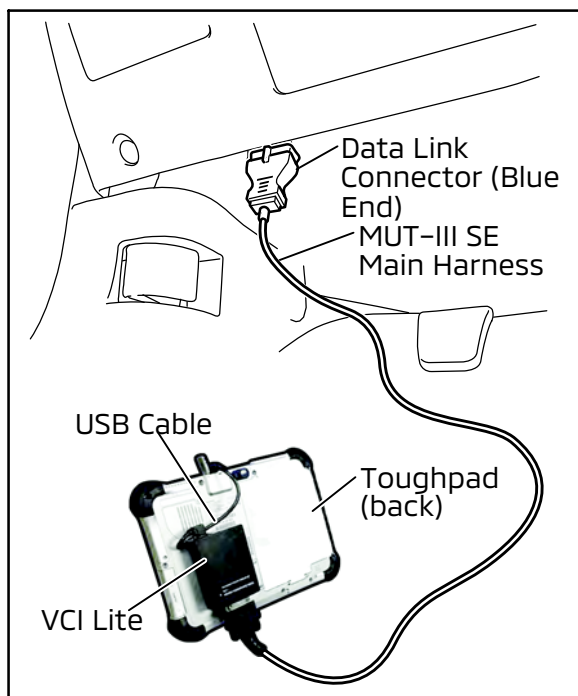
1. Connect the equipment as follows:

**NOTE:** VCI Lite and MEDIC 4.0 Toughpad shown for illustration purposes only.

- Turn the MEDIC PC/tablet on. If the battery indicator in the lower right hand corner of the screen does not show a full charge, it is recommended that either the battery be charged prior to beginning, or be used with the A/C power adaptor connected.
- Connect the USB cable to the VCI/VCI Lite. When the laptop/tablet displays the MUT-III SE main screen, connect the USB cable to the device.
- Connect the MUT-III SE main harness with the blue DLC connection to the VCI/VCI Lite. Connect the blue connection of the MUT-III SE main harness to the vehicle's data link connector.
- For VCI only (p/n MB991824): Turn the VCI power switch ON. Verify that the indicator lamp in the upper right corner of the screen is green.

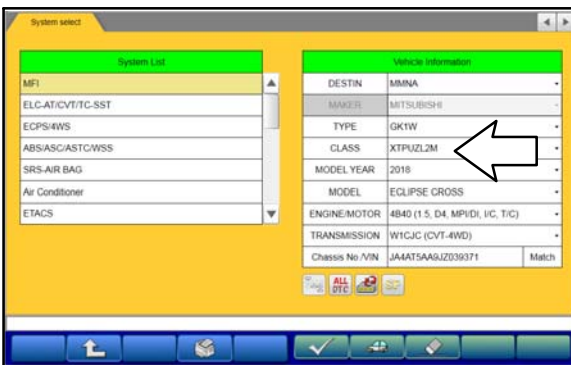
3. Using MEDIC, from the main page, click the "MUT3-SE" icon at the top center of the screen to open MUT-III SE. Click the STV button.

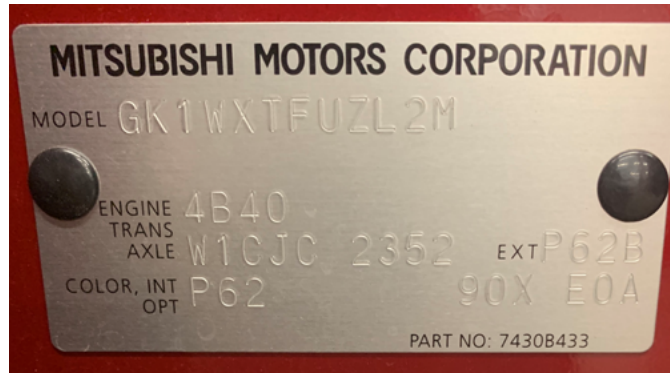
4. The System Select screen opens and populates with some basic information from the vehicle. Look at the label on the passenger side B pillar to identify the appropriate class. (See B pillar label below; class is labeled as "model"). If necessary, select the correct class from the drop-down list.

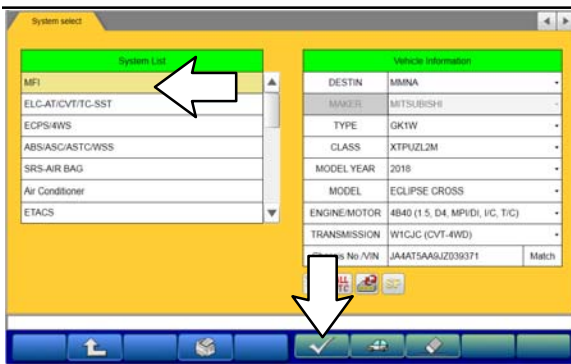
5. Verify that the ECU has not already been updated to the latest S/W number shown in the "ECU Reprogramming Chart" in this TSB. If the ECU is at the latest level, reprogramming is not necessary.

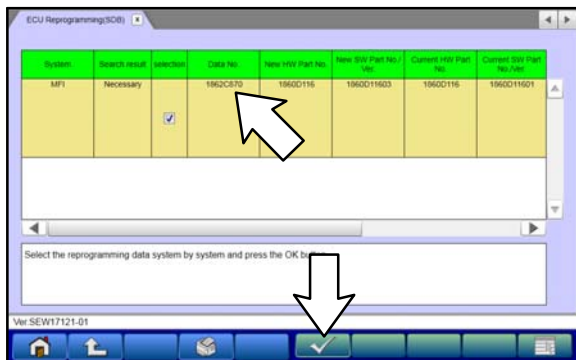
c. Select "MFI" in the System List, then click the check mark.

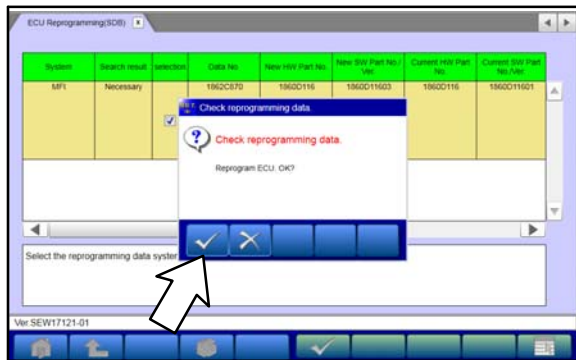
- d. Verify that the correct data file listed in the table matches the one in the "ECU Reprogramming Chart."
- e. Click the check mark at the bottom of the page to initiate reprogramming.

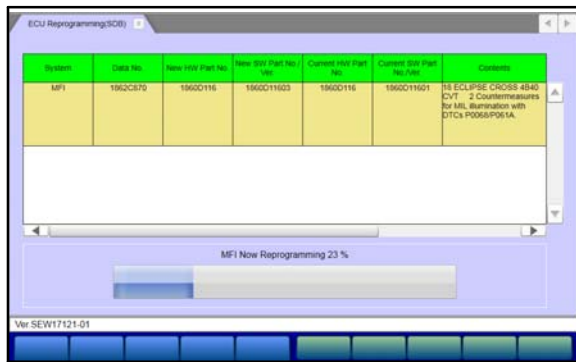
- f. Click the check mark in the "Check reprogramming data" dialog box.

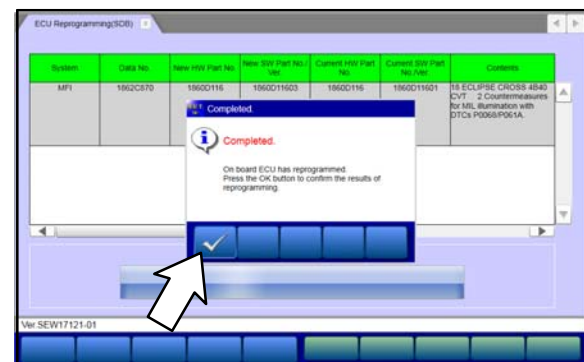
- g. Once the reprogramming is initiated, the screen shown will indicate the reprogramming progress.

**NOTE: Do NOT disturb the cables or turn off the ignition during reprogramming.**

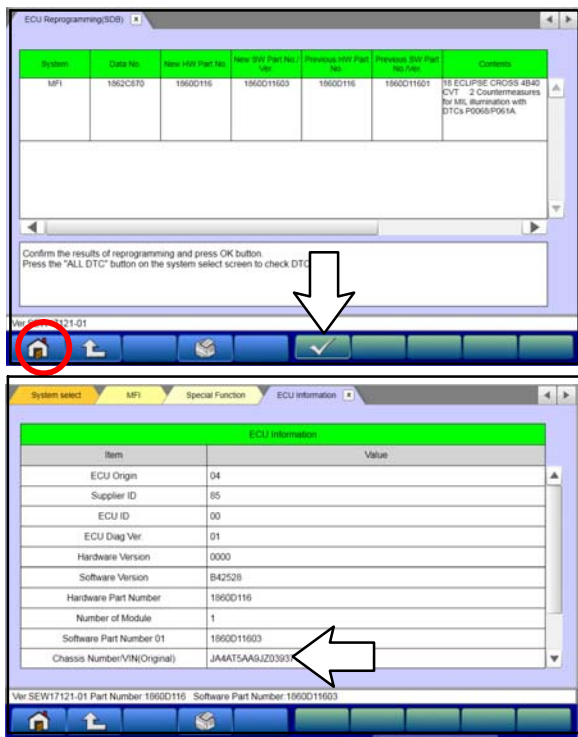
- h. Once reprogramming is completed, click the check mark in the "Completed" dialog box.

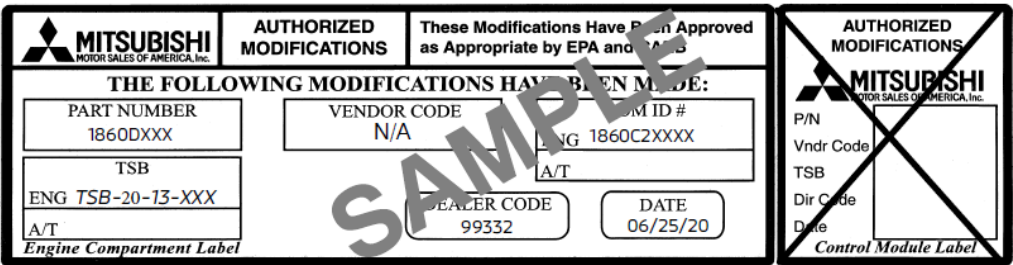
- 12. Using a ball-point pen, enter the appropriate ECU part number, Software Part Number (ROM ID#), this Technical Service Bulletin number, your dealer code, and the current date on the Engine Compartment/Control Module Label (p/n MSSF024G00). The Vendor Code is not applicable. The label is available from your facing PDC.
