December 11, 2020

2019-20 Odyssey: *Bluetooth*[®] HandsFreeLink[®] Freezes After Calls; Voice Tags Are Missing at Startup

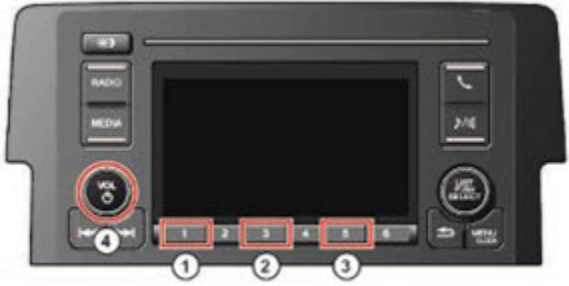
- With the audio unit OFF, press and hold the buttons in sequential order as shown. This will let you view the **Version display** screen.

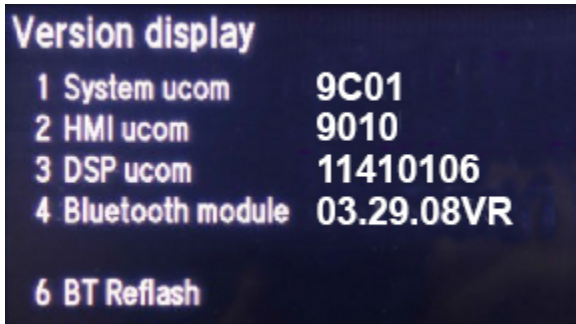
The image below is an example.

If any of the software versions do not match the ones listed in the table below, do not update the audio unit because you can damage it.

Software Details	Affected Software Versions
System ucom	9C01
HMI ucom	9010
DSP ucom	11410106
Bluetooth module	03.29.08VR

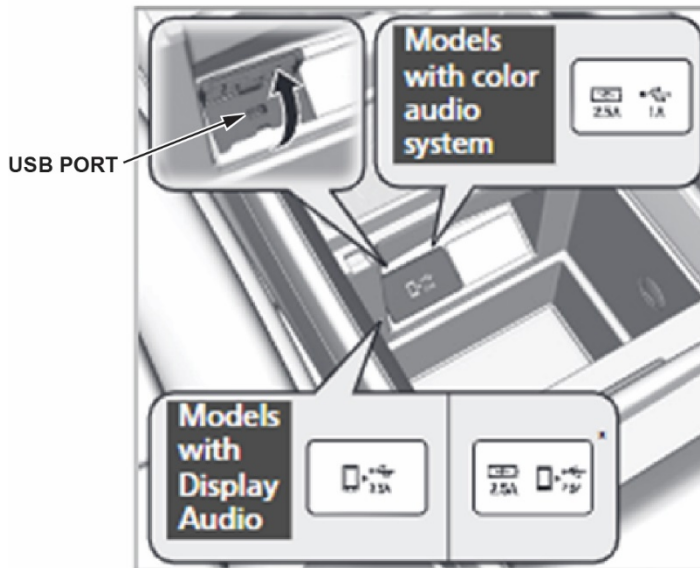
8. Plug the USB flash drive into the USB port to start the update. The audio unit will automatically detect the USB flash drive and start the update process.

Never disconnect the battery, turn the ignition to OFF, remove the USB flash drive, or press the **BACK** button while the update is in progress.

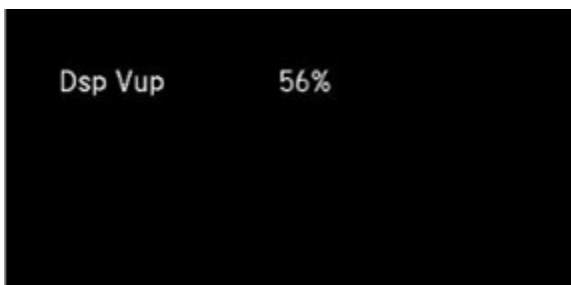
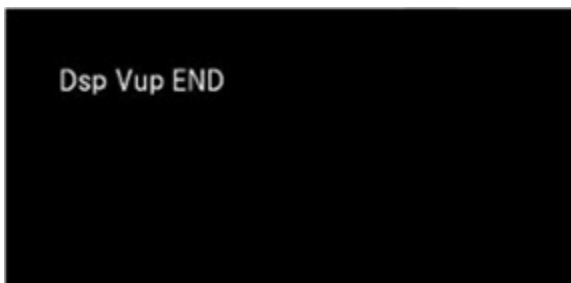
- Dsp Vup

You will see the following screens as the update runs.

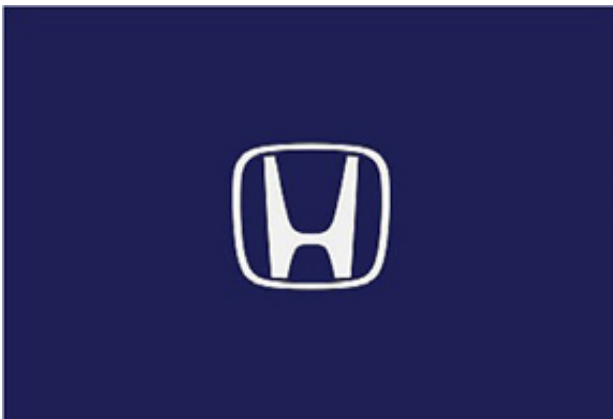
- The screen will go black and the buttons will begin blinking. The blinking will speed up and you will hear a beep every 10% of progress.
- When the software update is complete, you will hear a long beep, then the Honda logo will appear, and the audio unit will turn off.

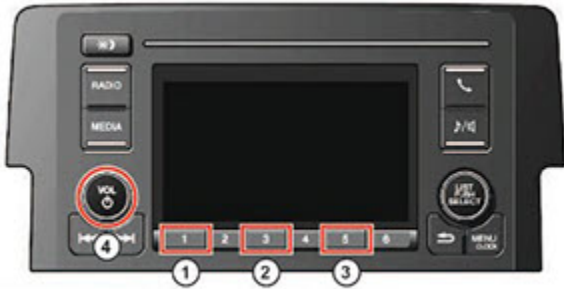
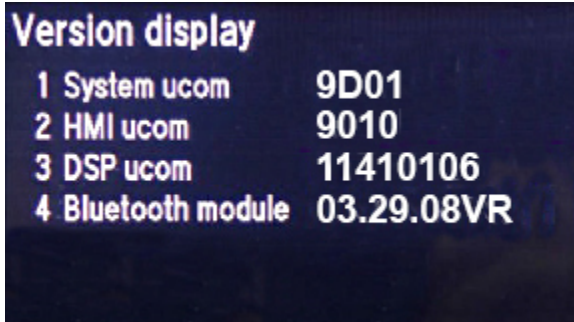
1. With the audio unit turned OFF, press and hold the buttons in sequential order as shown. This will let you view the **Version display** screen and verify the software version was updated.

Software Details	Affected Software Versions
System ucom	9D01
HMI ucom	9010
DSP ucom	11410106
Bluetooth module	03.29.08VR

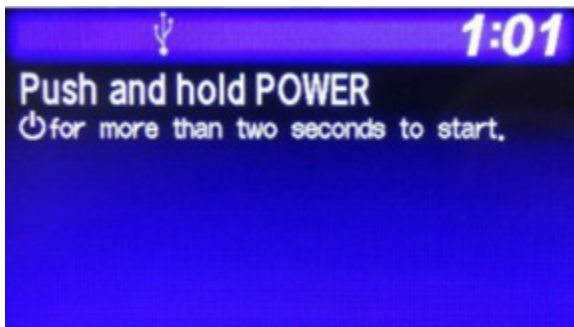
2. Press the VOL/Power button to exit the **Version display** screen.
3. Remove the USB flash drive.
4. Press and hold the VOL/Power button to sync the security code.
