Entune Audio Head Unit Software Update (Panasonic)

Service Category Audio/Visual/Telematics

Section Navigation/Multi Info Display

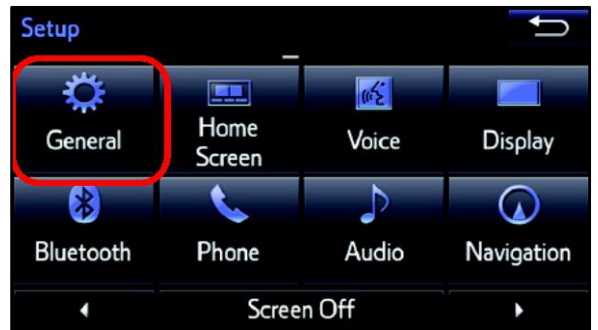
Figure 9.

6. Select General on the Setup screen.

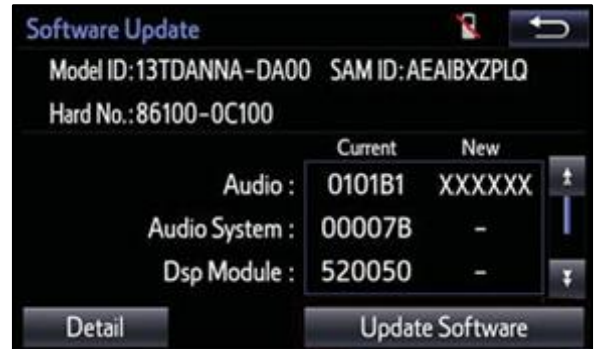
Figure 13.

9. Verify that the NEW software is up to date on the Software Update screen.

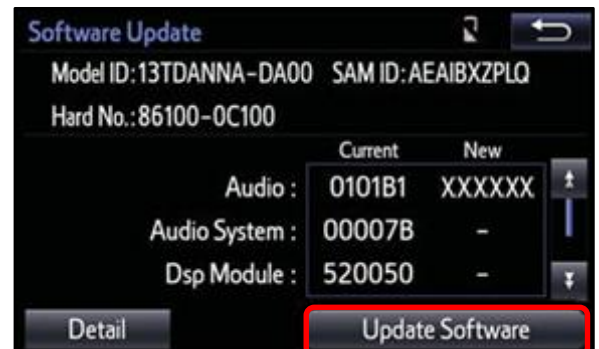
Figure 14.

- Select Update Software on the Software Update screen.
