WLK6 - Porsche Communication Management (PCM) Software Update (Workshop Campaign)

Model Line: **Macan (95B)**

Model Year: **2021**

Concerns: **Porsche Communication Management (PCM)**

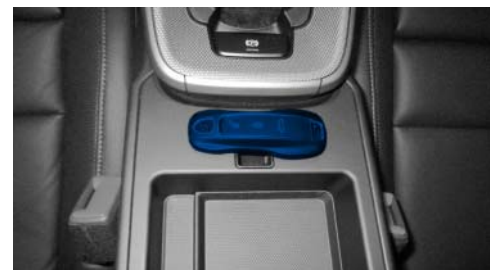
Emergency start tray

- 1 Connect a suitable battery charger, e.g. **Battery charger 90A**, to the jump-start terminals in the luggage compartment and switch it on.
- 2 Place the driver's key with the back facing down in the area in front of the storage compartment under the armrest (emergency start tray) in order to guarantee a permanent radio link between the vehicle and driver's key ⇒ *Emergency start tray*.
- 3 **9900 - PIWIS Tester 3** must be connected to the vehicle communication module (VCI) via the **USB cable**. Then connect the communication module to the vehicle and switch on the PIWIS Tester.
- 4 Switch on ignition.
- 5 On the PIWIS Tester start screen, call up the **'Diagnostics'** application.
The vehicle type is then read out, the diagnostic application is started and the control unit selection screen is populated.
- 6 Read out the fault memory of the PCM and delete it if necessary.
