**WLPO - Re-Programming PDK Control Unit (Workshop Campaign)**

Model Year: **2021**

Model Line: **911 (992)**

Concerns: **PDK control unit**

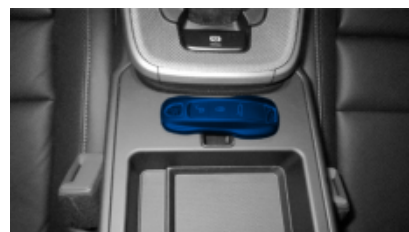
- Work Procedure: 1 Connect a suitable battery charger, e.g. **Battery charger 90A**, to the jump-start terminals in the luggage compartment and switch it on.
- 2 Place the driver's key with the back facing down in the area in front of the storage compartment under the armrest (emergency start tray) in order to guarantee a permanent radio link between the vehicle and driver's key ⇒ *Emergency start tray*.
- 3 Connect **9900 - PIWIS Tester 3** to the vehicle communication module (VCI) via the **USB cable**. Then connect the communication module to the vehicle and switch on the PIWIS Tester.
- 4 Switch on ignition.
- 5 On the PIWIS Tester start screen, call up the '**Diagnostics**' application.
- The vehicle type is then read out, the diagnostic application is started and the control unit selection screen is populated.

*Emergency start tray*

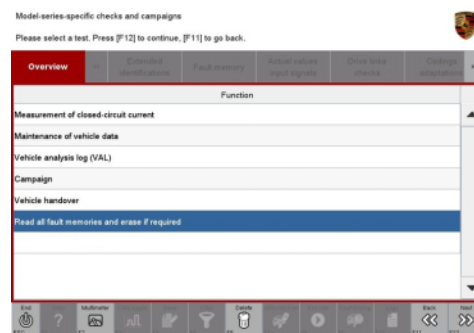
- 1.1 Press •F7" in the control unit selection screen ('Overview' menu) to call up the Additional menu.
- 1.2 Select the function "Read all fault memories and erase if required" and press •F12" ('Next') to confirm your selection ⇒ *Erasing fault memories*.

*Erasing fault memories*

- The fault memories of the control units are read out.
- 1.3 Once you have read out the fault memories, check the fault memory entries.

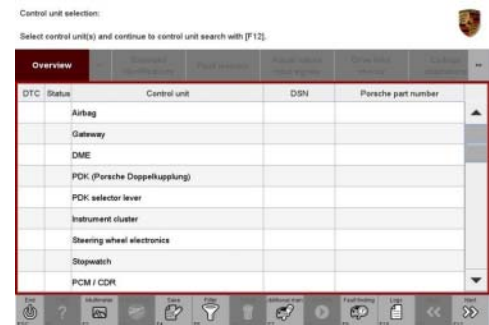
- 1.6 Once you have erased the fault memories, select the **'Overview'** menu to return to the control unit selection screen ⇒ *Control unit selection*.

*Control unit selection*
