SLINGSHOT

SERVICE ADVISORY

Communication #: TSA-20-01

SUBJECT: 2020 AUTODRIVE CALIBRATION ENHANCEMENTS

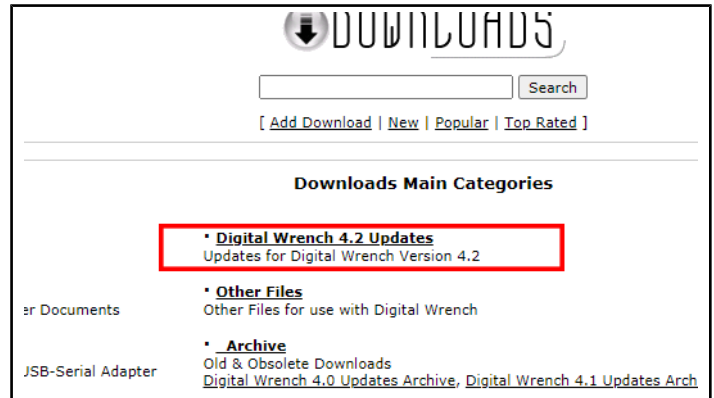
4. Click on **Digital Wrench Version 4.2 Updates**.

5. Download and install **Digital Wrench Version 4.2 – Update 12/18/2020 or higher**.

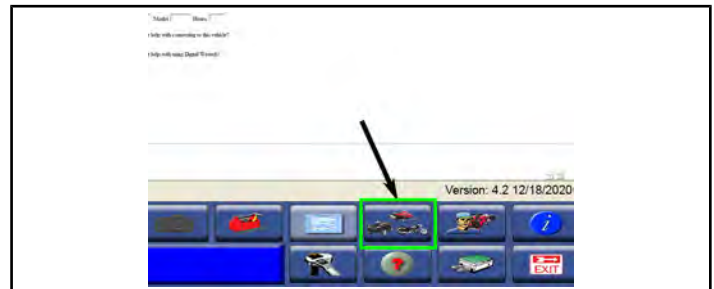
6. Connect MultiLink XP cables to PC and vehicle.
7. Open the Digital Wrench program.
8. Select the model year, product line, and vehicle description by selecting the “Change Vehicle Type” icon

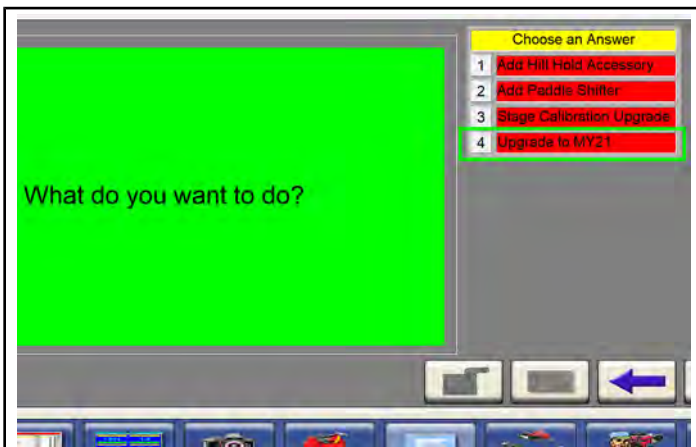
11. Select **Accessory Option Install** ②.

12. Select **Upgrade to MY21**.
