Service Action

Code: 90o8

Subject MyAudi Software Update – USA ONLY

Release Date December 11, 2020

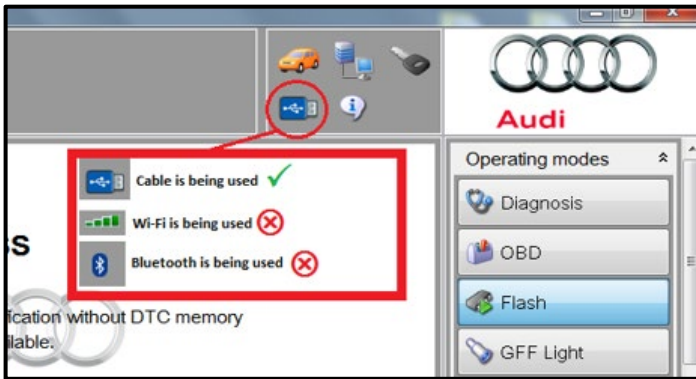
- Confirm that scan tool is communicating with the diagnostic head by USB cable.
 - If the Bluetooth or WiFi symbol is shown, then disconnect the diagnostic head from the vehicle and reconnect the USB cable to the diagnostic head and then reattach to the vehicle.

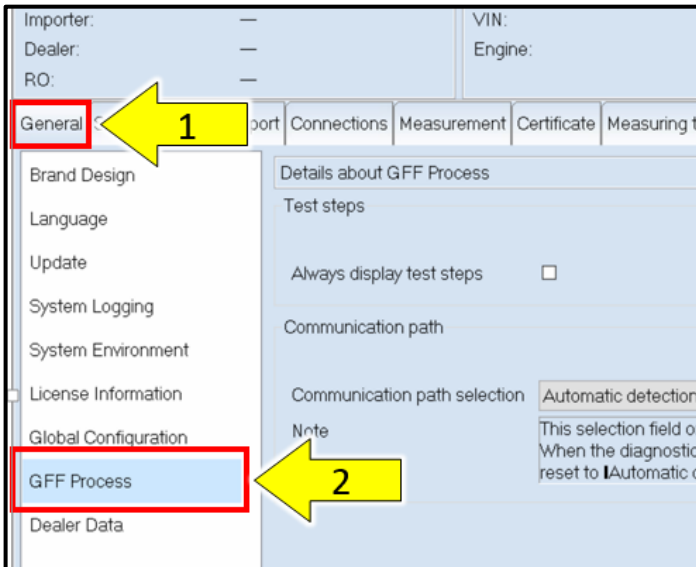
- From the “General” tab <arrow 1>, select “GFF Process” <arrow 2>.

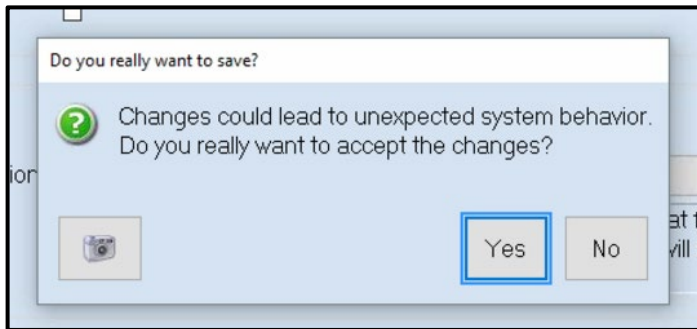
- Select “Yes” when prompted, “Do you really want to save?”
- Return to the home screen of the scan tool.

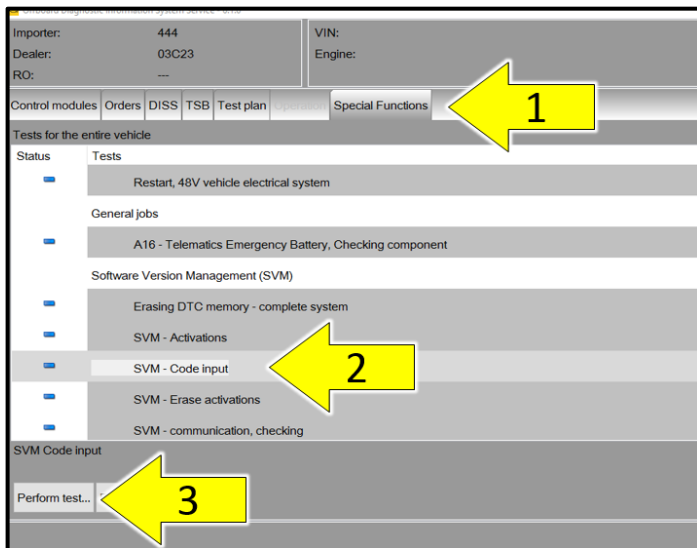
- After the diagnostic scan is complete:
 - Select the “Special Functions” tab <1>.
 - Select “SVM Code Input” <2>.
 - Select “Perform test...” <3>.
- Follow the on screen prompts.

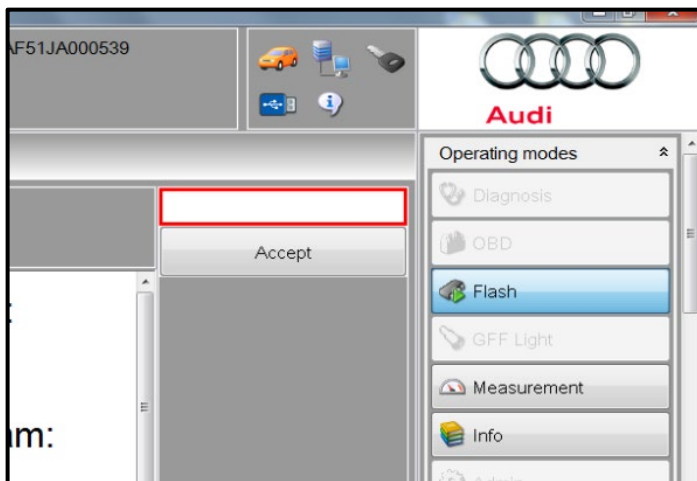
- Enter the corrective action code (SVM code) as listed below.

SVM code
90O8A108
(uppercase letter O)
