NUMBER: 08-015-21

GROUP: 08 - Electrical

Radio Enhancements

This bulletin involves updating the radio software level to ****1848.34.****

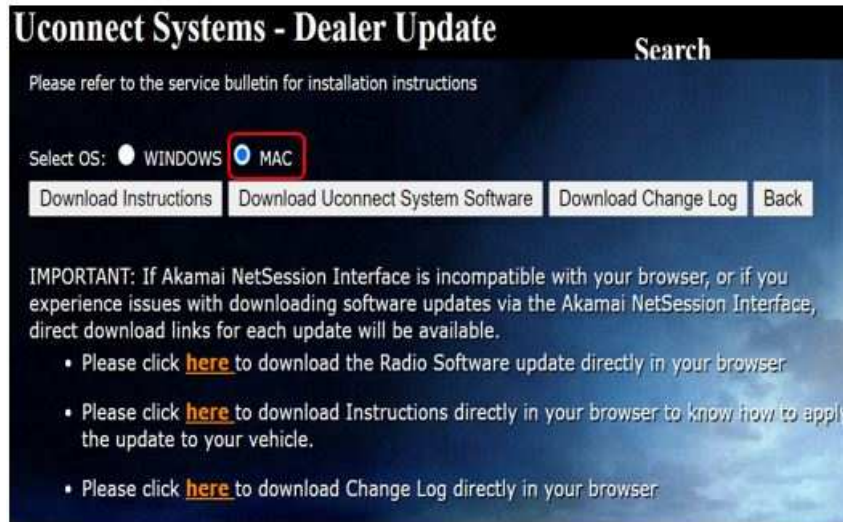
5. Use a blank USB flash drive with at least 8 GB of space. Follow the on-screen instructions to download the software files.
6. Download the software update file to your local PC's desktop. Make sure to select the "MAC" radial button for all downloads (Fig. 3) .

Fig. 3
MAC Download Steps

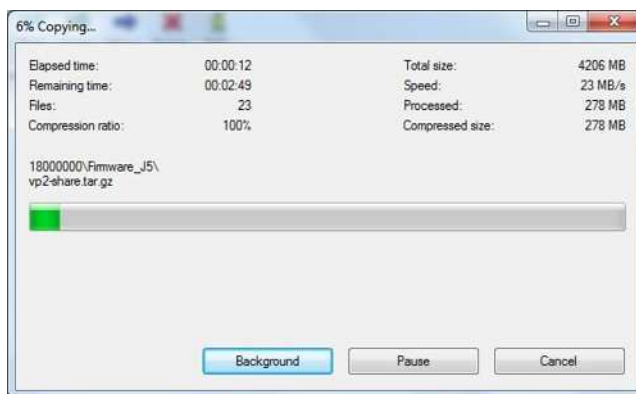
8. Extract the downloaded file to the USB flash drive (Fig. 5) .

Fig. 5
Extract File To USB

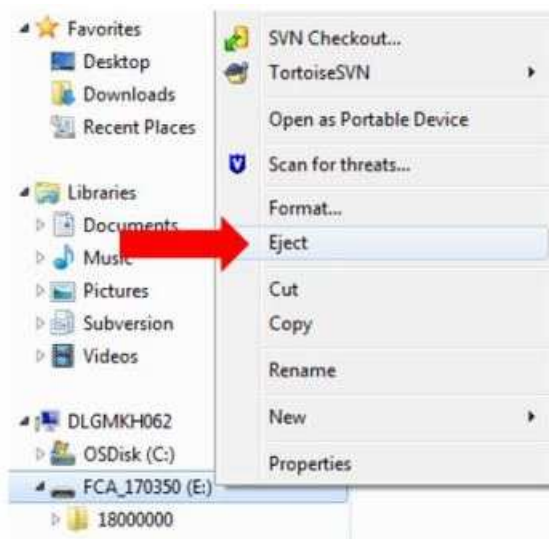
10. Perform the following steps to properly eject the USB flash drive (Fig. 6) :

- a. Right click on the location of the USB flash drive.
- b. Click “Eject” to avoid data corruption.
- c. Remove the USB flash drive from the PC.

Fig. 6
Ejecting The USB Flash Drive

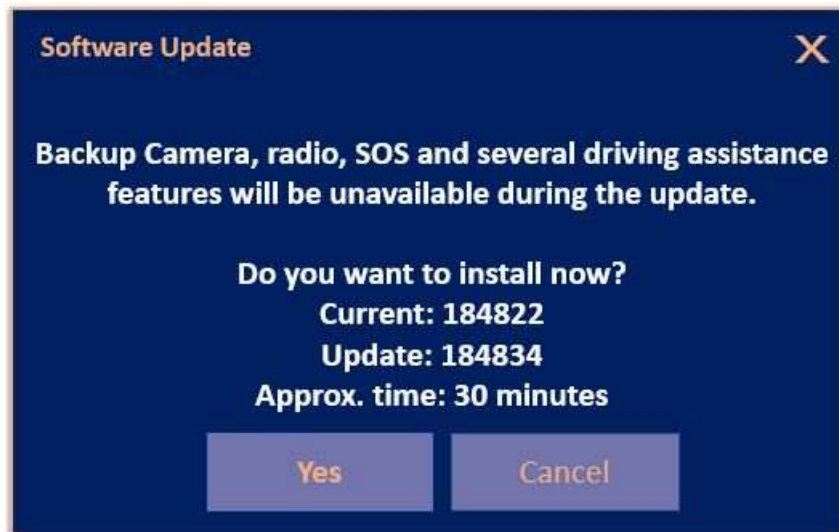
Fig. 7

16. Press "Yes" to start the update. The software update takes approximately 30 minutes to complete ([Fig. 7](#)).

Update Ready to Install

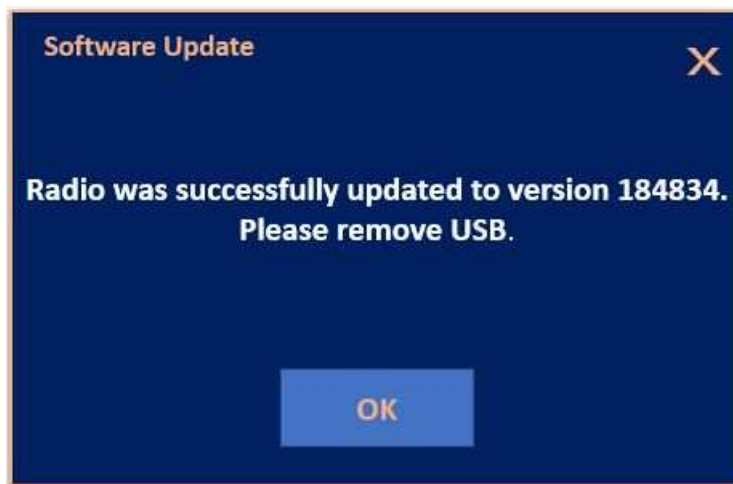
19. Wait for the "Radio was successfully updated" screen (Fig. 9) .

Fig. 9
Update Successful Screen
