DCM Reset and Firmware Update (LG)

Service Category Audio/Visual/Telematics

Section Cellular Communication

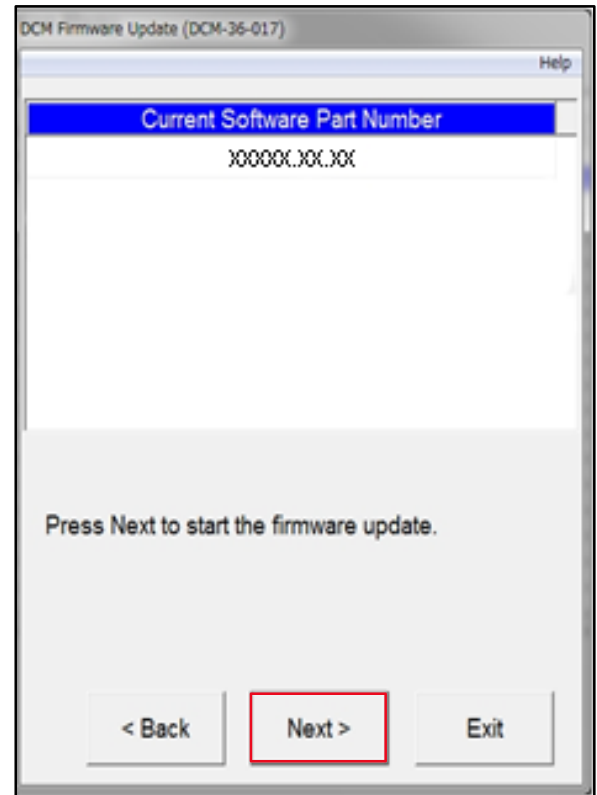
Figure 5.

- Click on Next when the current software part number screen appears.

If the screen in Figure 5 does NOT appear and an error message displays, begin the Firmware Update Procedure again from step 4. The battery reset MUST be performed again.

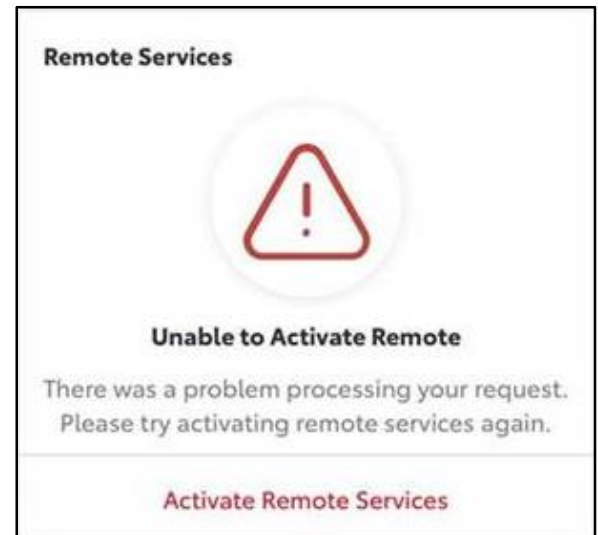
Figure 8.

15. Using Techstream, perform a Health Check and clear ALL DTCs that may have occurred during the update process.
16. In the customer’s Toyota app, perform steps 17 – 19 for customers with the “Unable to Activate Remote” message.

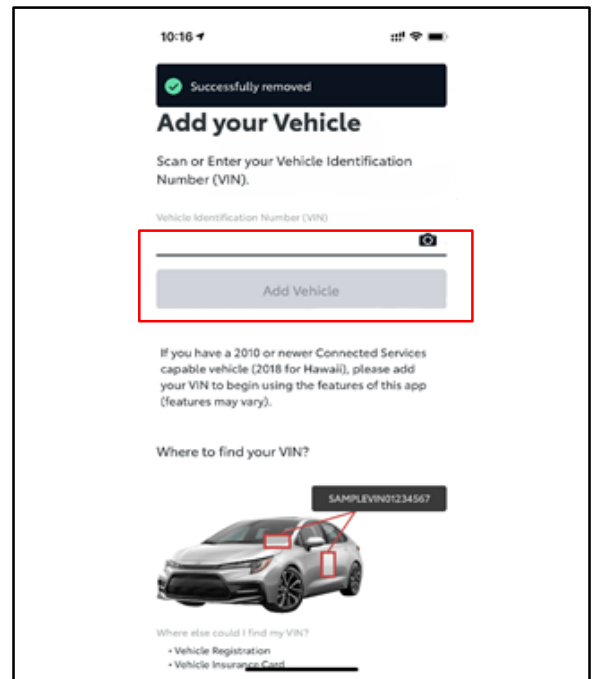
Figure 11.

- Click on Add Vehicle to perform the enrollment again.
