# RECALL CAMPAIGN BULLETIN

## SOFTWARE UPDATE FOR INFOTAINMENT ISSUES

**APPLIED VEHICLES:** 2019 Sentra (B17) – SV, SR, SL, NISMO

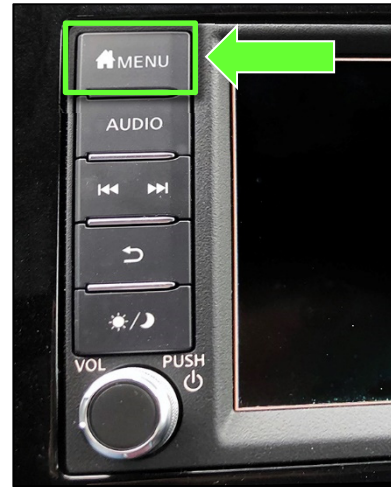
Figure 2

1. Push the **MENU** button.

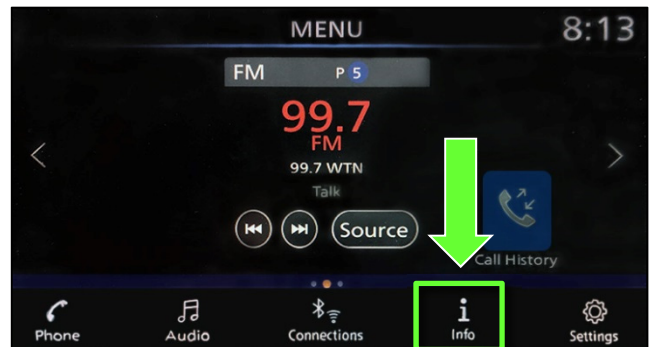
Figure 3

2. Select the **Info** icon.
  - If the Info icon does not appear as shown in Figure 3, this bulletin does not apply.

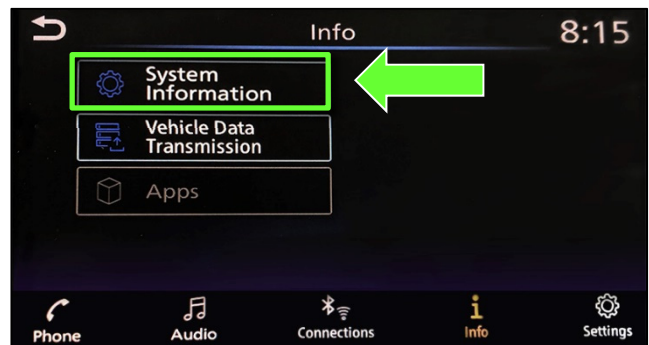
Figure 4

3. Select **System Information**.

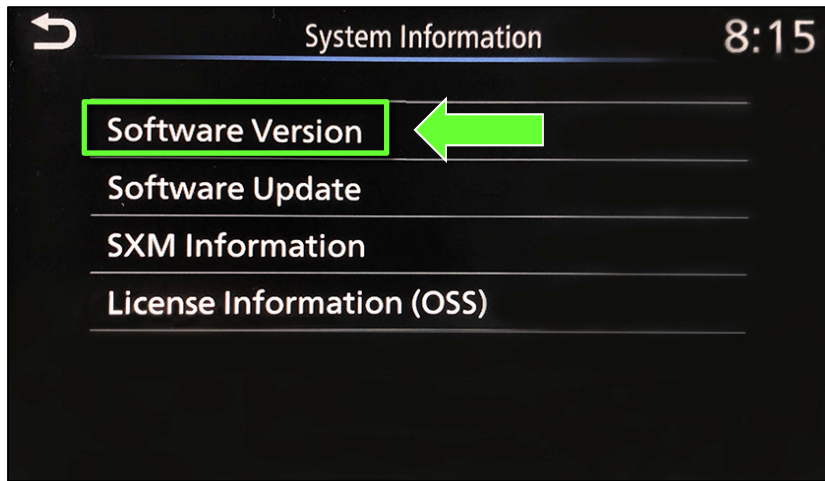
Figure 5

4. Select **Software Version**.

- If the Software version is NOT **0910 or higher**, select the back button and continue to step 5 on the next page.
- If the Software version is **0910 or higher**, select the back button, this bulletin does not apply.

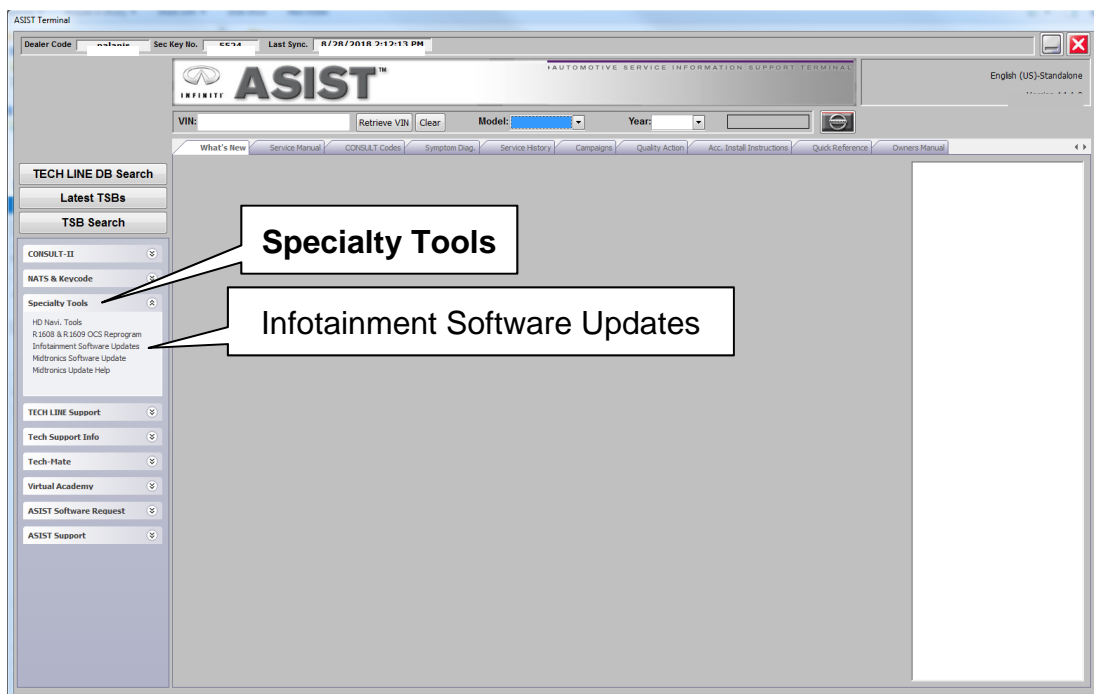
Figure 7

7. Select **Specialty Tools**, and then select **Infotainment Software Updates**.

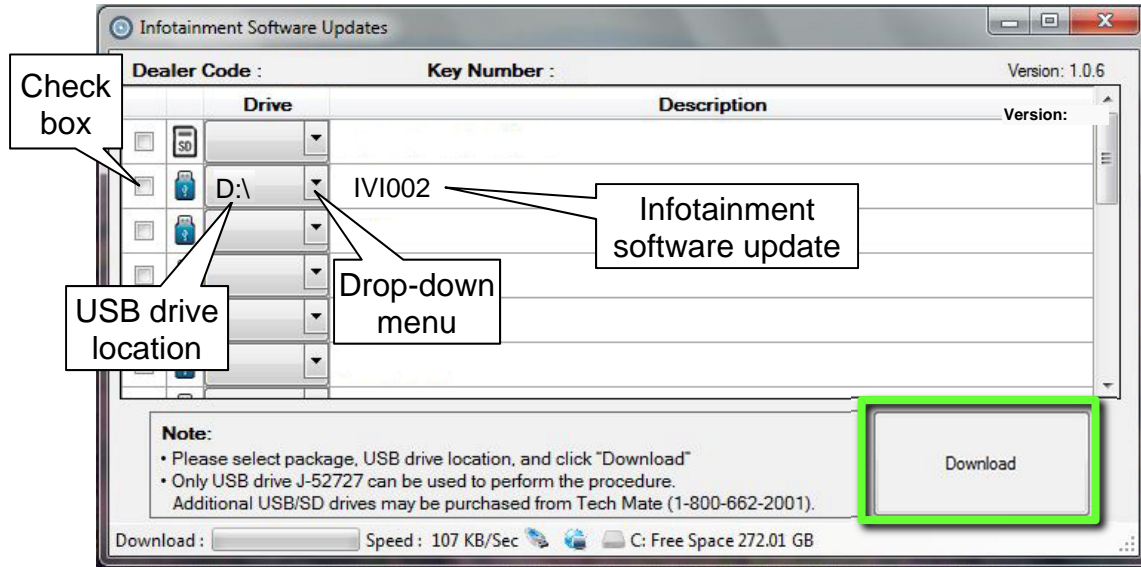
8. Select the check box next to the **IVI002** infotainment software update (refer to Figure 8 below).
9. Use the drop-down menu and select the location of the USB drive that was inserted in step 5.

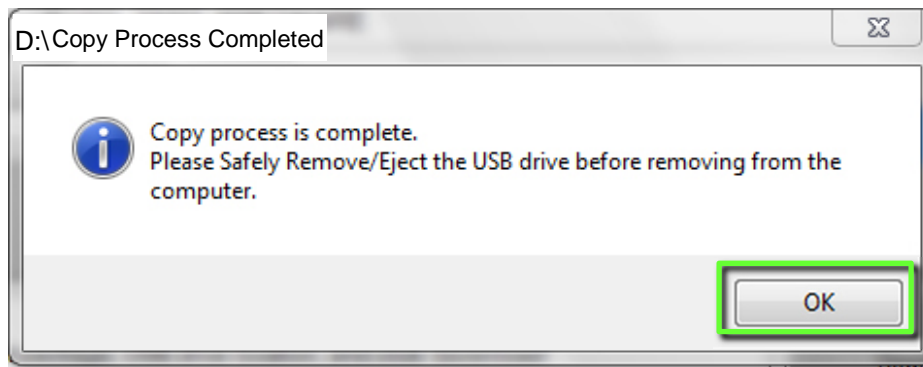
Figure 10

11. Select **OK**.

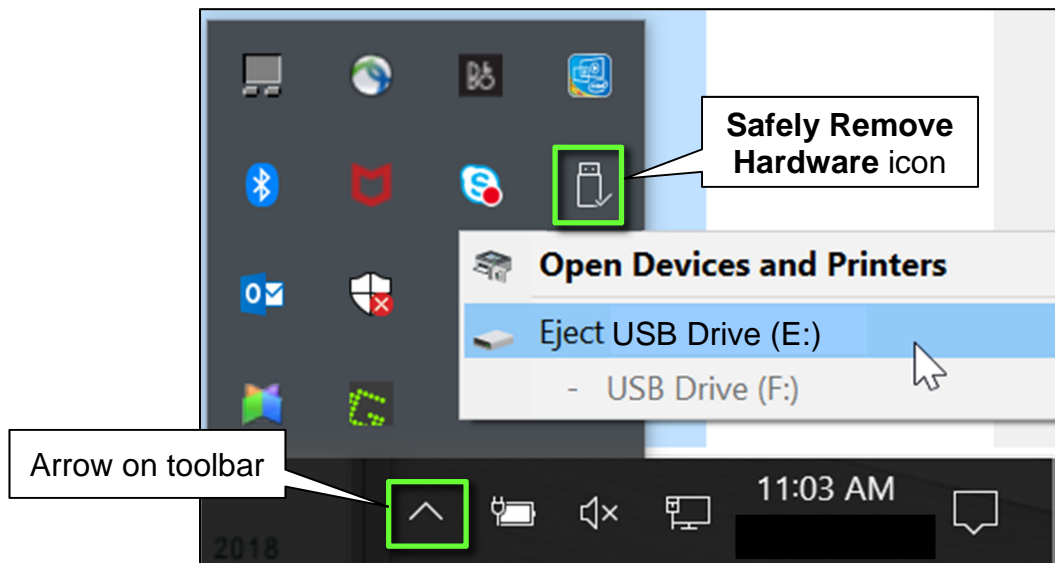
Figure 11

12. Once the transfer is complete, safely remove the USB drive from the ASIST Station.

- a. From the PC toolbar, select the **Safely Remove Hardware** icon.
  - The icon is on the toolbar, or can be found after selecting the arrow.
- b. Select the USB drive to be removed, and then remove the USB drive from the ASIST Station.

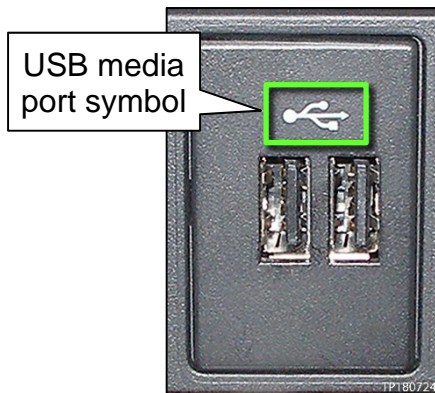
Figure 12

16. Insert the USB drive with infotainment update software into the vehicle's USB media port (see Figure 12).
- Do not remove the USB drive during the update to the vehicle until instructed to.

**NOTICE** Do not insert the USB drive into a charging port. If used, the update software and/or USB drive may become damaged. Only insert the USB drive in a USB media port.

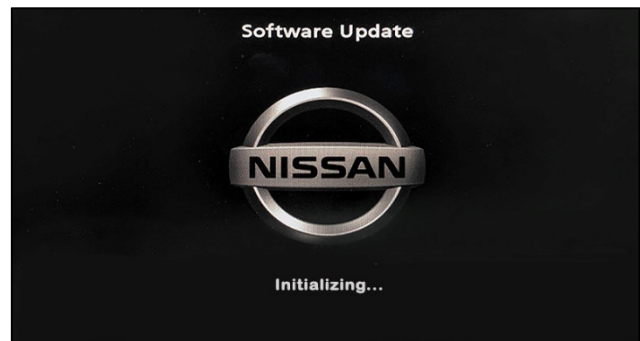
17. Wait approximately 10-30 seconds for the screen in Figure 14 to appear.

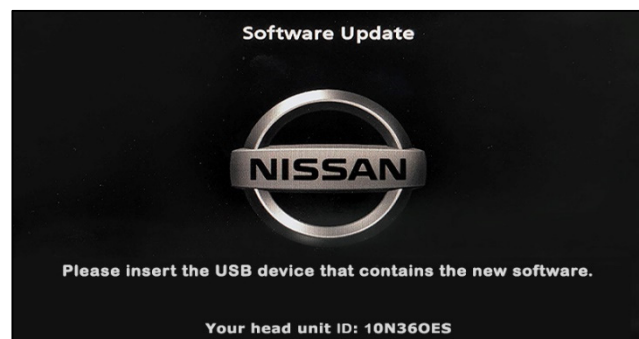
- The screen in Figure 15 may briefly appear. **Do not remove the USB drive.** The audio system will detect the USB drive and continue the update.

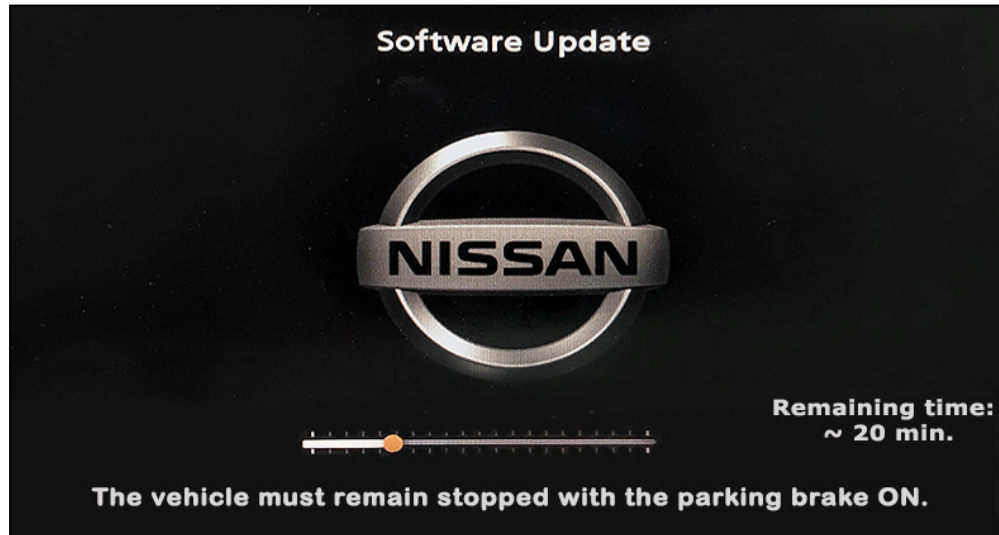
Figure 16

18. Wait for the update to complete.
- Follow the on-screen instructions while waiting.
- HINT:** The update lasts 15-25 minutes.

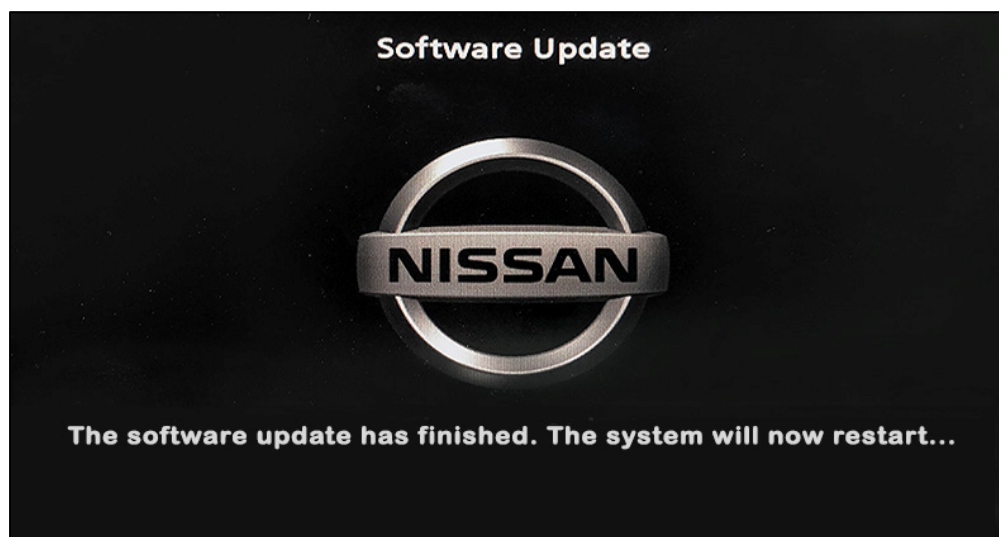
Figure 17

19. Once the update is complete (Figure 17), remove the USB drive; the system will reboot (restart).
- HINT:** The system will not reboot until the USB drive is removed.

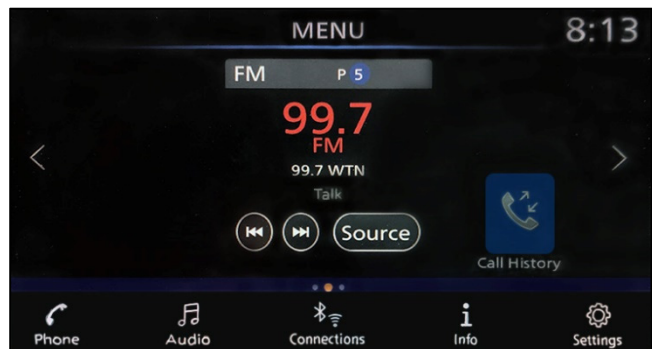
25. After the Nissan logo appears, wait about one (1) minute.
  - The MENU (Home) screen in Figure 19 will be displayed.
