JTB00593NAS2

**TECHNICAL BULLETIN**

415-01: Information and Entertainment Systems

InControl® Touch Pro™ Features May Not Function As Expected; Phase 3.0 Update

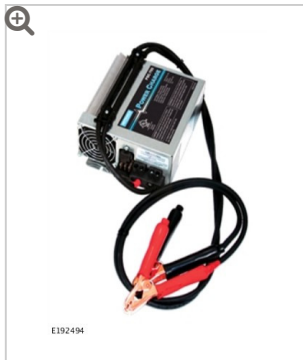
Jaguar Land  
Rover-approved  
Midtronics  
battery power  
supply

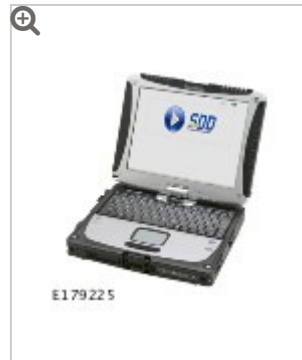
Jaguar Land  
Rover-approved  
diagnostic tool  
with latest SDD  
software,  
Calibration File,  
and InControl©  
Touch Pro™  
Software

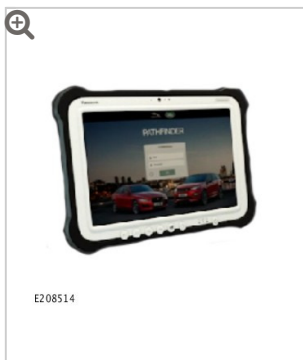
Jaguar Land  
Rover-approved  
diagnostic tool  
with latest  
PATHFINDER  
software

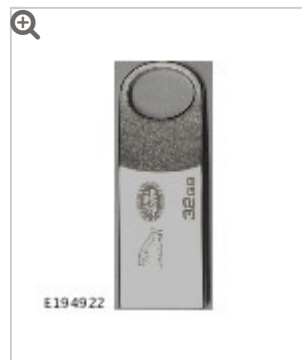
**DTSE9G  
2/32GB**

Jaguar Land  
Rover-approved  
USB memory  
device
