Classification:
AN18-023dReference:
ITB18-040dCOPYRIGHT© NISSAN NORTH AMERICA, INC.
Date:
February 10, 2021

SOFTWARE UPDATES FOR INFOTAINMENT ISSUES

APPLIED VEHICLES:

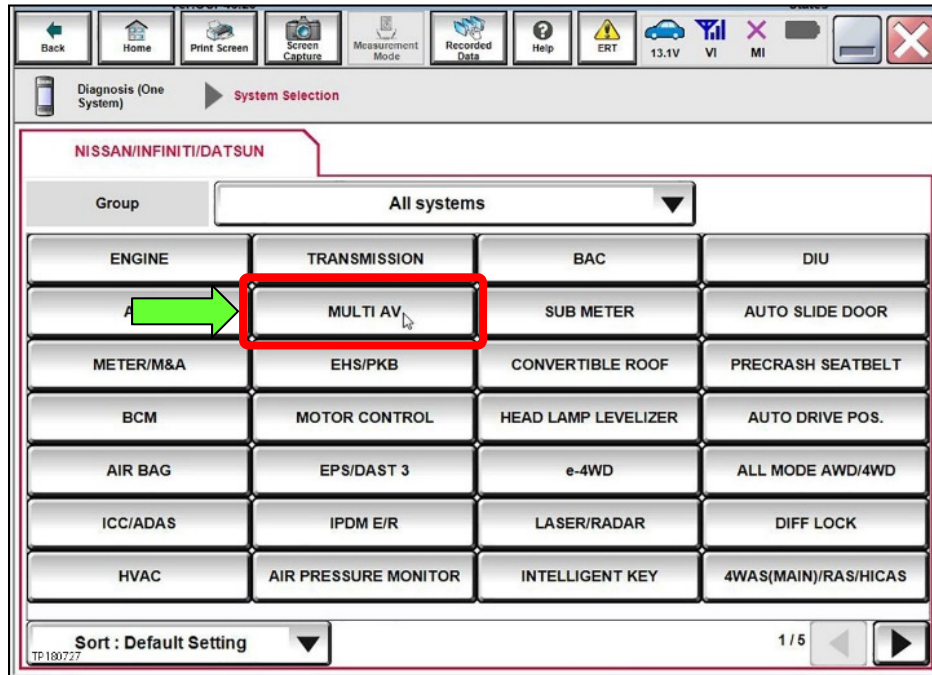
Figure 3

6. Select MULTI AV.

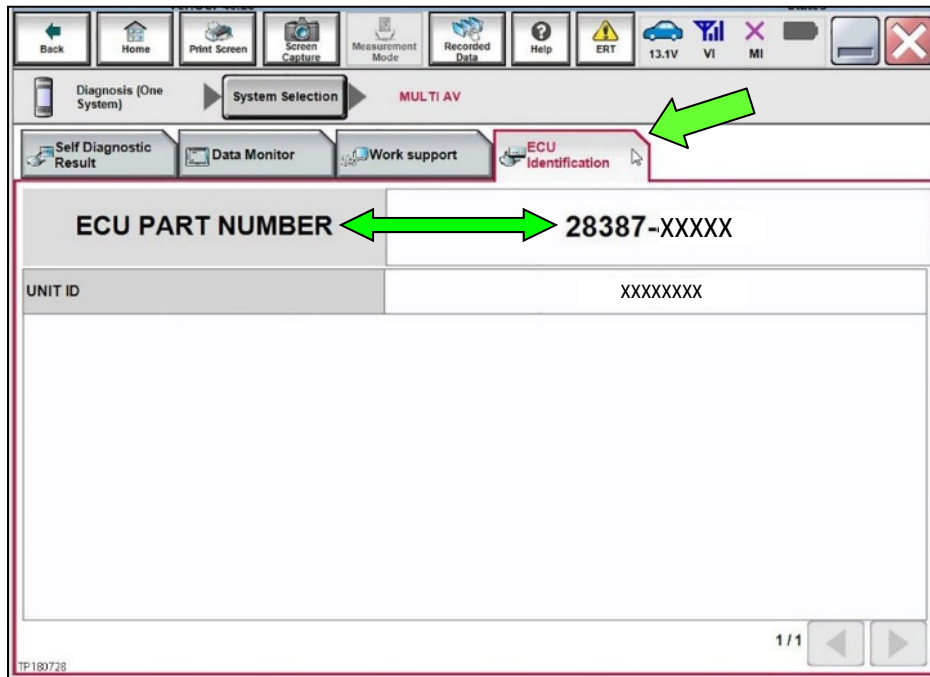
7. Select the **ECU Identification** tab.
8. When the screen in Figure 4 displays, confirm this bulletin applies as follows:
 - a. Write down the **ECU PART NUMBER** on the repair order.

NOTE: This is the current DCU part number (P/N).

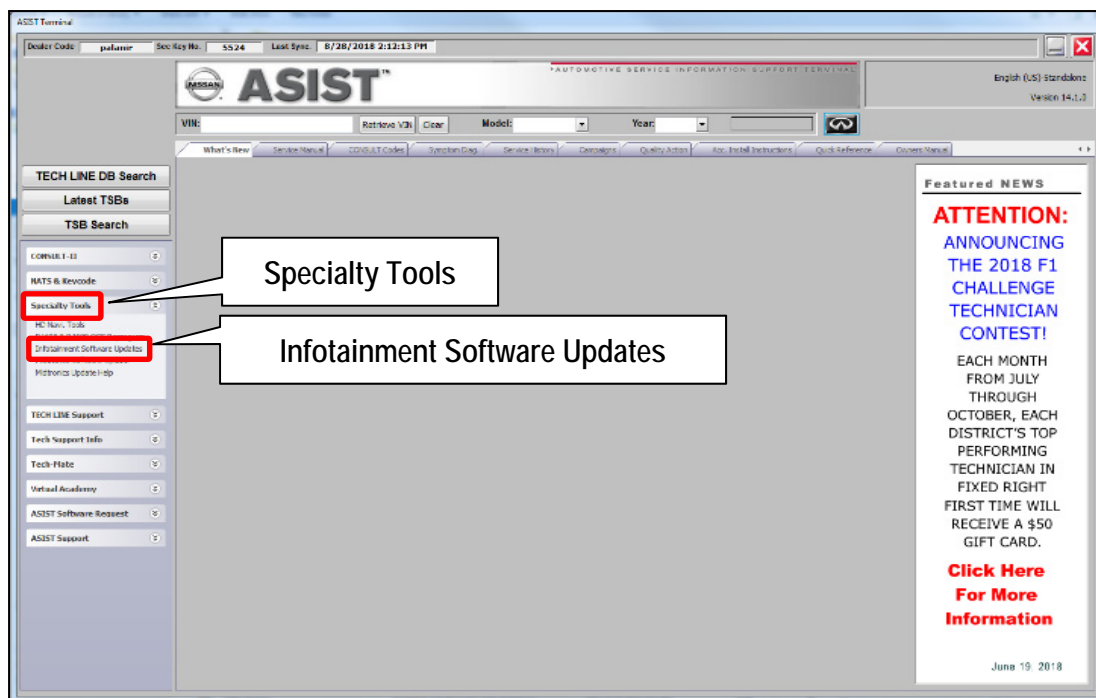
Figure 5

11. Select **Specialty Tools**, and then select **Infotainment Software Updates**.

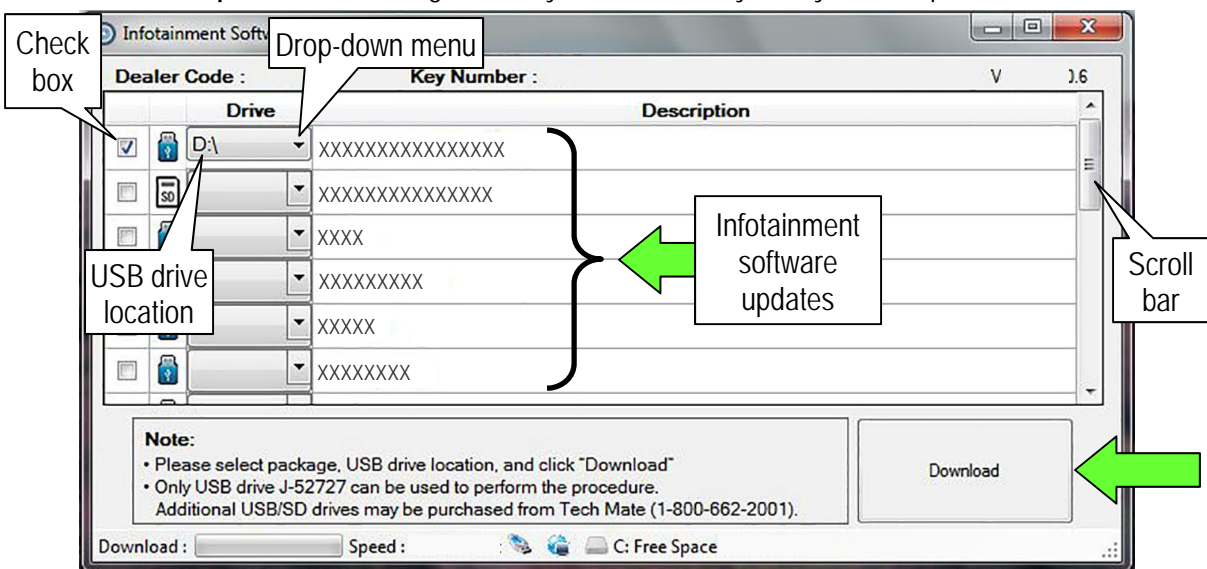
12. Select the check box next to the correct update software package based on **Table B** below (see Figure 6).
HINT: Use the scroll bar, if needed, to find the correct update software package.

13. Use the drop-down menu and select the location of the USB drive that was inserted in step 9.

HINT: The **Description** section in Figure 6 may show differently than your C-III plus screen.

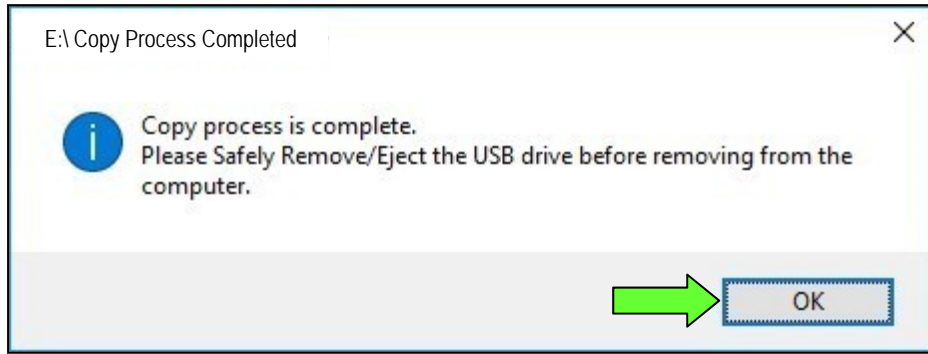
Figure 7

14. Select **Download**, and then wait for the download to complete.

15. Select **OK**.

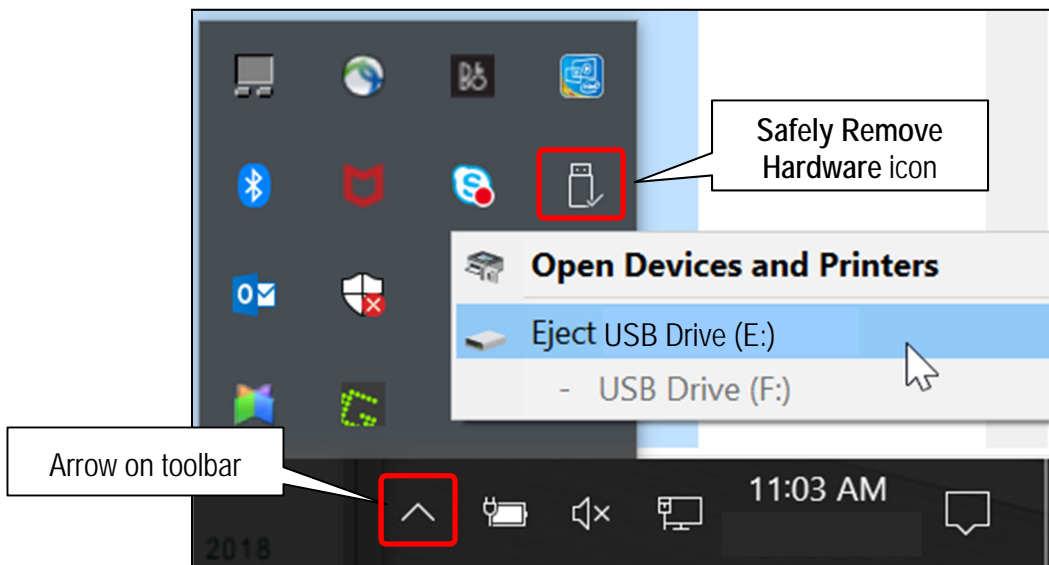
Figure 8

16. Once the transfer is complete, safely remove the USB drive from the ASIST Station.

- a. From the PC toolbar, select the **Safely Remove Hardware** icon.
 - The icon is on the toolbar, or to be found after selecting the arrow.
- b. Select the USB drive to be removed, and then remove the USB drive from the ASIST Station.

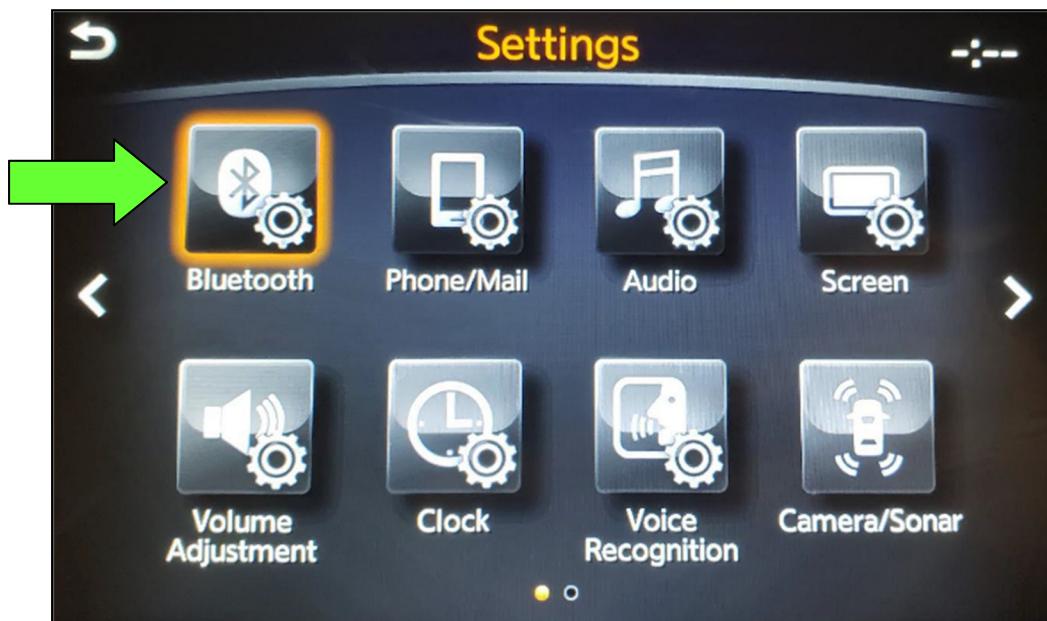
Figure 9

19. Open the Settings Menu, and then select **Bluetooth**.

- The **Settings** menu is accessed with the hard button located under the display.

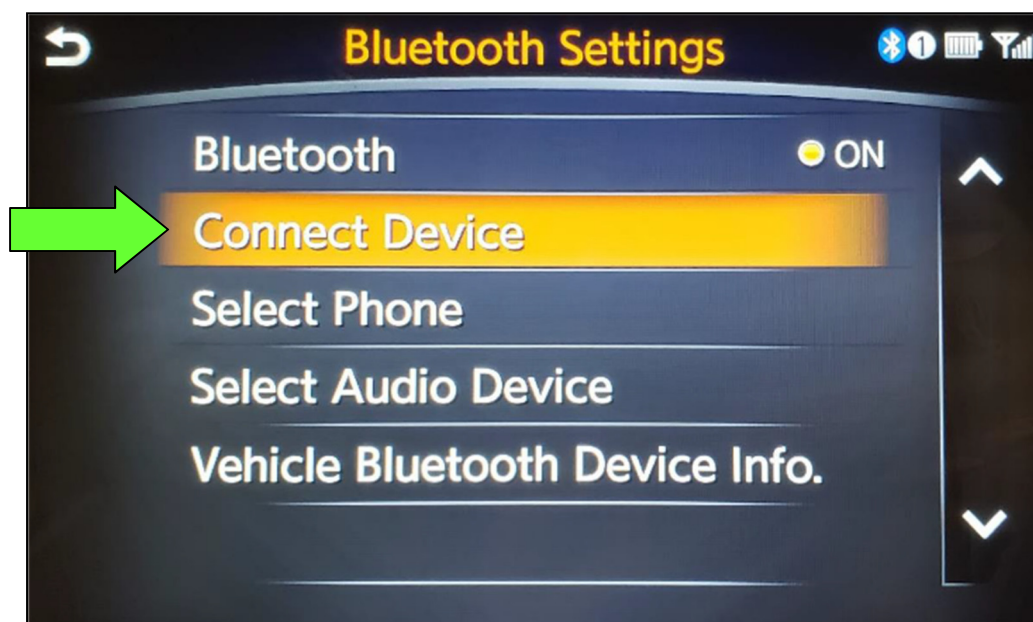
Figure 10

20. Select **Connect Device** from the **Bluetooth Settings** menu.

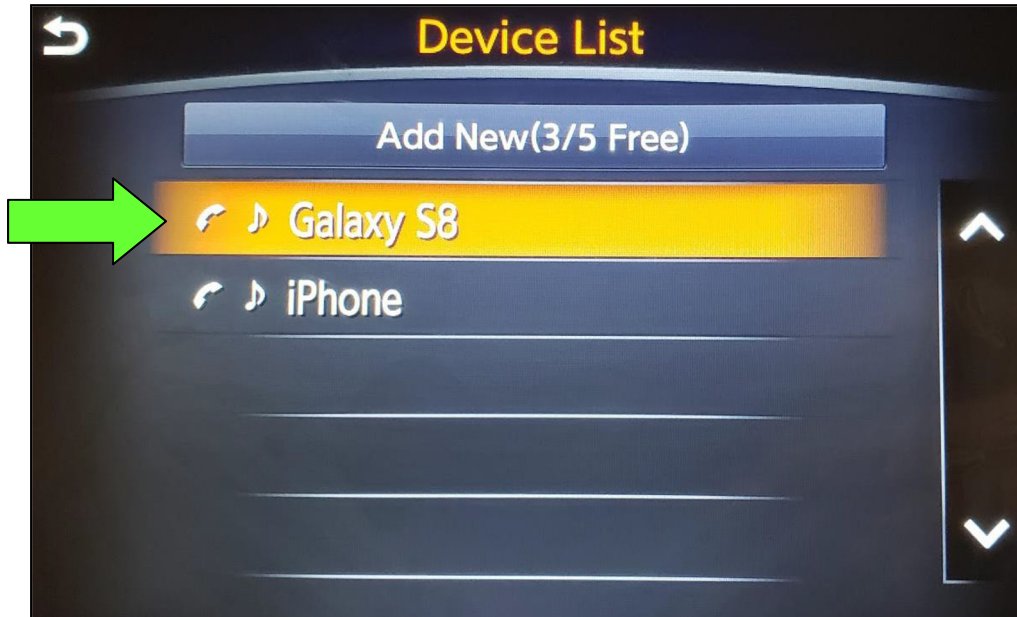
Figure 11

21. Check for devices in the **Device List**:

- **YES**, one or more devices are listed: Select a device, and then proceed to step 22.
- **NO**, there are no listed devices: Skip to step 24.

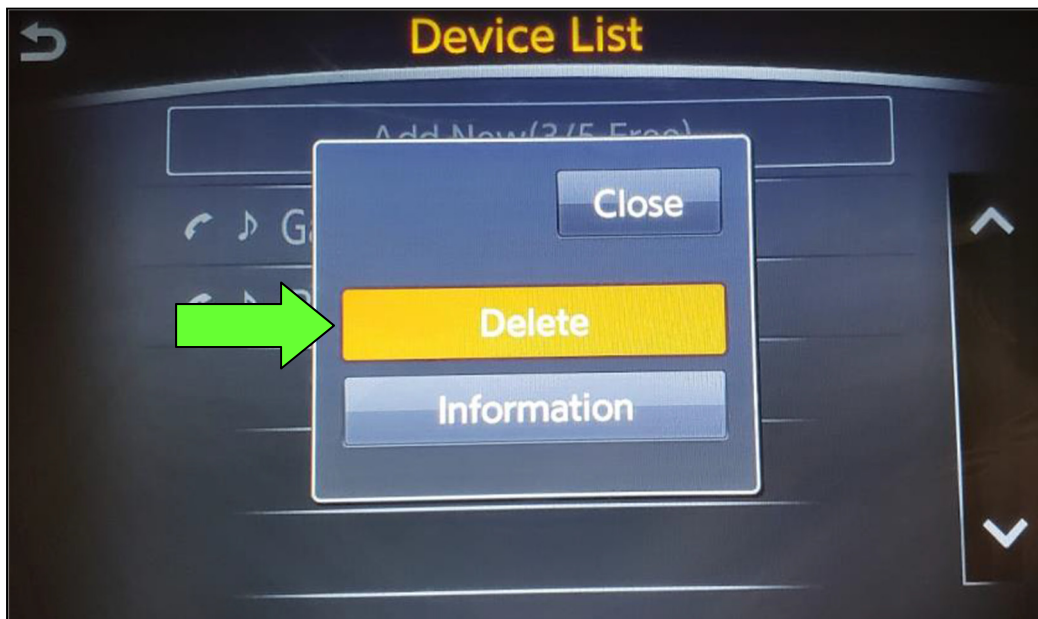
Figure 12

22. Select **Delete** and confirm the screens in Figure 13 and then Figure 14 are displayed.

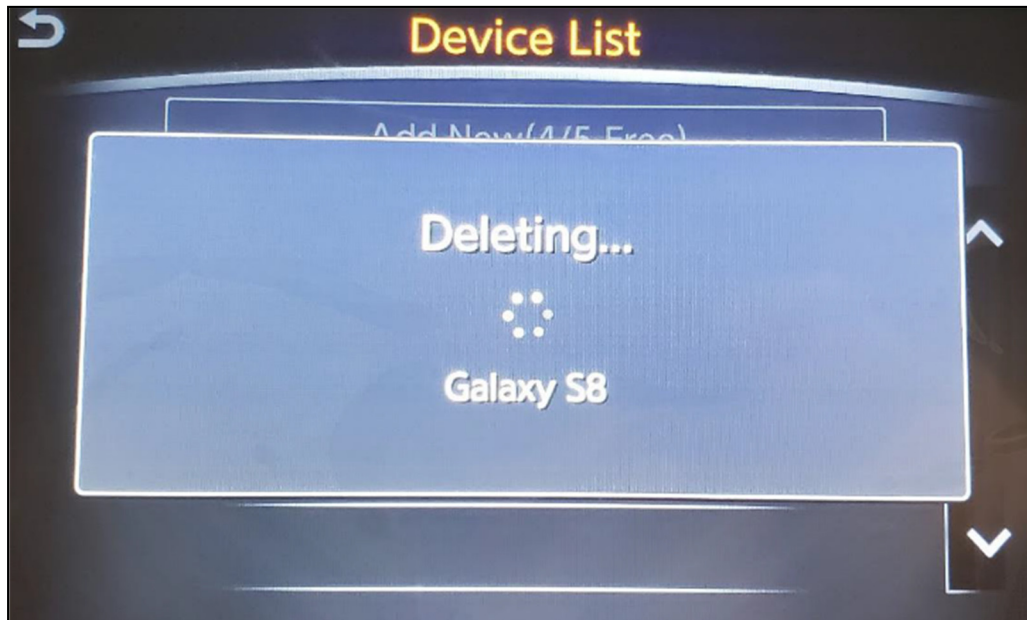
Figure 13

HINT: The following screens will be displayed while a paired device is being deleted.

- The first screen will show "Deleting..." followed by the device name.

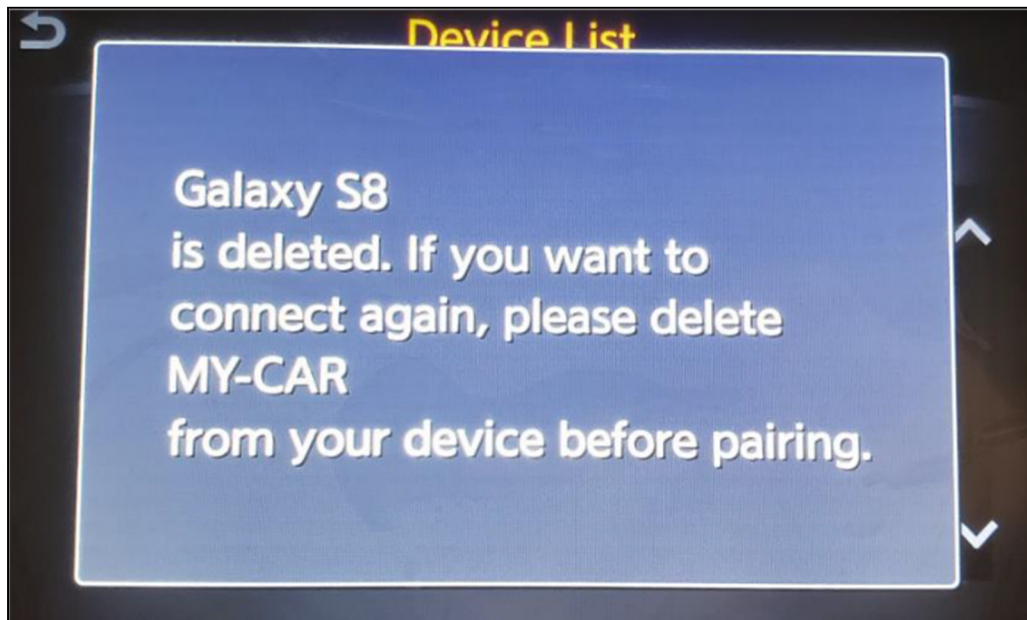
Figure 14

- The second screen will show information regarding repairing the Bluetooth® device.

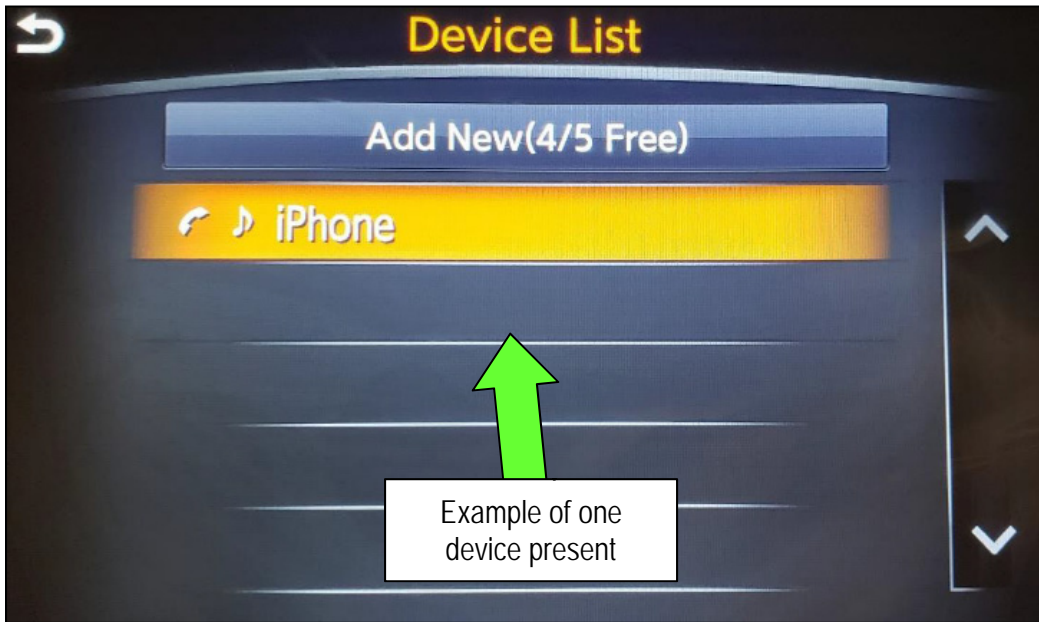
Figure 15

23. Check for additional devices in the **Device List**:

- **YES**, there are more listed devices: Perform steps 21 and 22 until all listed devices are deleted.
- **NO**, there are no listed devices: Proceed to step 24.

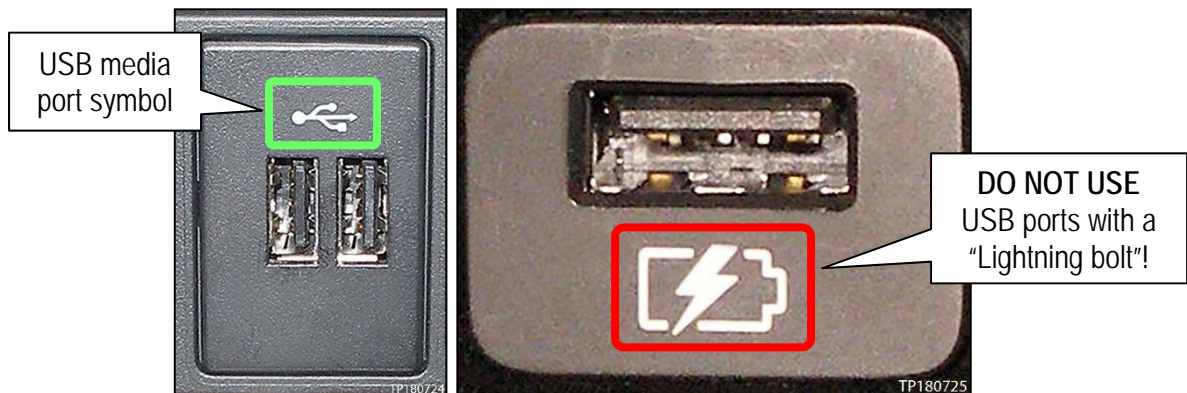
Figure 17

24. Insert the USB drive with infotainment update software into the vehicle's USB media port (see Figure 17).

HINT: Charging ports are marked in the vehicle with a "lightning bolt" symbol.

Do not insert the USB drive into a charging port. If used, the update software and/or USB drive may become damaged. Only insert the USB drive in a USB media port.

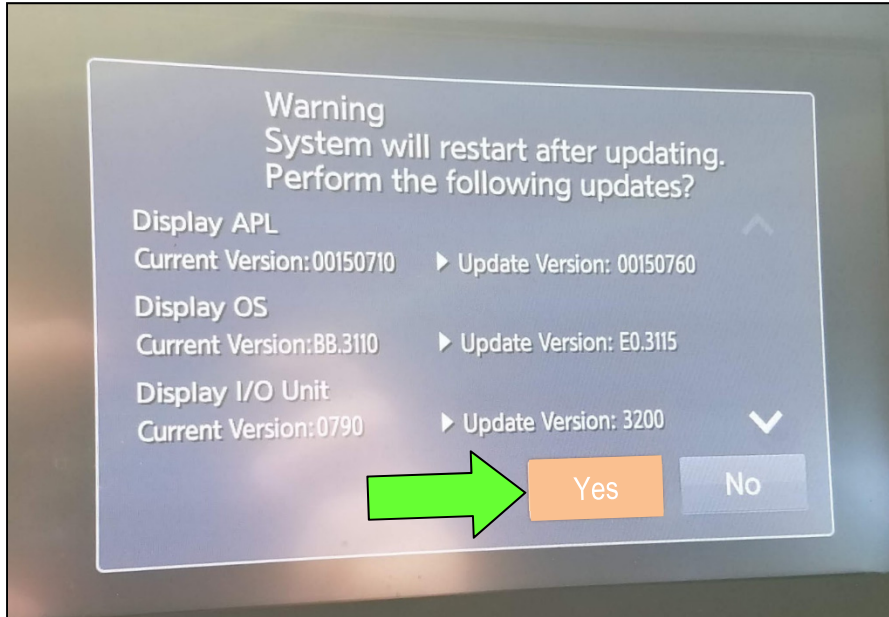
25. Wait approximately 10-30 seconds for the screen in Figure 19 or Figure 20 to appear.

- If the screen shown in Figure 19 appears, proceed to step 26 below.
- If the screen shown in Figure 20 appears, then no software update is available. Refer to ASIST for further diagnostic information.

1. To confirm an update applies to the Display Control Unit (DCU) of the vehicle being worked on, you **MUST** refer to page 4, step 8, **AND** page 14, Figure 19 in the **SERVICE PROCEDURE**.

1. Comparing the DCU part number with those listed in **Table A** on page 5,
AND
2. Verifying new software is required as shown on page 14, Figure 19.

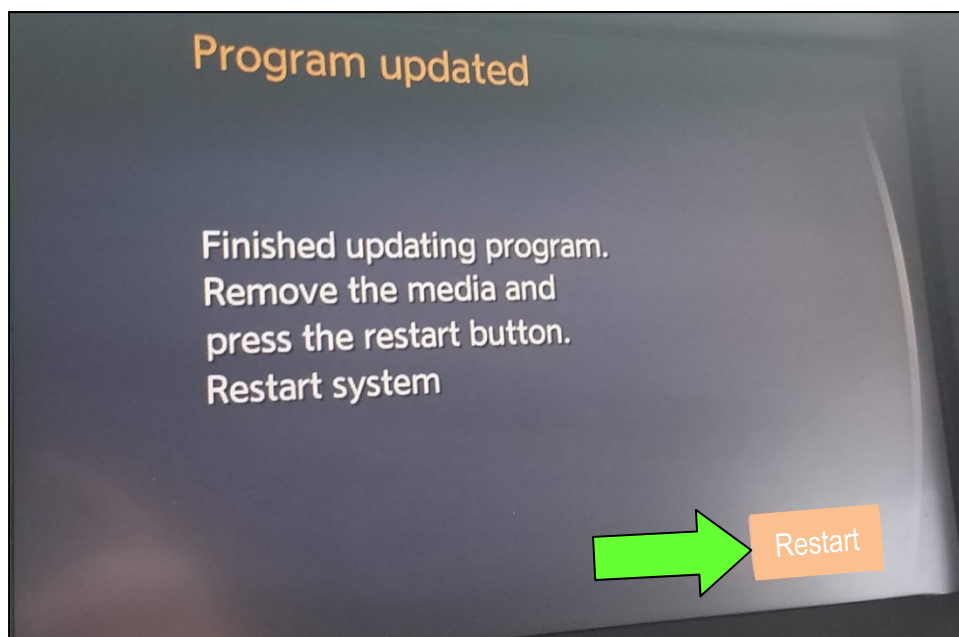
Figure 22

28. Once the update is complete, remove the USB drive, and then select **Restart**.
