Entune Audio Head Unit Software Update (Panasonic)

Service Category Audio/Visual/Telematics

Section Navigation/Multi Info Display

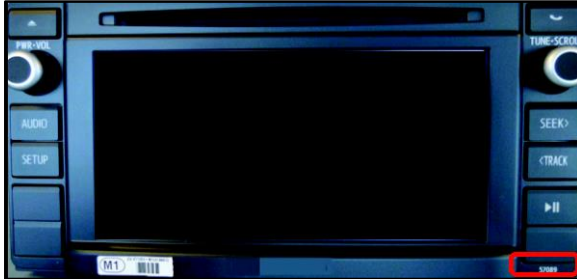
Figure 1. Avalon, Avalon HV, Highlander, Highlander HV, Prius, Prius V, Sienna, Sequoia, Tacoma, Tundra

1. Confirm the audio system type by checking the faceplate ID printed on the bottom-right or bottom-center of the head unit. See Table 1 for the applicable model faceplate ID number.

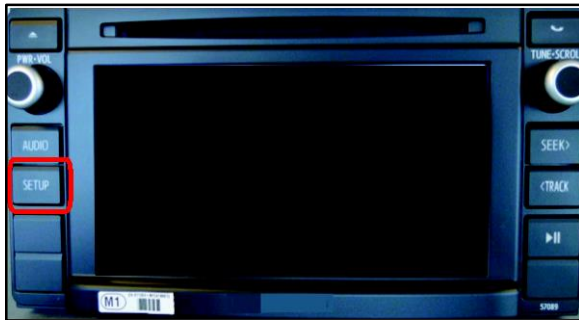
Figure 3. Tacoma, Prius, Prius V

4. Go to the Setup screen.
 - A. For Entune™ Audio: Press the Setup button on the panel.

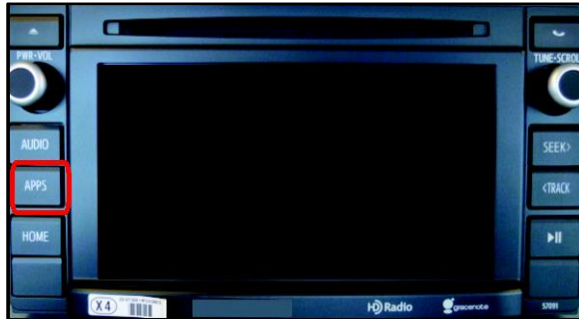
Figure 5. 4Runner, Avalon, Avalon HV, Highlander, Highlander HV, Prius, Prius V, Sienna, Sequoia, Tacoma

- B. For Entune™ Audio Plus and Entune™ Premium Audio: Press the Apps button on the panel.

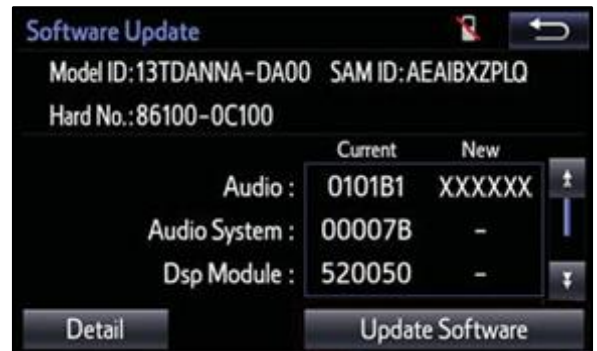
Figure 13.

9. Verify that the NEW software is up to date on the Software Update screen.

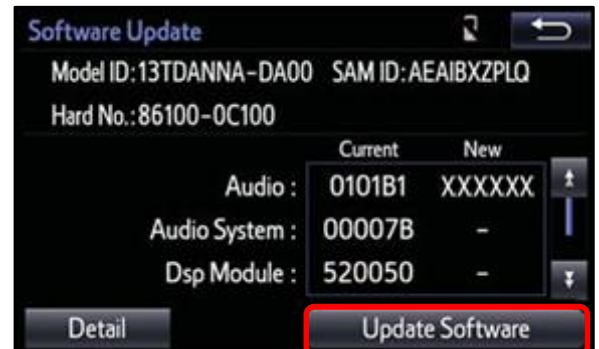
Figure 14.

- Select Update Software on the Software Update screen.

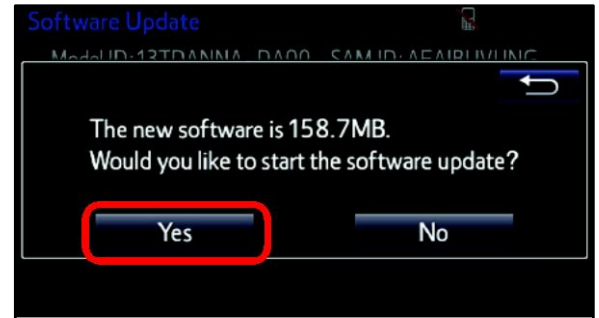
Figure 15.

11. Select Yes on the “Would you like to start the software update?” pop-up.

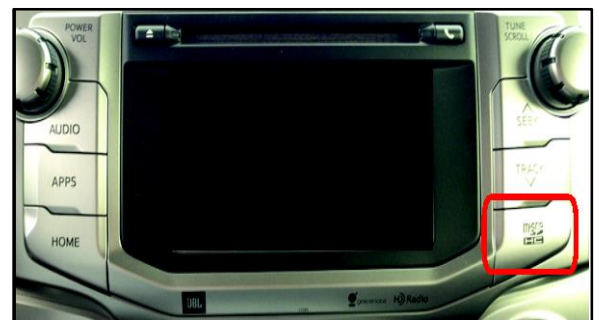
Figure 17.

- If the update fails and the error message “New software is not compatible with the system” displays, cycle the ignition OFF, remove the map micro SD card from the head unit, then repeat steps 3 – 12.
- A software update error is more likely to occur in areas with more traffic information.

Once the update is completed, reinsert the map micro SD card into the head unit, cycle the ignition OFF, then continue to step 13.

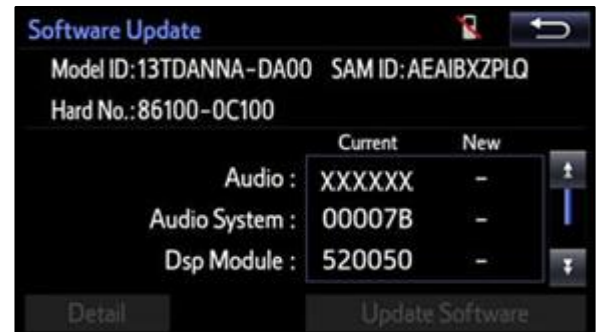
Figure 19.

- Perform steps 3 – 7 of the Software Update Procedure to re-enter the Software Update screen.
- Verify that the software information is updated on the Software Update screen. See Table 3 for the current software version.
