# Mack Chassis - Vehicles Equipped With A Vertical Selective Catalytic Reduction (SCR) System - Diagnostic Trouble Codes ( DTC ) P1031 With Possible P24DA Lighting The Malfunction Indicator Lamp ( MIL ) - US17+OBD16 (GHG17, Common Rail Fuel System) Emi

## **Mack Chassis - Particulate Matter (PM) Sensor Diagnostic Trouble Codes (DTC) Illuminating The Malfunction Indicator Lamp (MIL); Tech Tip TT-014-2016 - US14+OBD16, US17+OBD16 And Newer Emissions, Common Model Year 2017 And Newer - To Be Used For EVERY**

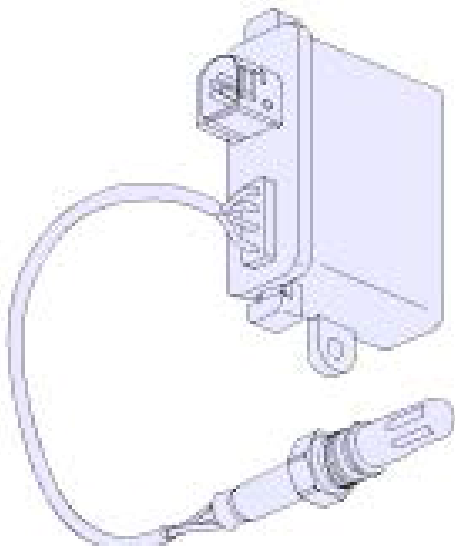
1. The PM sensor is a smart sensor (12V supply and CAN lines) **with an orientation tab as seen below:**

**Nm +/- 5 Nm**

**Installation torque of 50**

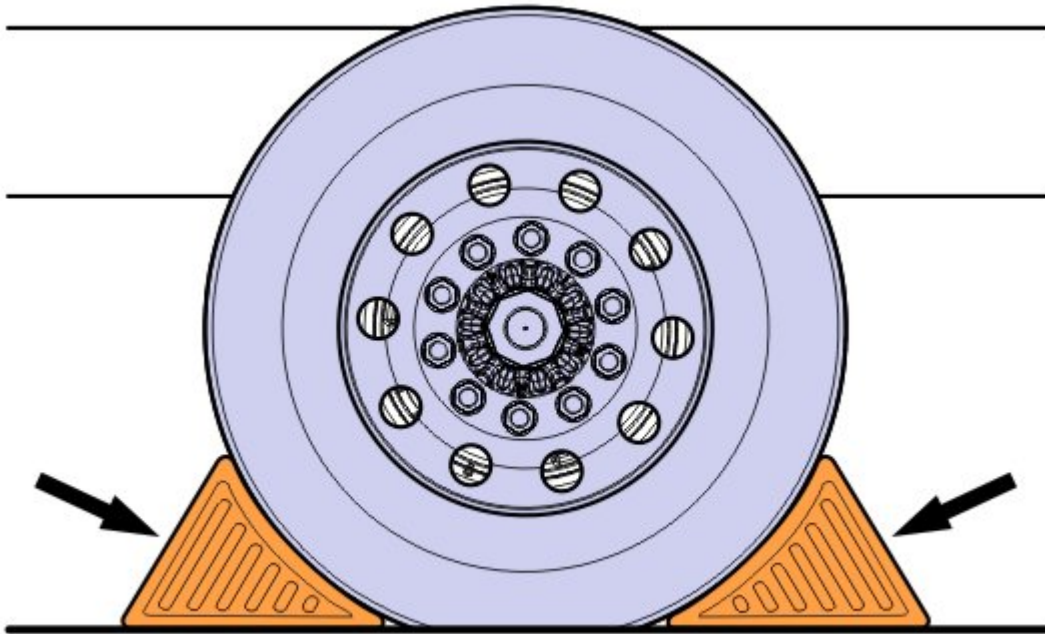
1. Park the vehicle on a level surface.
2. Apply the parking brake.
3. Place the transmission in neutral or park.
4. Install the wheel chocks.

5. Connect Premium Tech Tool (PTT) to the vehicle diagnostics connector using the 16 pin OBD cable 88890304 and Communication Interface 88890300. Connect the PC to a functional LAN or modem connection and a 120 Volt AC source.
6. Turn the ignition switch "ON".
7. Log in to PTT and Identify Vehicle is displayed.
8. Once the vehicle has been identified, enter the Work Order Number information, then click Start Work.

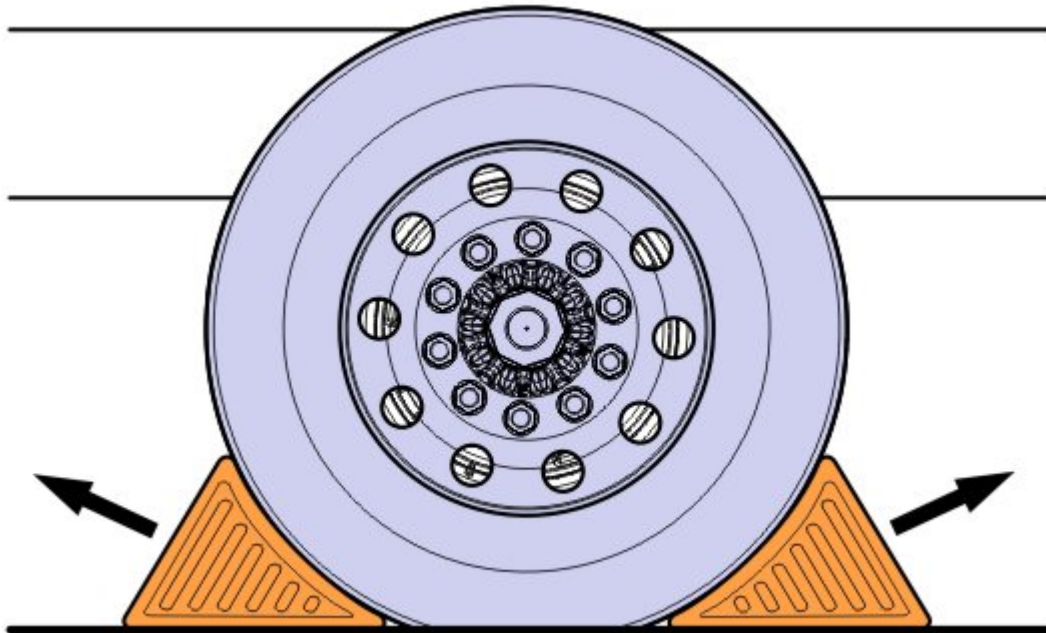
14. When programming is complete, click Exit to return to Main Menu to program the ACM.
15. When all programing is complete, clear any diagnostic trouble codes (DTC) and Finish Work.
16. Remove the wheel chocks.
