# SERVICE BULLETIN

Classification: AN16-037A	Reference: NTB16-093A	Date: March 12, 2021
------------------------------	--------------------------	-------------------------

## NAVIGATION FREEZES, BLUETOOTH CALL VOLUME FLUCTUATES, BUTTON ILLUMINATION DIM, OR USB DEVICE NOT RECOGNIZED

**APPLIED VEHICLES:** 2015-2016 Murano (Z52)  
2016 Murano Hybrid (Z52)  
2016 Maxima (A36)

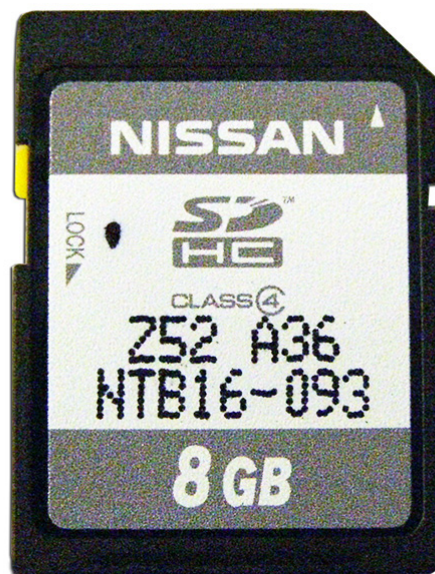
Figure A

## SD Card Information

- Each dealer has been mailed one software update SD card, free of charge, from Clarion.
- Replacement software update SD cards, due to loss or damage, can be obtained by contacting Clarion: 1-800-347-8933.

Update the Navigation system software using the SD card shown on page 2 and the Service Procedure beginning on page 3.

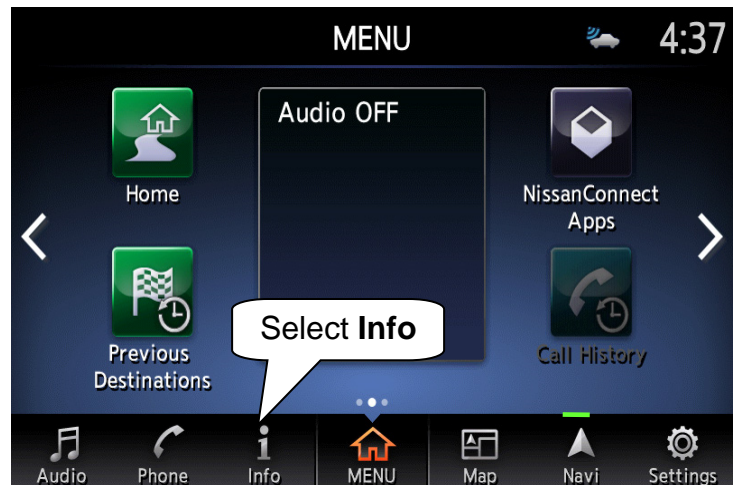
Figure 1

1. Turn the ignition to the ON position and wait for the MAP screen to display.
2. Turn the audio system OFF by pressing the volume knob.
  - If the audio system is turned ON, press the volume knob again to turn the audio system OFF.

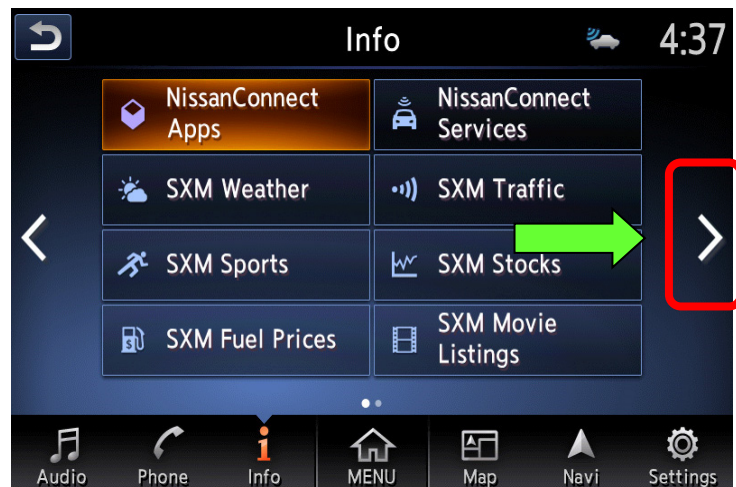
Figure 2

4. Scroll to the Info screen using the arrows (Figure 2) until **Navigation Version** (Figure 3) is available.

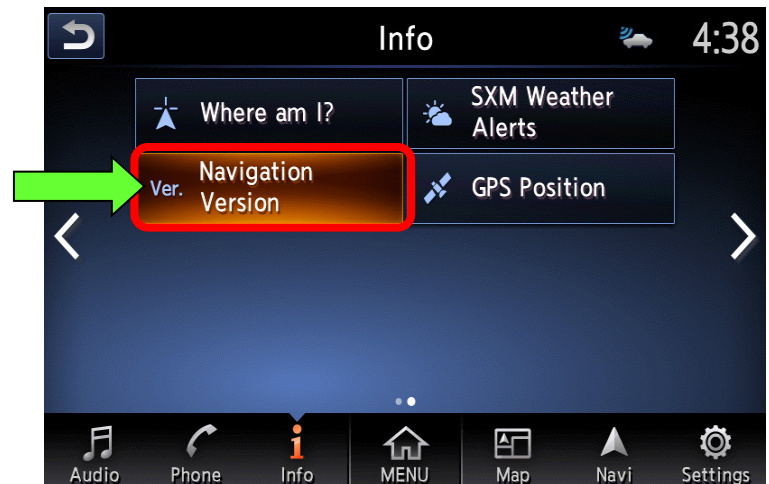
Figure 3

5. Select **Navigation Version**.

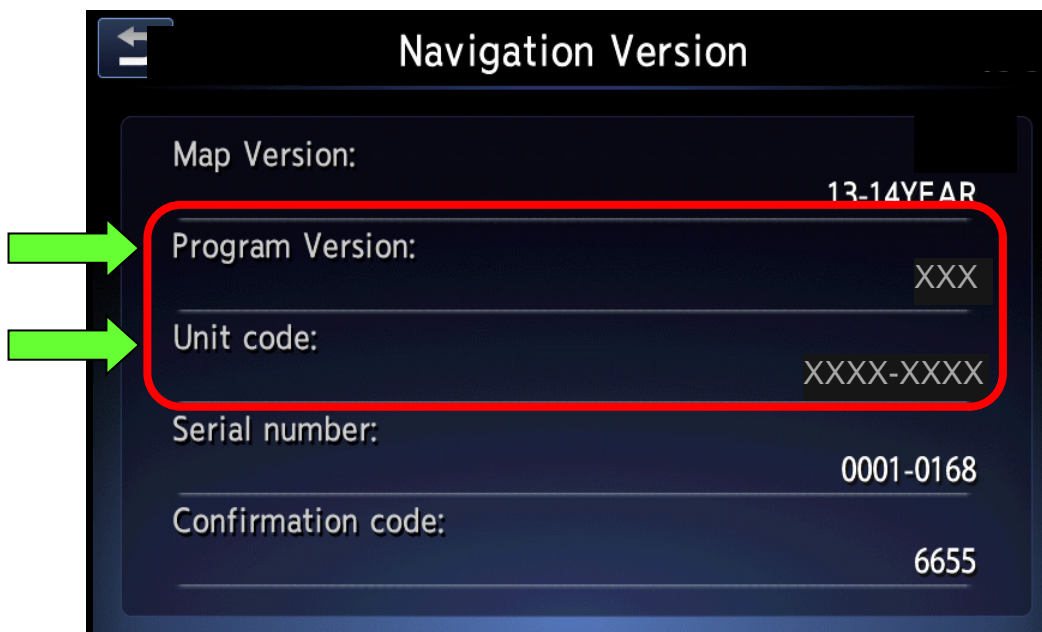
Figure 4

6. Check the **Unit code** and **Program Version** number.

For vehicles with Unit code **QY80-\*\*NA**, **QY80-\*\*NB**, or **QY80-\*\*NC**:

- A software update is needed if the Program Version is not **143**.

For vehicles with Unit code **QY81-\*\*NA** or **QY81-\*\*NB**:

For vehicles with Unit code **QY84-\*\*NA** or **QY84-\*\*NB**:

- A software update is needed if the Program Version is not **564**.

For vehicles with Unit code **QY84-\*\*NC**:

- A software update is not needed.

7. Write down the **Unit code** and **Program Version** values on the repair order and then go to page 5, AV Control Unit Software Update with Software Update SD Card.

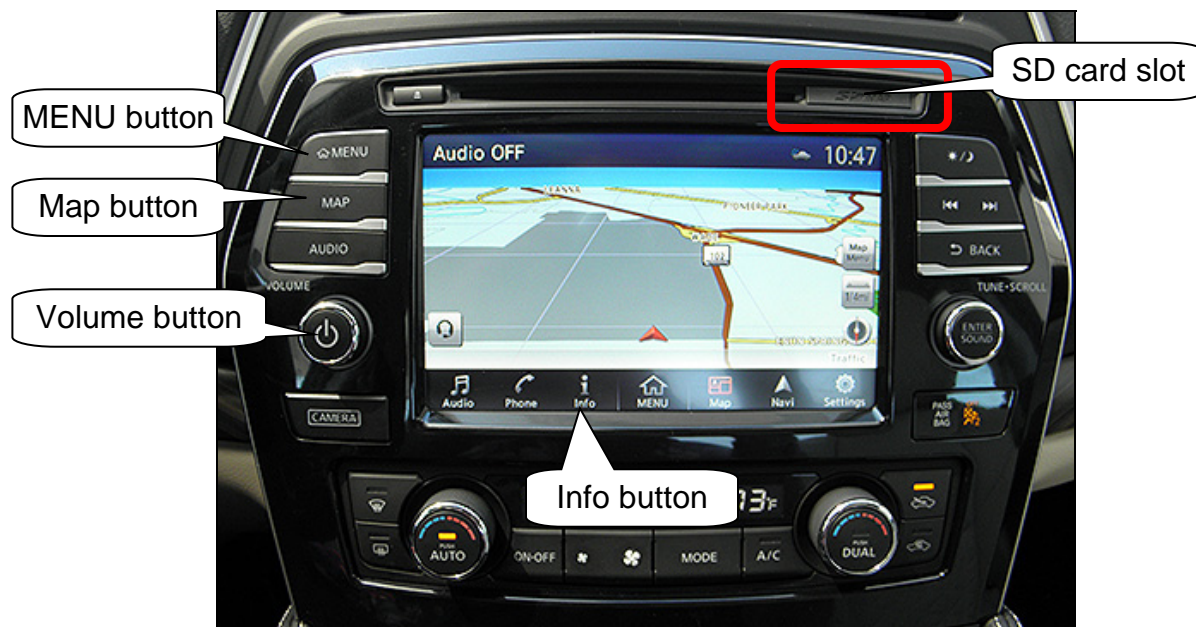
- Refer to Figure 5 below for location of controls and SD card.
- Make sure the MAP SD card (not the software update card) is inserted in the SD card slot before starting the software update procedure.

- Refer to page 5, Figure 5 for SD card location.
- The SD card slot has a small cover. To access the MAP SD card, open the cover with a suitable tool.
- Push on the MAP SD card, and then it will pop out.

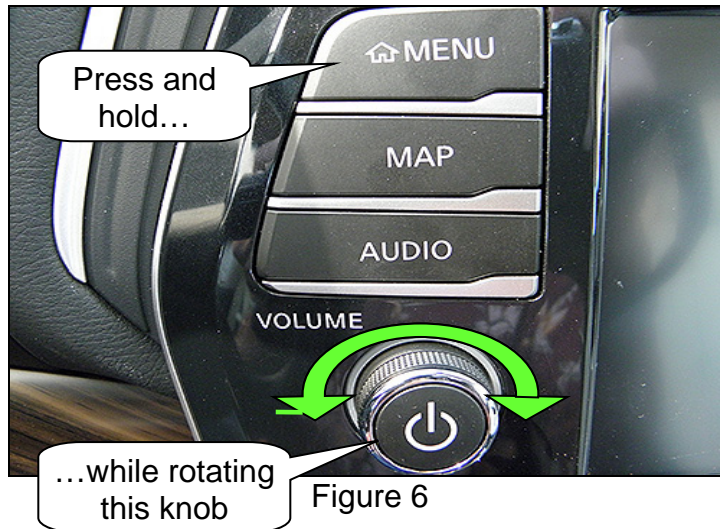
4. Enter **System Diagnostic Menu**.

- Press and hold down the MENU button and at the same time rotate the volume knob more than three clicks in each direction (back and forth) until **System Diagnostic Menu** displays.

**NOTE:** The audio system must be OFF in order to enter **System Diagnostic Menu**.

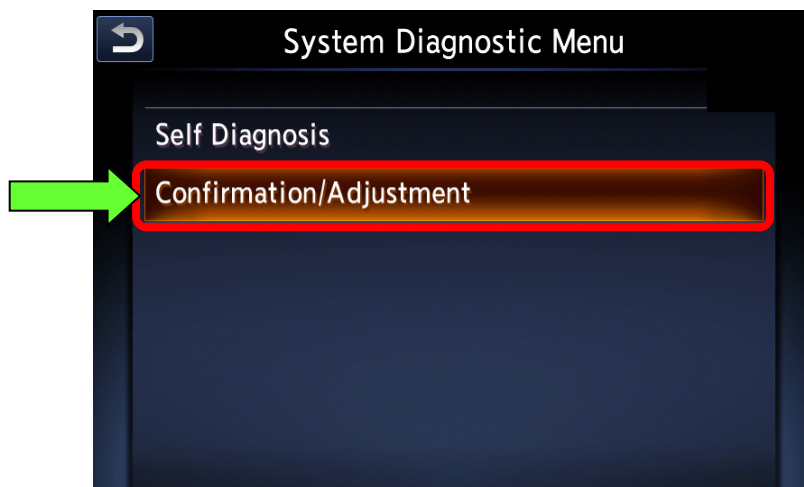
5. Select **Confirmation/Adjustment**.

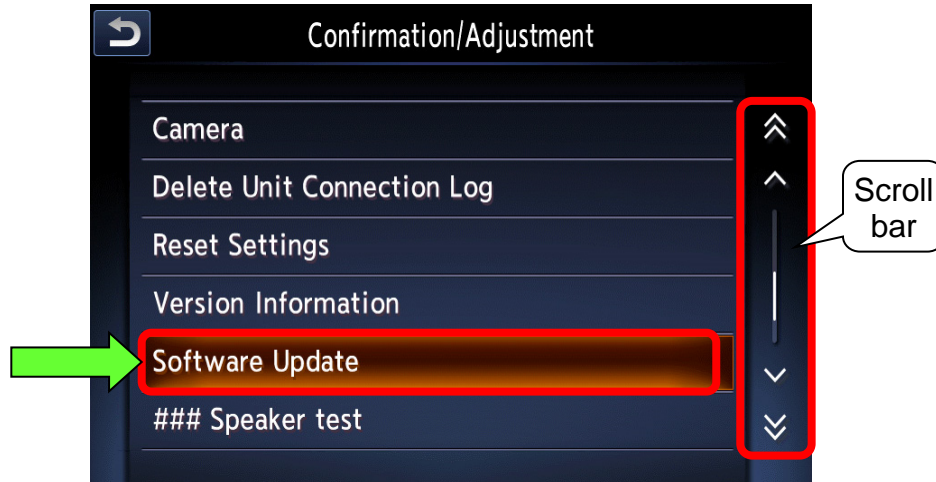
Figure 8

6. Use the scroll bar to get **Software Update** to display, and then select **Software Update**.

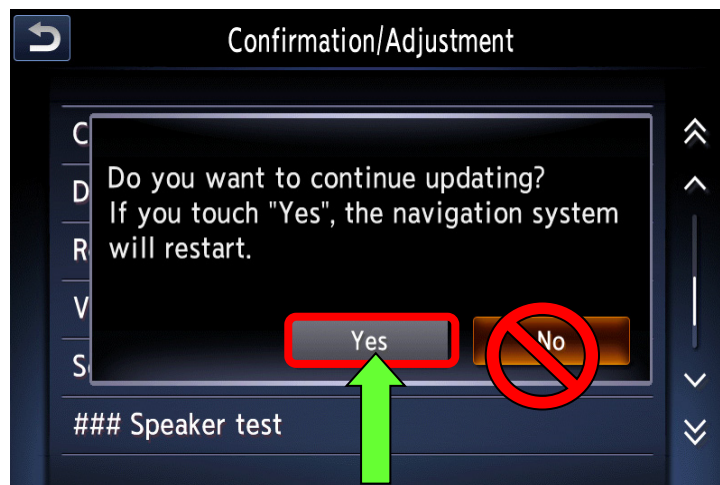
7. Once **Software Update** is selected, the message in Figure 9 will appear.
  - Select **Yes** (the system will then reboot automatically).

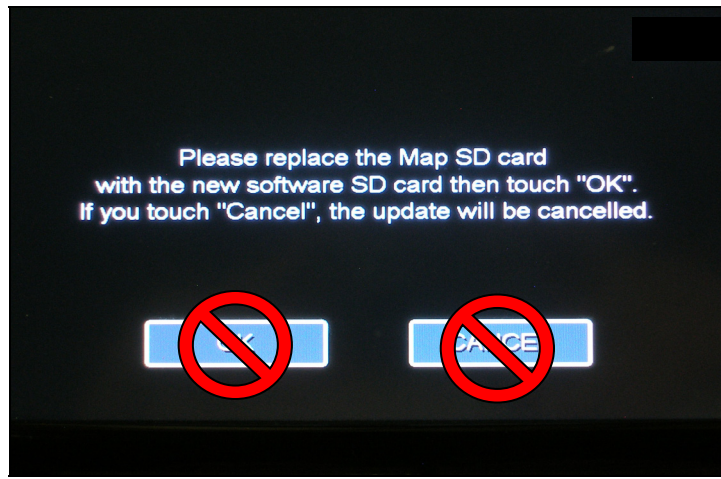
8. Rebooting has completed when the message in Figure 10 displays.

- **DO NOT select “OK” or “CANCEL”.**

**NOTE:** If the message in Figure 10 (page 8) displays instead of the message in Figure 11, above, perform step 11-13 again.

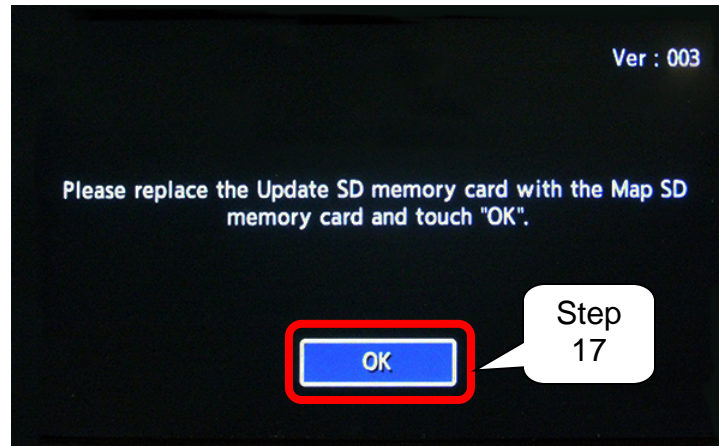
Figure 11

14. A message will display that reads:

**Please replace the Update SD memory card with the MAP SD memory card and touch "OK".**

17. Select **OK** (see Figure 11).

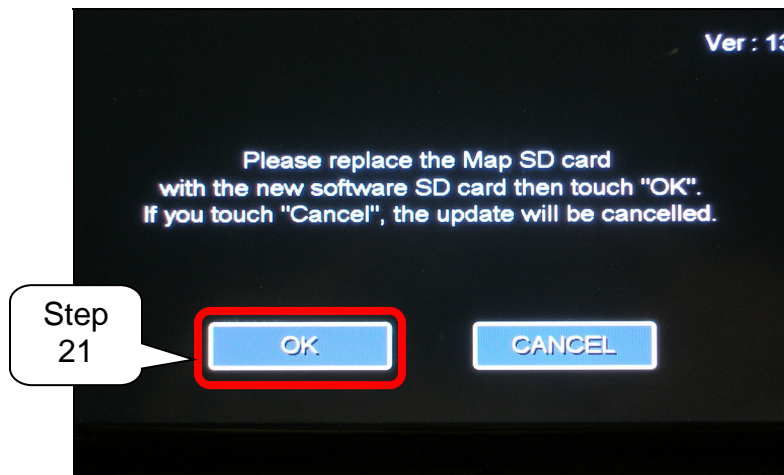
Figure 12

18. After a few seconds, a message will display that reads:

**Please replace the MAP SD card with the new software SD card then touch "OK". If you touch "Cancel", the update will be cancelled.**

21. Select **OK** (see Figure 12).

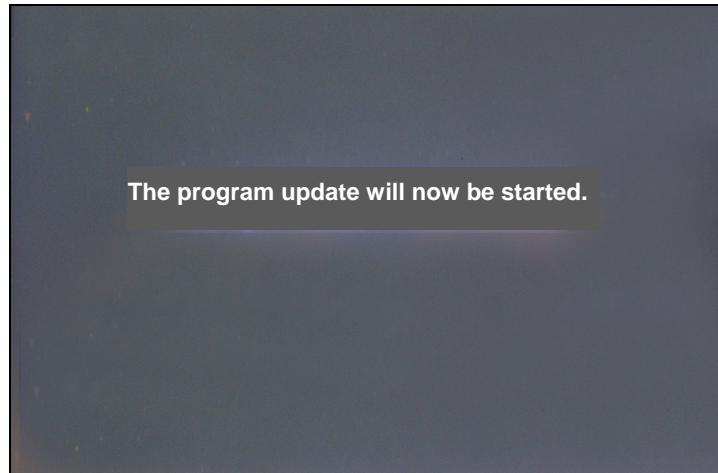
22. After selecting **OK**, a message will display that reads:

**The program update will now be started.**

23. After the screen in Figure 13 appears, a screen showing an update status progress bar will appear (see Figure 14).

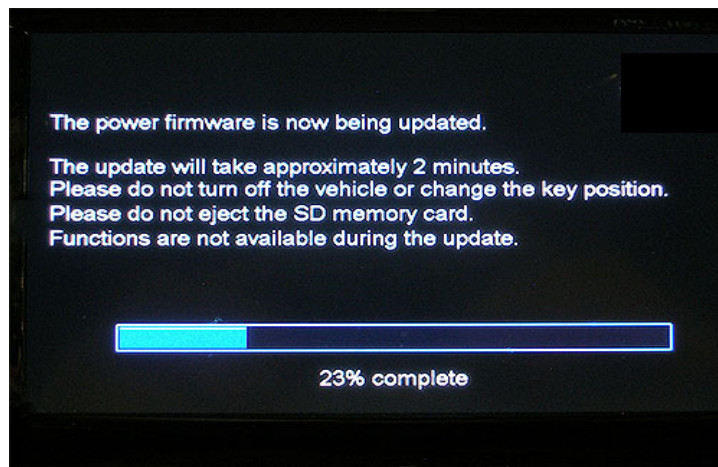
Figure 14

- The software update will take 10-20 minutes.

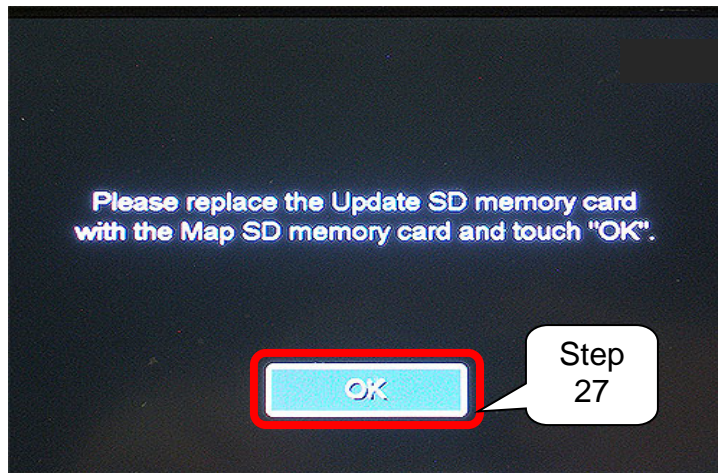
Figure 15

24. Shortly before the updating process is complete, a message will display that reads:

**Please replace the Update SD memory card with the Map SD memory card and touch "OK".**

27. Select **OK** (see Figure 15).

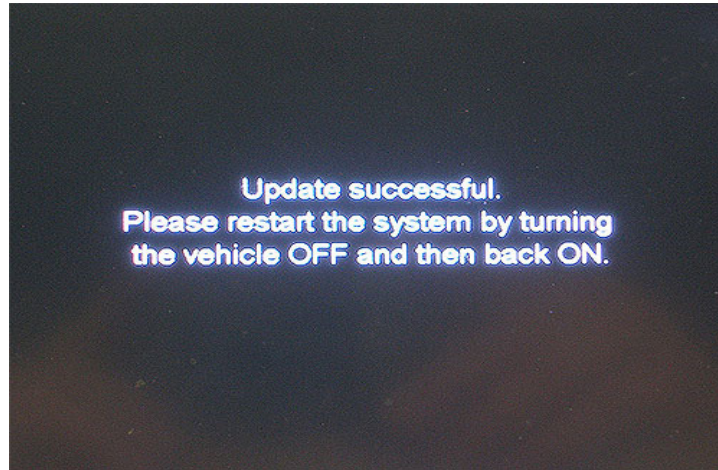
Figure 16

28. After a few minutes, a message will display that reads:

**Update successful. Please restart the system by turning the vehicle OFF and then back ON.**
