SERVICE BULLETIN

| Classification: AN17-009A | Reference: NTB17-024A | Date: March 17, 2021 |

NAVIGATION SYSTEM REBOOTS WHEN SXM TRAFFIC IS ENABLED

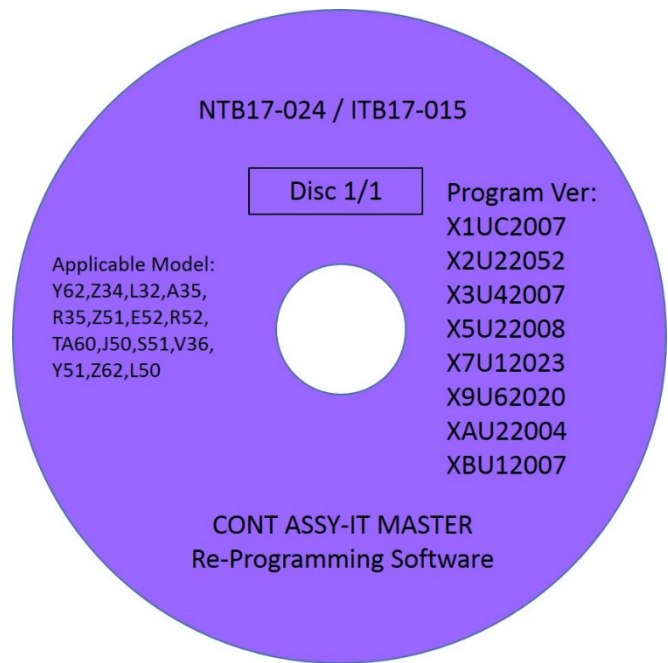
Figure A

Re-programming software DVD required for this procedure:

Update the Navigation system software using the DVD shown on page 2.

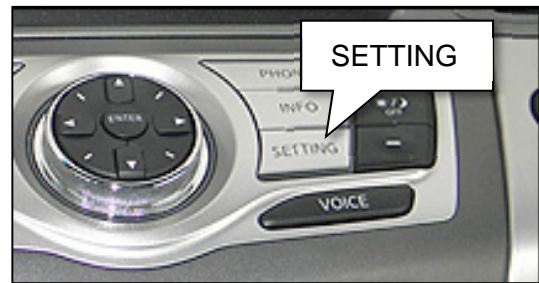
Figure 1

a. Press the **SETTING** button.

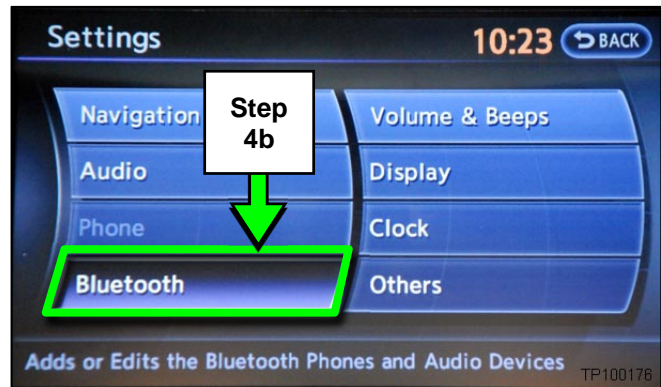
Figure 2

b. Select **Bluetooth**.

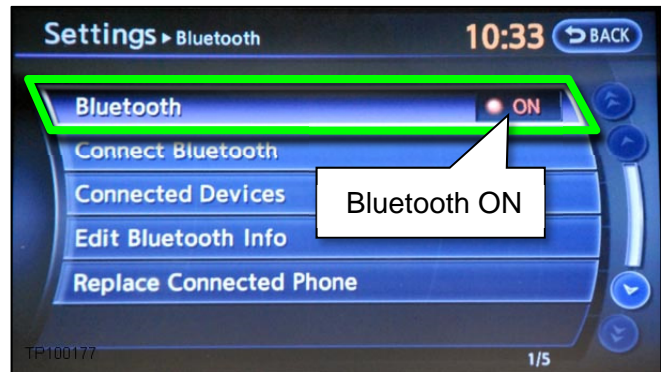
Figure 3

c. Take note of the current setting (ON or OFF) for Bluetooth. See Figures 3 and 4.

- This preference will need to be reset in a later step.
- Bluetooth is ON when the ON indicator displays in orange.
- Bluetooth is OFF when the ON indicator is "grayed" out.

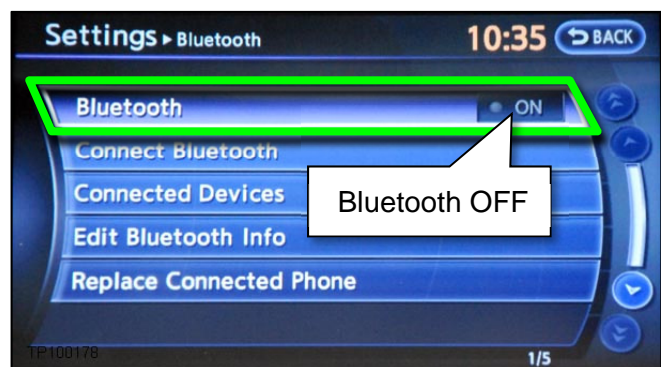
Figure 4

d. Make sure Bluetooth is OFF.

- Selecting **Bluetooth** will change the setting from ON to OFF or OFF to ON.

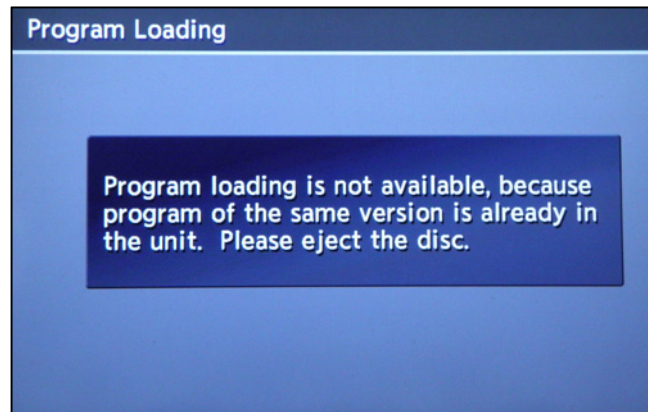
- If the screen in Figure 5 is displayed:
 - Remove the DVD from the CD slot.
 - Proceed to step 15 on page 7.

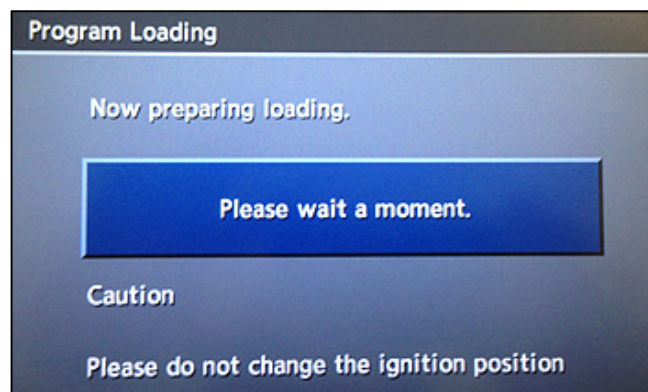
- If “Now preparing loading” shown in Figure 6 is displayed, follow the on screen Caution while the Navigation is updated.

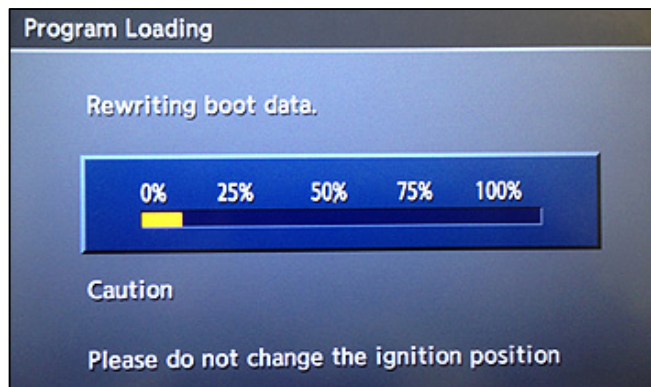
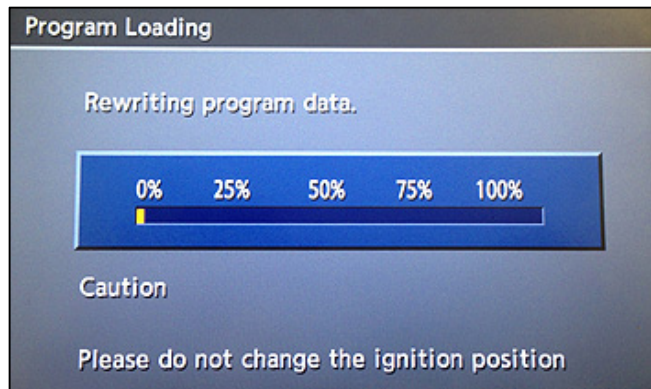
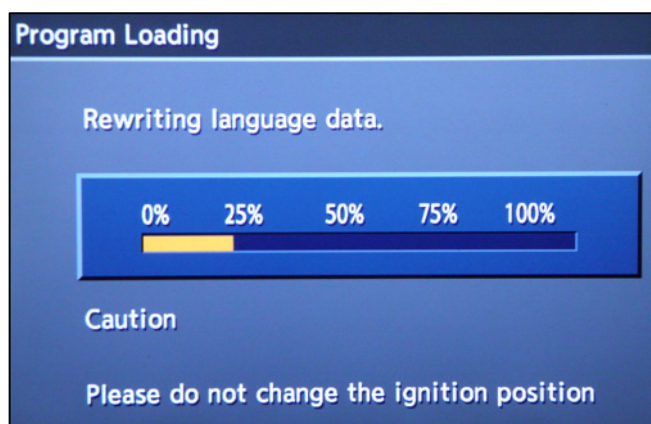
- Rewriting boot data (Figure 7)
- Rewriting program data (Figure 8)
- Rewriting language data (Figure 9)

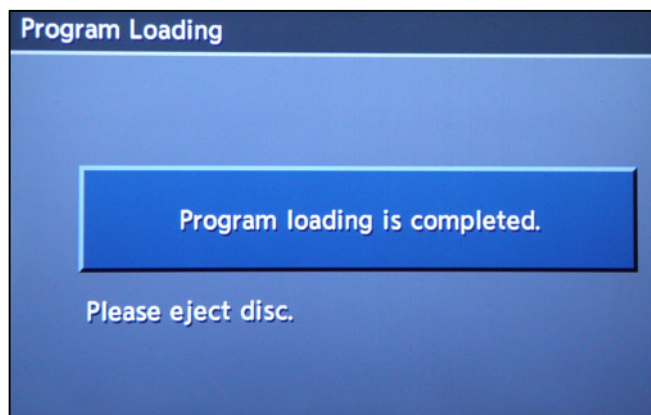
Figure 10

- “Program loading is completed” will be displayed (Figure 10).
- The Re-programming Software DVD will automatically eject.

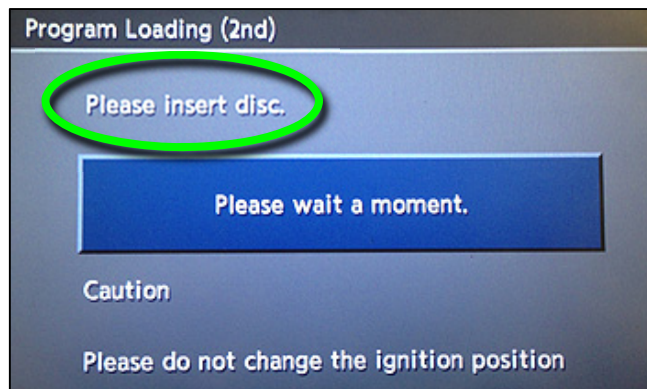
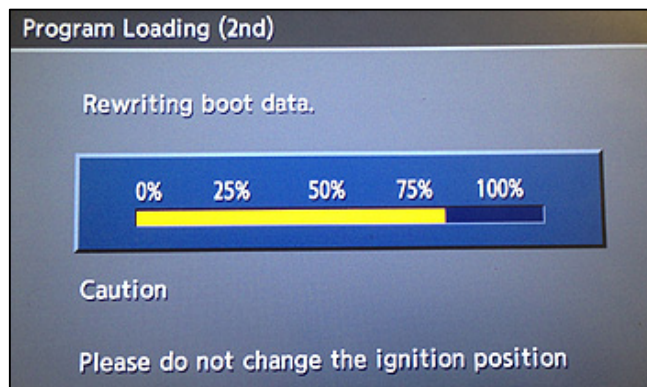
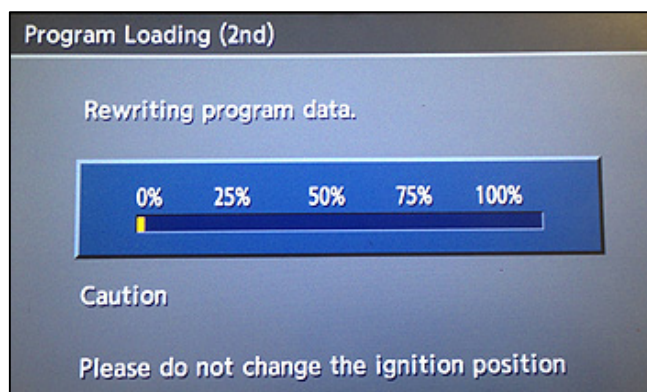
11. “Rewriting boot data” and “Rewriting program data” will be displayed once the DVD is reinstalled.

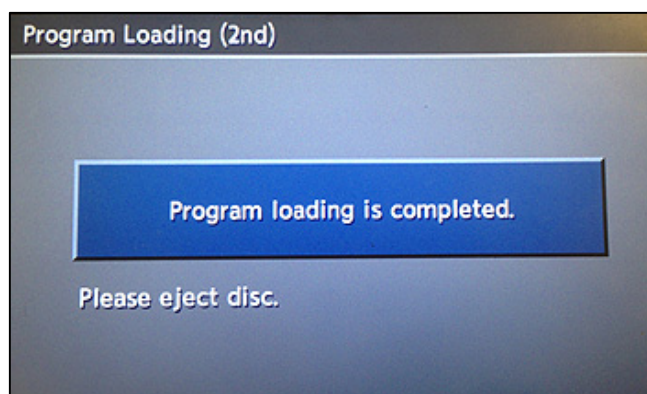
Figure 14

- “Program loading is completed” will be displayed (Figure 14).
- The Re-programming Software DVD will automatically eject.
- The Navigation system will restart.

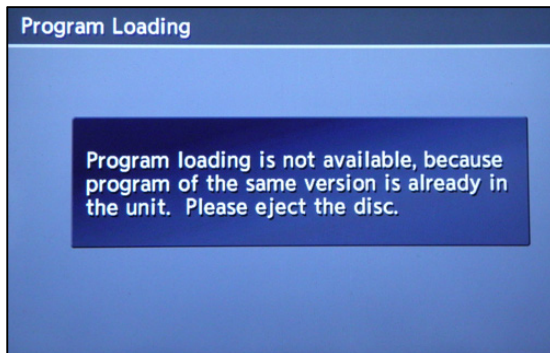
13. To confirm that the Navigation version has been successfully updated, load the DVD into the CD slot again.
 - If Figure 15 is displayed:
 - The re-program has been completed. Proceed to step 14.
 - If Figure 16 is displayed:
 - Allow the update to complete (steps 7-12) and follow the on screen instructions, then perform step 13 to confirm the re-program has completed.

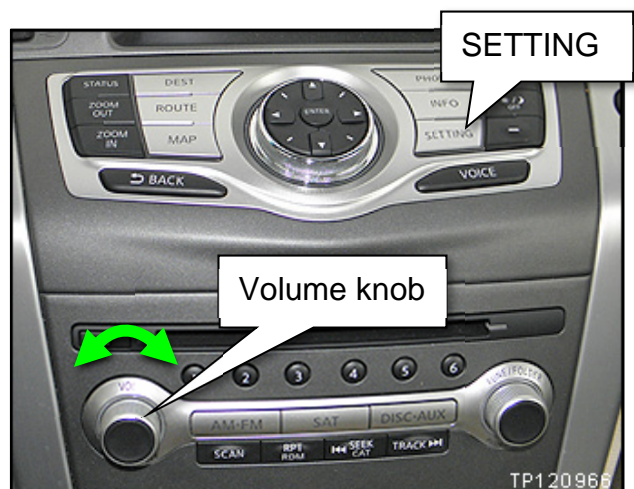
Figure 17

15. Turn the audio system OFF.
16. Put the AV system into System Diagnostic Mode as follows:
 - a. Press and hold the **SETTING** button.
 - b. While holding the **SETTING** button, turn the volume control knob right and left several times.
 - When the system goes into the System Diagnostic Menu, the screen in Figure 18 on the next page will display.

Your vehicle may look different

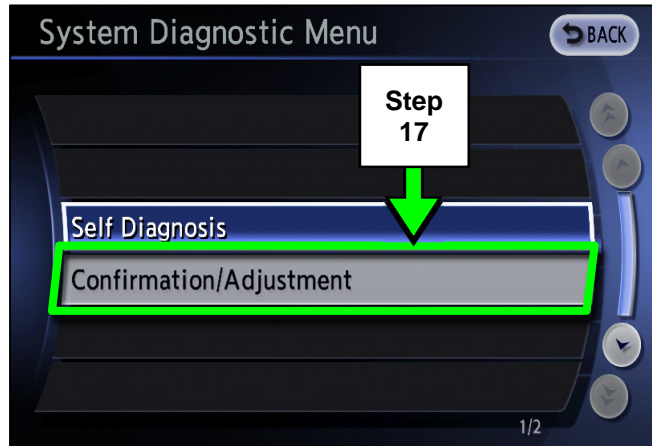
Figure 18

17. Select **Confirmation/Adjustment**.

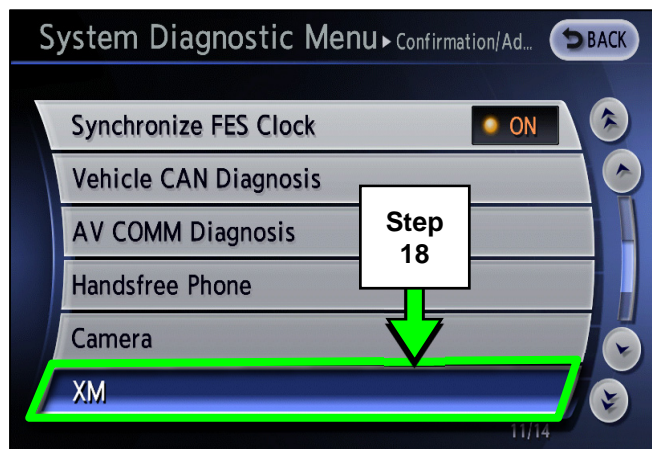
Figure 19

18. Select **XM**.

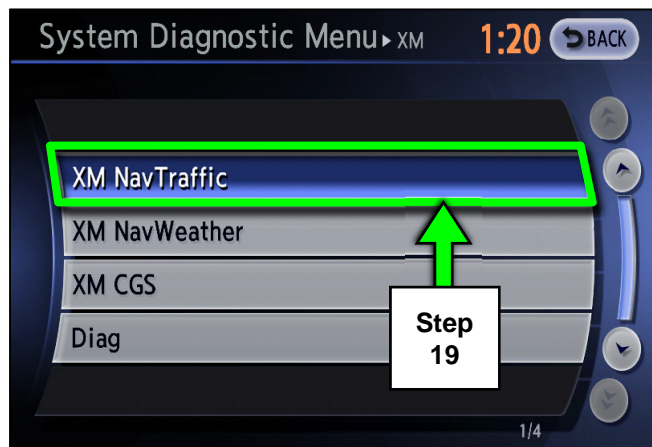
Figure 20

19. Select **XM NavTraffic**.

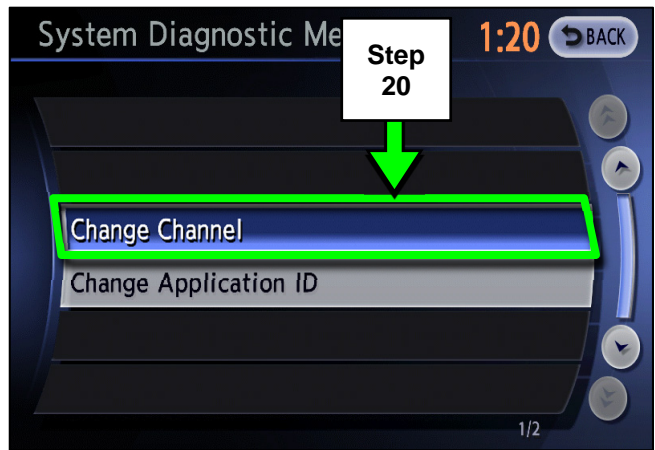
Figure 21

- 20. Select **Change Channel**.

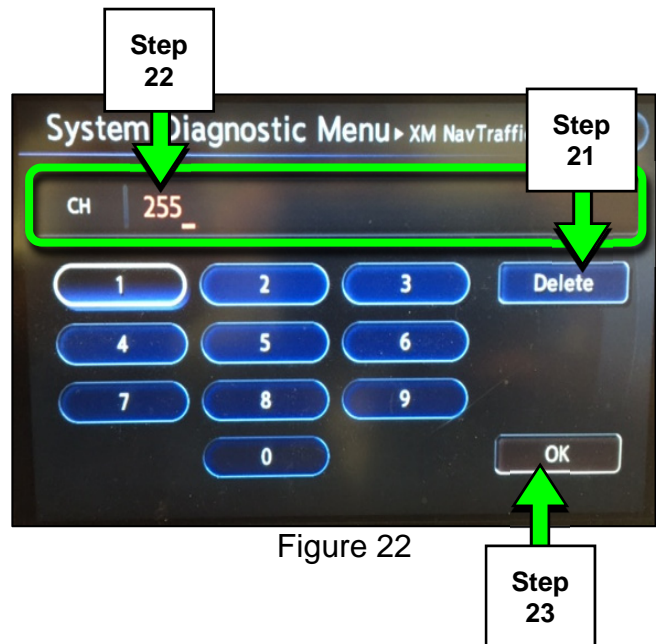
Figure 22

- 21. Press **Delete** until all numbers entered in the "CH" field are erased.

- 22. Enter "**255**".

- 23. Select **OK**.

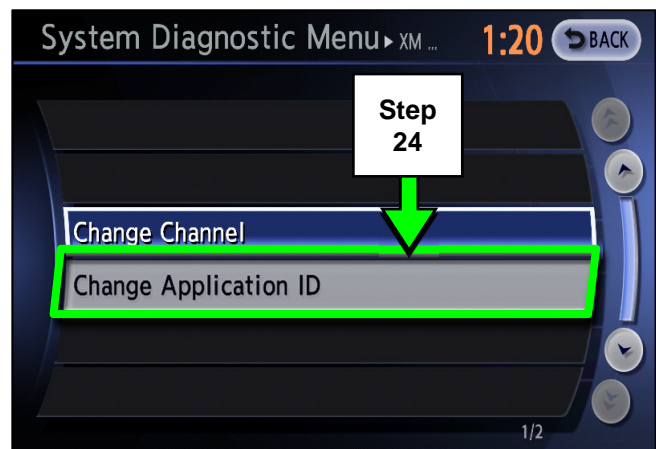
Figure 23

- 24. Select **Change Application ID**.

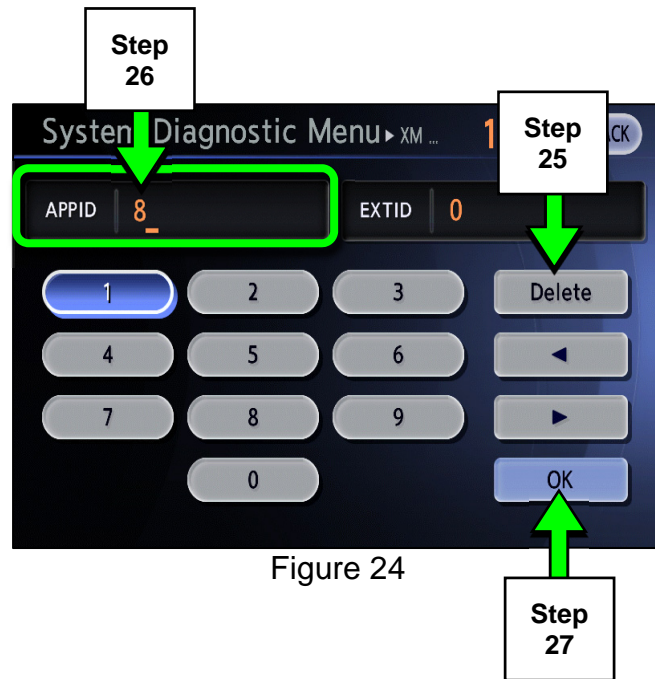
Figure 24

25. Press **Delete** until all numbers entered in the “APPID” field are erased.

26. Enter “8” into the APPID field.

27. Select **OK**.

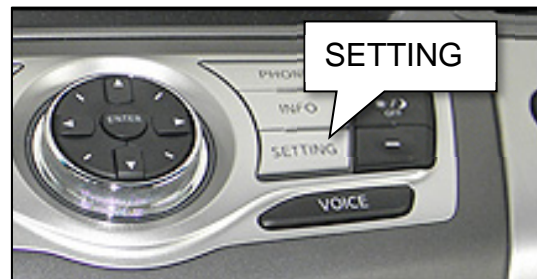
Figure 25

a. Press the **SETTING** button.

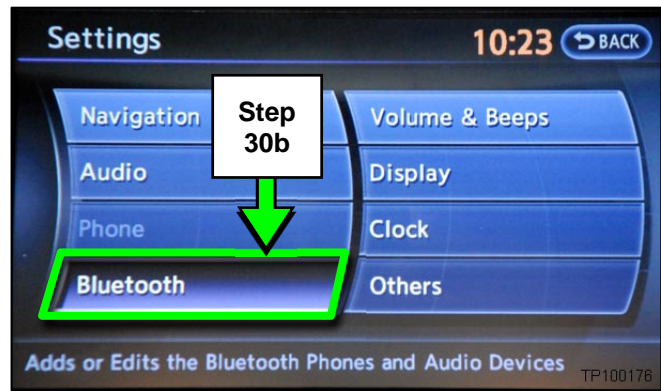
Figure 26

b. Select **Bluetooth**.

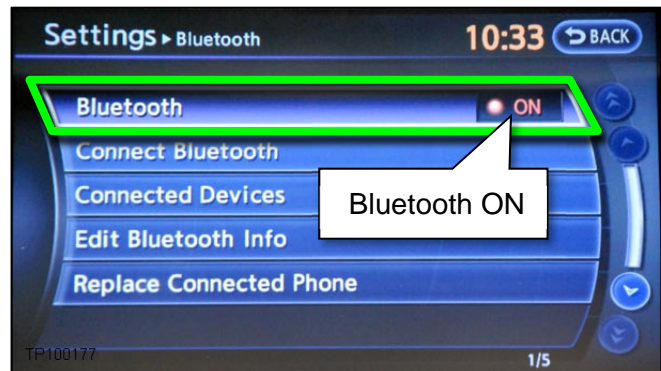
Figure 27

c. Select **Bluetooth** to change the setting to ON.

- Bluetooth is ON when the ON indicator displays in orange.
