GROUP Product Improvement	MODEL 2010-2011MY Forte/Forte Koup (TD) w/2.4L MPI
	NUMBER PI2102	DATE April 2021
PRODUCT IMPROVEMENT CAMPAIGN		
SUBJECT: THETA 2.4L MPI - KNOCK SENSOR DETECTION SYSTEM (KSDS) ECU LOGIC IMPROVEMENT (PI2102)

SUBJECT: THETA 2.4MPI - KNOCK SENSOR DETECTION SYSTEM (KSDS) ECU UPGRADE (PI2102)

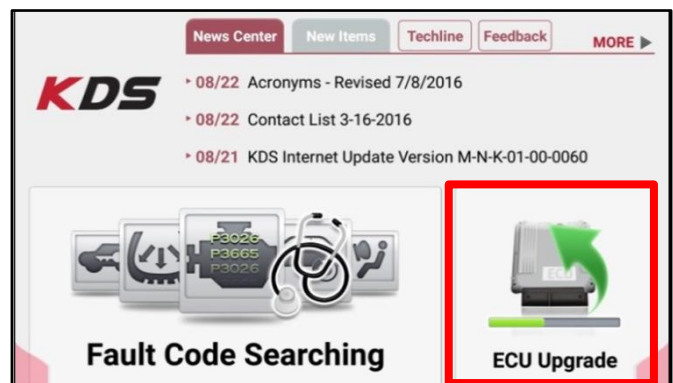
4. Select **ECU Upgrade**.

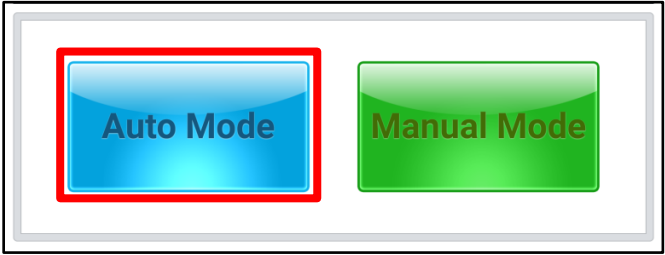
- Select **Auto Mode**.

CAUTION
 Do NOT attempt to perform a Manual Mode upgrade UNLESS Auto Mode fails. Always follow the instructions given on the KDS in either Auto or Manual mode.
