Service Action

Code: 69BS

Subject Front Passenger Seat Belt Load Limiter Software

Release Date April 16, 2021

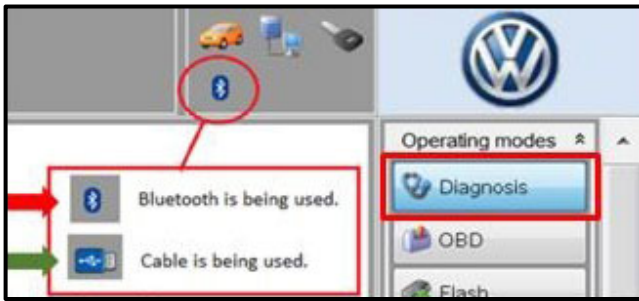
- Confirm that scan tool is communicating with the diagnostic head by USB <Green Arrow>.
 - If the Bluetooth symbol is shown <Red Arrow> then disconnect the diagnostic head from the vehicle and reconnect the USB cable to the diagnostic head and then reattach to the vehicle.
- Upon ODIS startup, verify the “Diagnosis” operating mode is selected <as shown>.

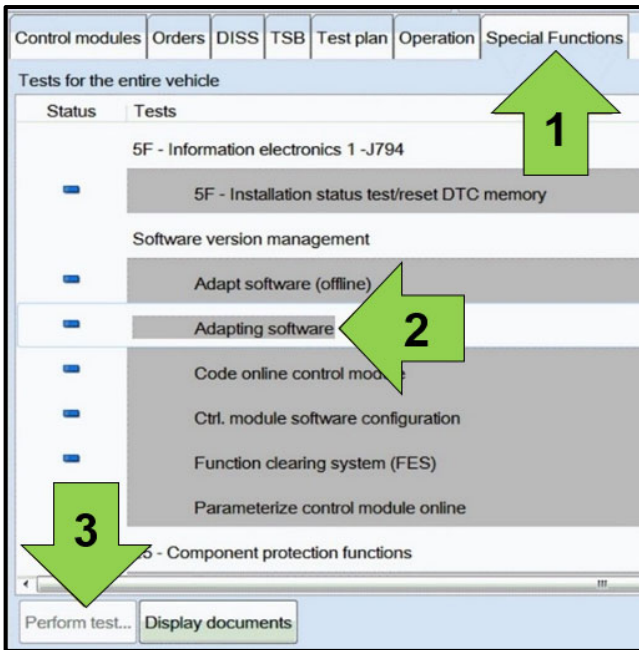
- Once the GFF scan is complete, select “Special functions” <arrow 1>, then “Adapting software” <arrow 2>, then select “Perform test” <arrow 3>.

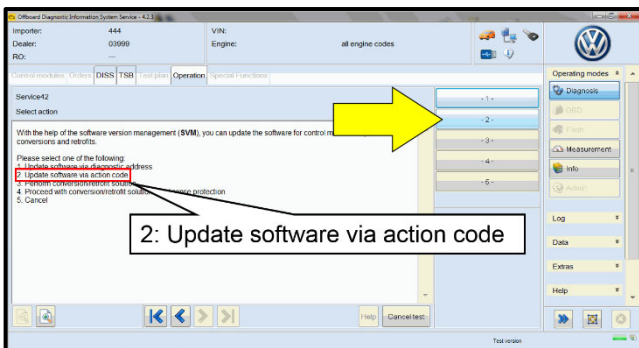
- Select the correct option to “Update software via action code” OR “Software update via measured code”.

NOTE
The different options to perform the SVM operation may vary based on model.

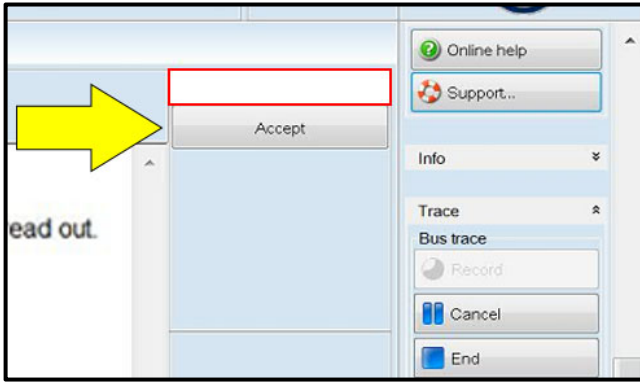
SVM code
457C

- Select “Accept” <arrow> and follow the on screen prompts.
- During the SVM process, this screen appears when each operation is performed.

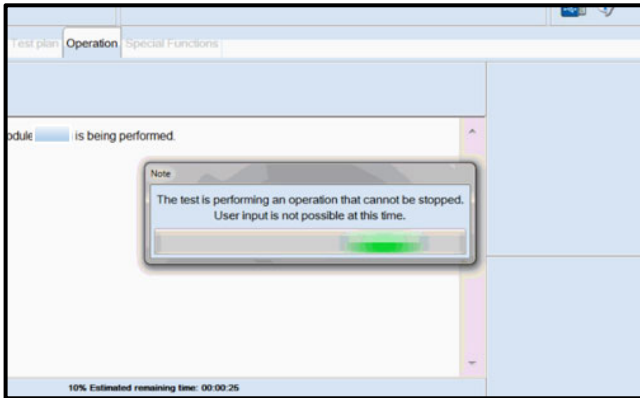
- Select Complete/Continue <arrow> after each operation is completed.

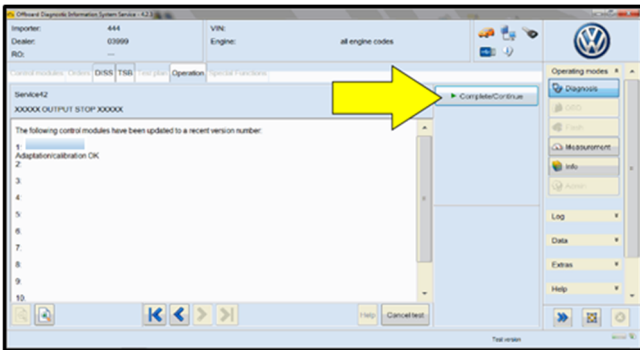
- When the SVM update is complete a confirmation message is displayed <as shown>.
- Select “Complete/Continue” <arrow>.

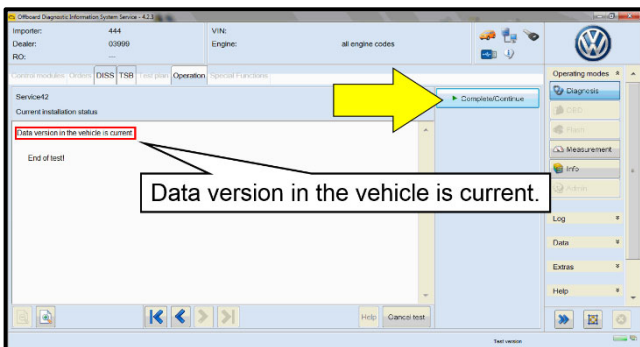
If the software in the vehicle is already current, a message may appear indicating this. If this occurs, complete the ODIS test plan and send the diagnostic protocol online.

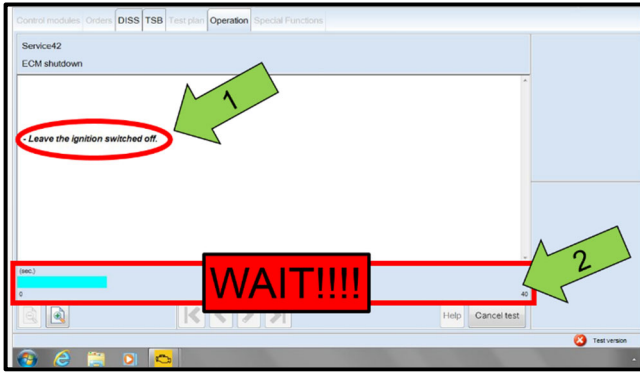
- It is **IMPERATIVE** that **ALL** of the ignition cycle on/off delay requests are fulfilled in their entirety during this SVM process <arrow 1>.
- Failing to wait for the ignition on/off timing cycle to complete (progress bar and countdown timer <arrow 2>) before cycling the ignition on/off **MAY** damage a control module.
- Damage to control modules as a result of failing to wait the specified time displayed by the progress bar and countdown timer <arrow 2> are **NOT** covered under this action.

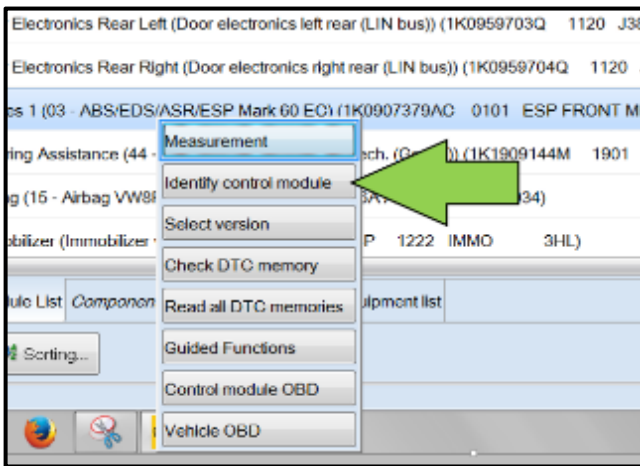
- After the software update is completed and before sending the GFF Log Online:
 - Select the “Control Module” tab.
 - Scroll down and right click on the module that was updated (0015).
 - Select “Identify Control Module” <arrow>.
