MODEL
2016-2017MY
Soul (PS EV)

NUMBER
238

TECHNICAL SERVICE BULLETIN

SUBJECT: SERVICE ACTION: BMS/FATC OPERATION LOGIC IMPROVEMENT WHILE BATTERY CHARGING (SA473)

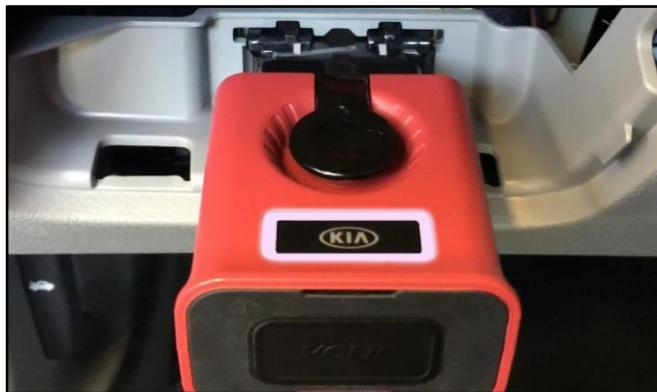
The ECU upgrade function on KDS operates wirelessly. It is not necessary to perform the upgrade via USB cable.

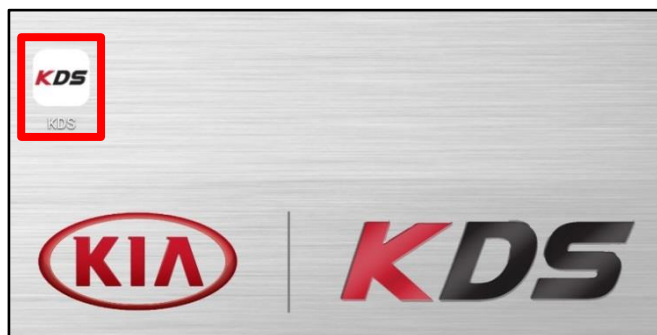
2. With the ignition ON, turn ON the KDS tablet. Select **KDS** from the home screen.

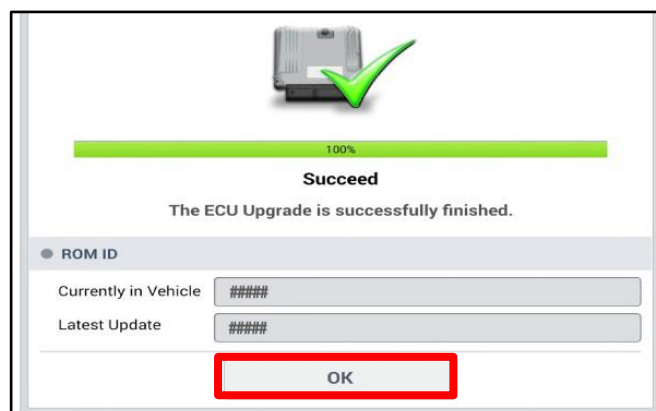
12. When prompted, select **YES** to check for Diagnostic Trouble Codes (DTC) and erase any DTCs stored such as EPS, ESC, and TPMS that may have been set during the upgrade.

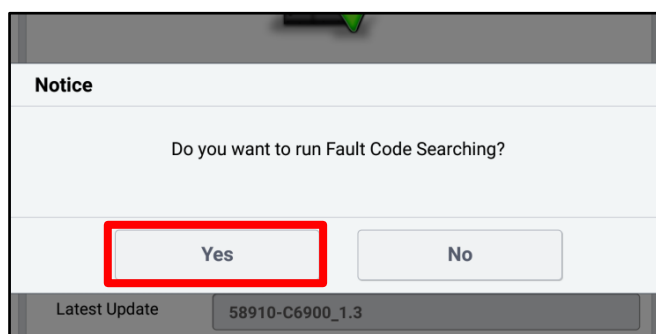
13. Start the engine to confirm proper operation of the vehicle.
