# Service Bulletin

Bulletin No.: 20-NA-119

**Subject: Radio Software Version 34.9.2 and 46.1.6**

Brand:	Model:	Model Year:		Breakpoint:		Engine:	Transmission:
		from	to	from	to		
Chevrolet	Bolt EV	2019	2020	SOP	Built Prior to February 5, 2020	All	All

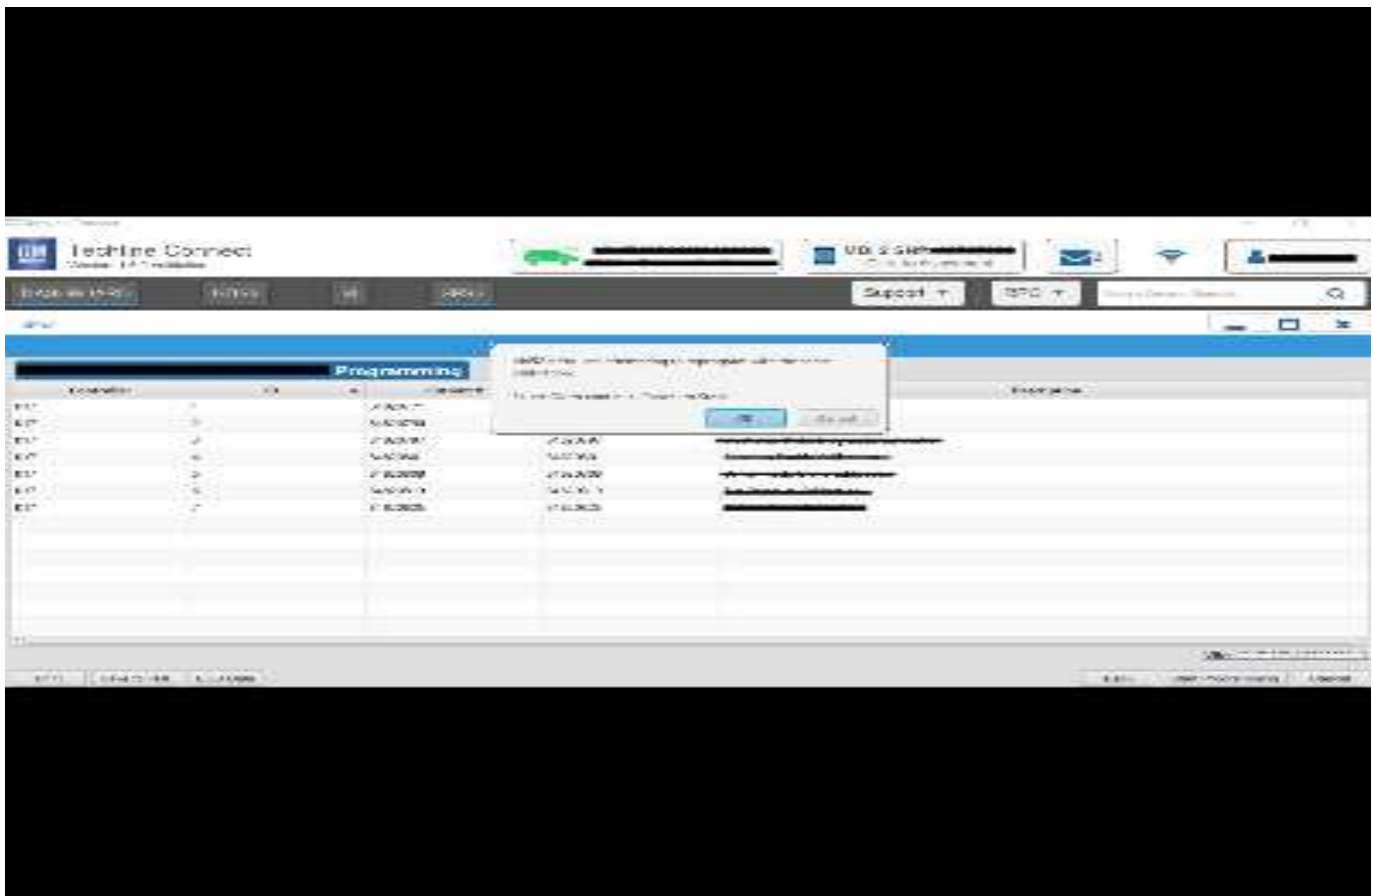
5644477

**Important:** Techline Connect and TIS2WEB screens shown above.

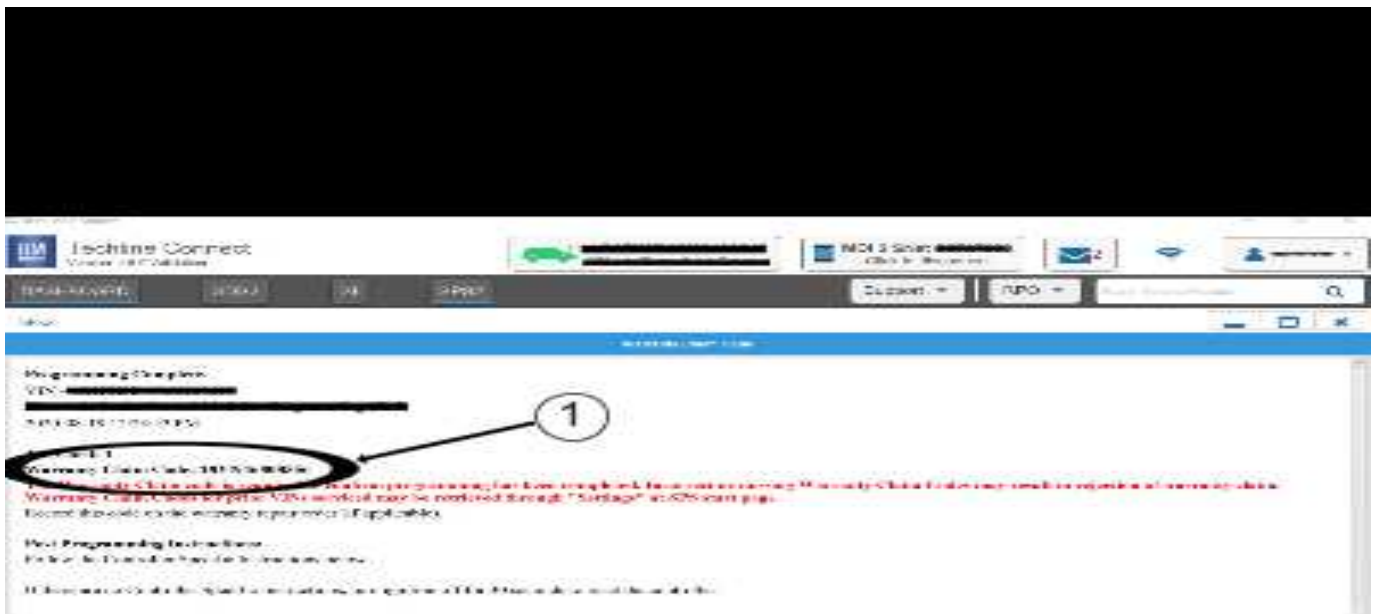
5644478

**Note:** The screenshots above are an example of module programming and may not be indicative of the specific module that is being programmed. Module selection and VIN information have been blacked out.

**Important:** To avoid warranty transaction rejections, you **MUST** record the warranty claim code provided on the SPS Warranty Claim Code (WCC) screen shown above on the job card. Refer to callout 1 above for the location of the WCC on the SPS screen.

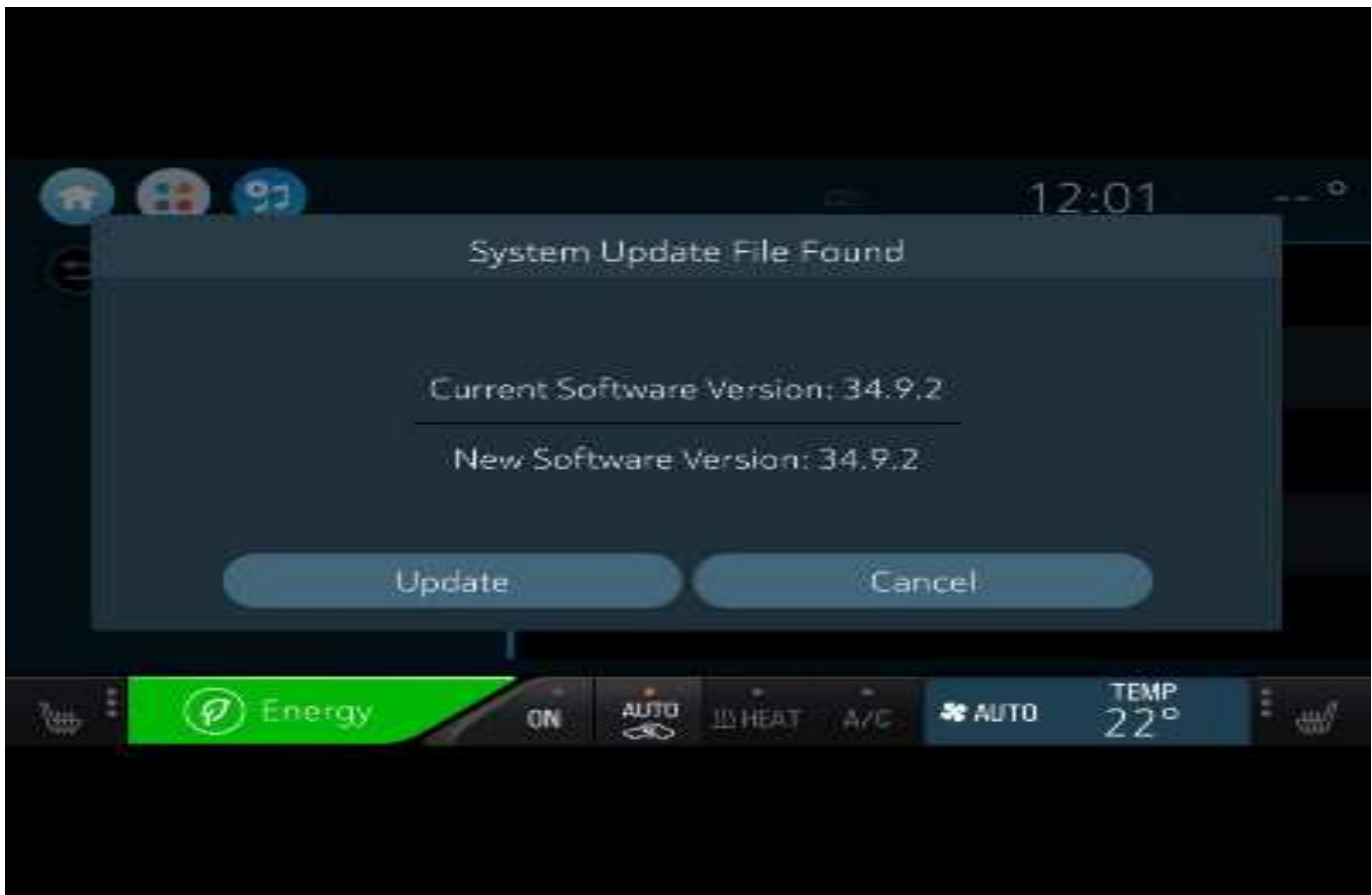
Model Year 2019:

1. Reprogram the radio through USB update. Refer to *A11 Radio: Programming and Setup* in SI and download the files needed to a USB drive using TIS2WEB.
2. Insert the USB stick into the USB receptacle in the vehicle and follow the on-screen instructions.
