GROUP ELE	MODEL 2016-2017MY Soul (PS EV)
NUMBER 238	DATE May 2021

TECHNICAL SERVICE BULLETIN

SUBJECT: SERVICE ACTION: BMS/FATC OPERATION LOGIC IMPROVEMENT WHILE BATTERY CHARGING (SA473)

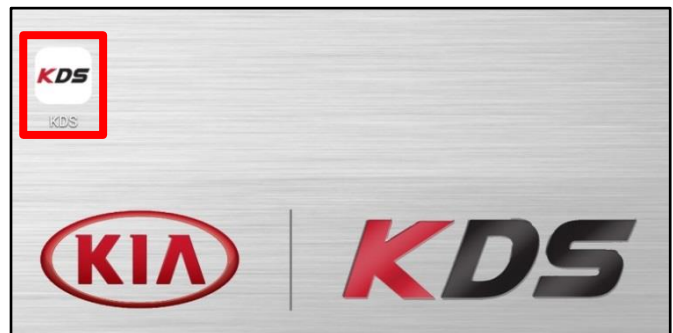
2. With the ignition ON, turn ON the KDS tablet. Select **KDS** from the home screen.

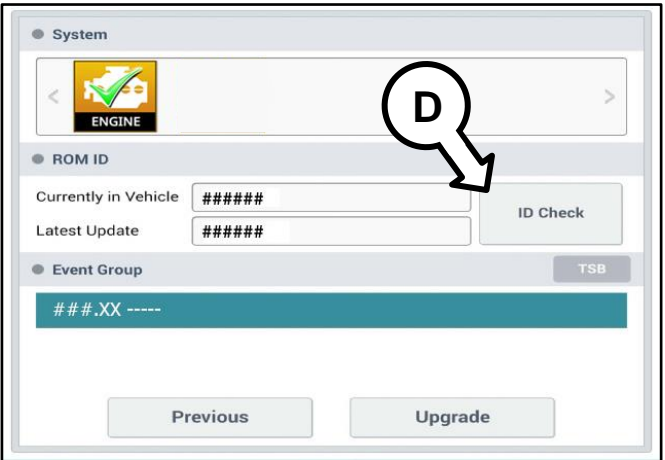
- Select the **BMS/FATC** system under the System selection menu.

Touch **ID Check (D)** and confirm that the latest update is available.

Select **Upgrade Event #501 and #540** and select **Upgrade** to continue.
